Foul and Surface Water Drainage Strategy Report

Victoria House, 2 – 4 Ennerdale Road, Kew Gardens, Richmond, Surrey TW9 3PG

Reference **C3247**

Date **11th November 2024**

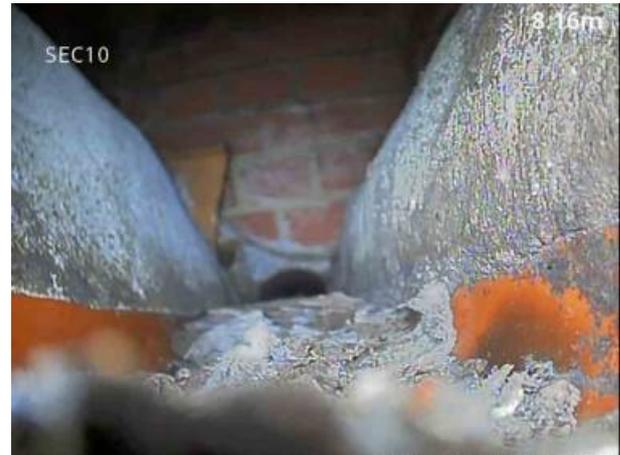
7, 00:00:46, 8.16 m
Settled deposits, coarse, 35% cross-sectional area loss, start

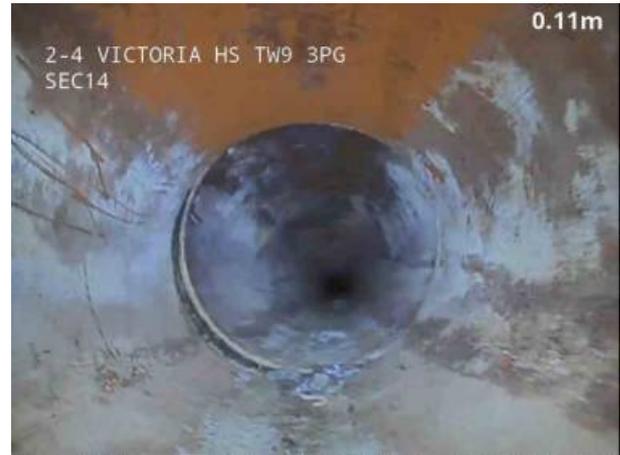
2, 00:00:04, 0.30 m
Open joint, medium

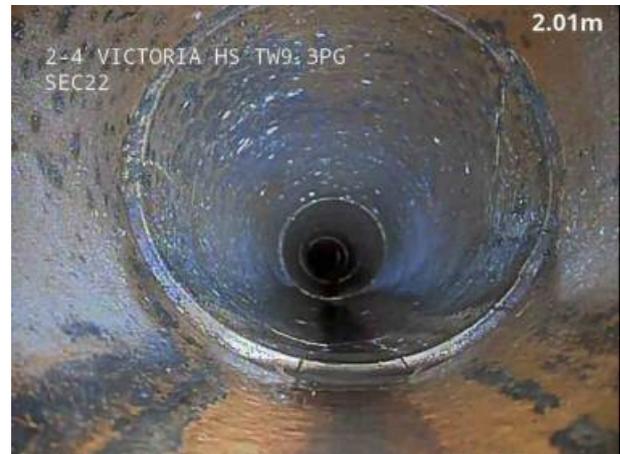
3, 00:00:43, 1.70 m
Fractures, multiple at joint from 10 o'clock to 6 o'clock

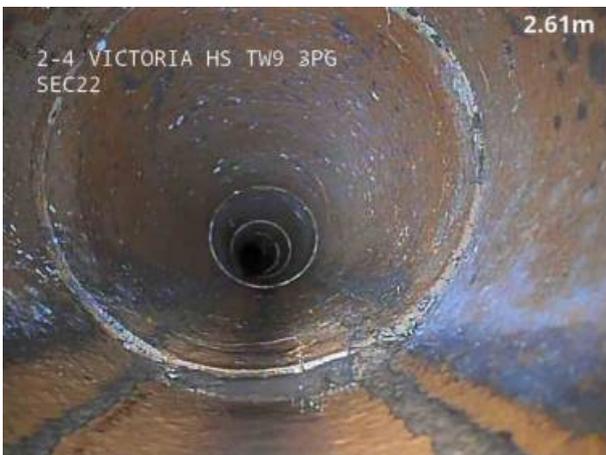
4, 00:00:47, 2.30 m
Fractures, multiple at joint from 2 o'clock to 9 o'clock

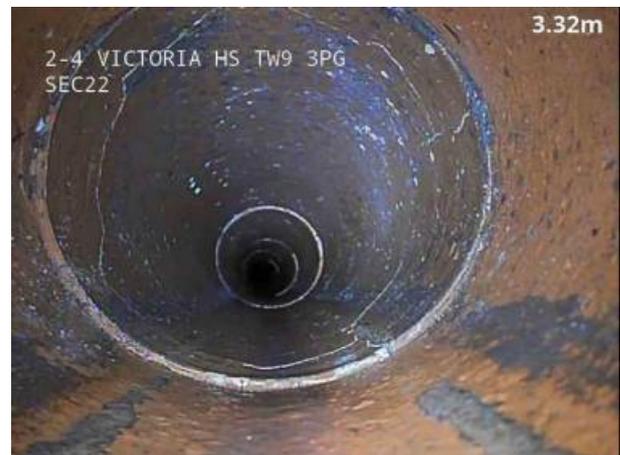
5, 00:00:55, 2.90 m
Fractures, multiple at joint from 1 o'clock to 8 o'clock

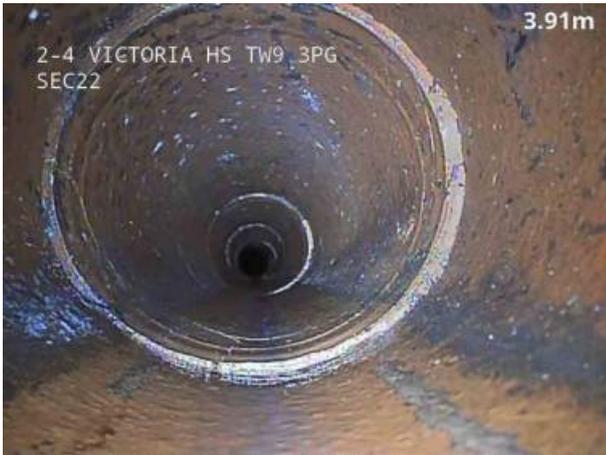
6, 00:01:00, 3.60 m
Fractures, multiple at joint from 12 o'clock to 12 o'clock

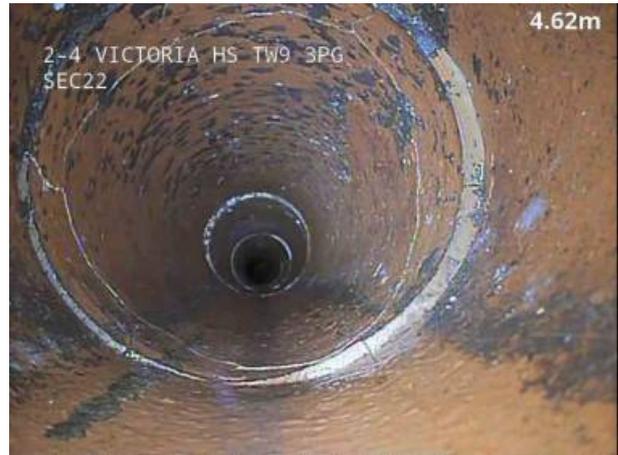
7, 00:01:12, 4.20 m
Fractures, multiple at joint from 12 o'clock to 12 o'clock

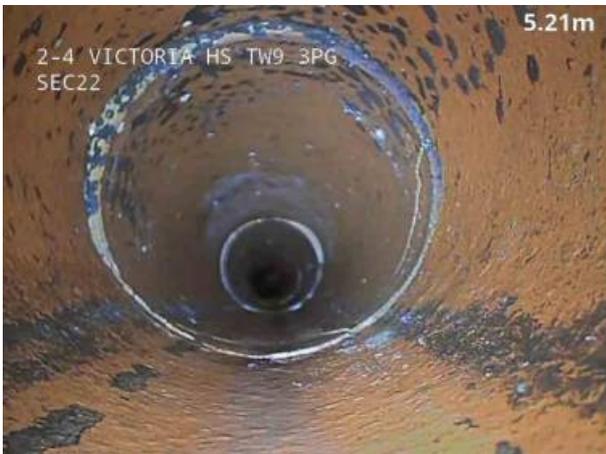
8, 00:01:19, 4.90 m
Fractures, multiple at joint from 12 o'clock to 12 o'clock

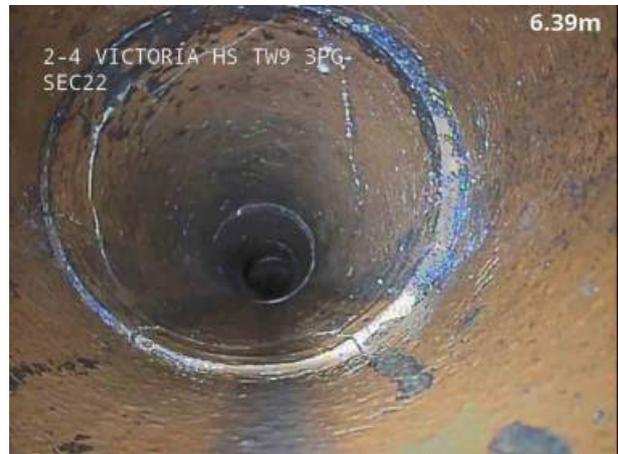
9, 00:01:39, 5.50 m
Fracture, circumferential at joint from 3 o'clock to 7 o'clock

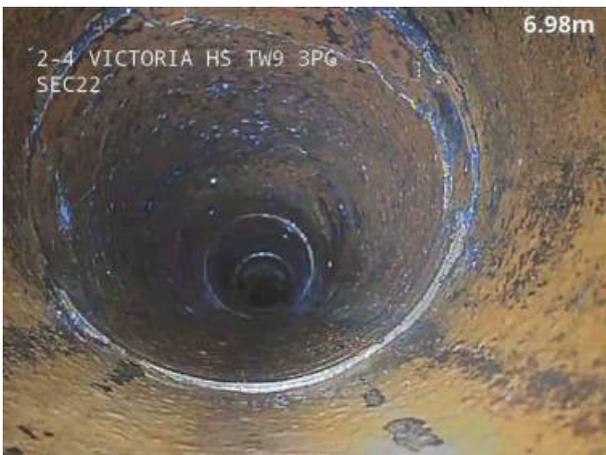
10, 00:02:04, 6.70 m
Fractures, multiple at joint from 4 o'clock to 12 o'clock

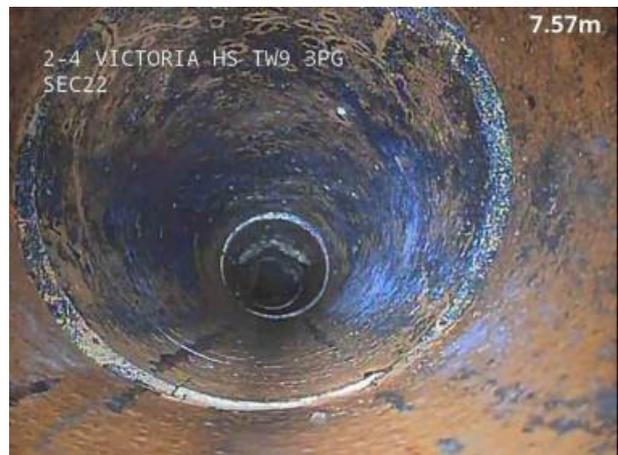
11, 00:02:14, 7.30 m
Fracture, circumferential at joint from 9 o'clock to 3 o'clock

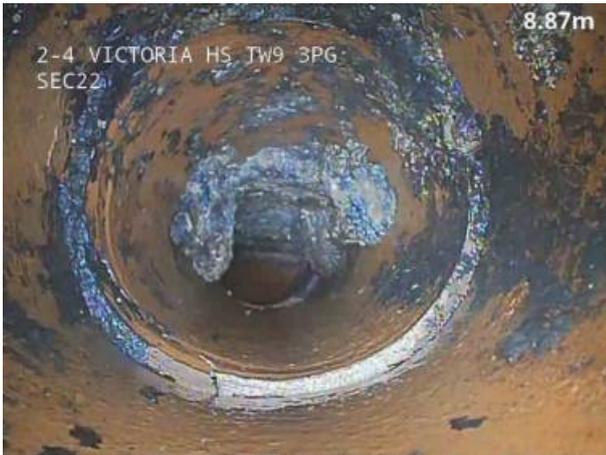
12, 00:02:21, 7.90 m
Fracture, circumferential at joint from 12 o'clock to 12 o'clock

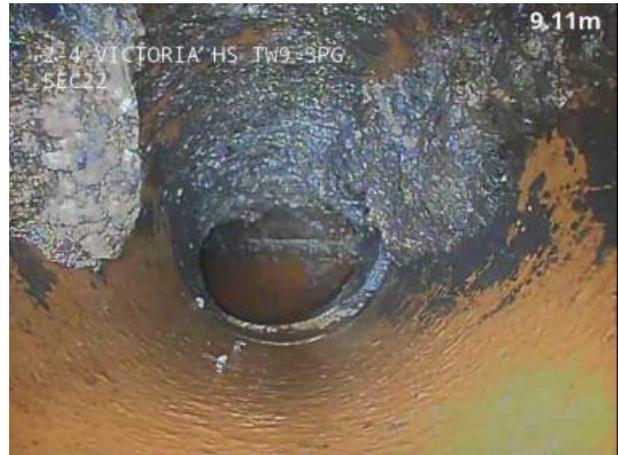
13, 00:02:36, 9.00 m
Fracture, longitudinal at joint at 7 o'clock

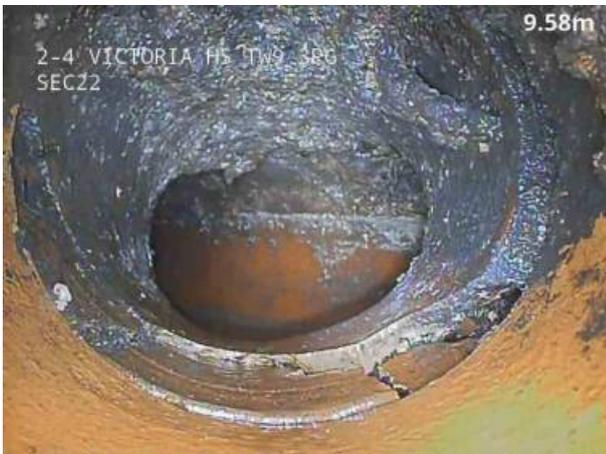
14, 00:02:43, 9.20 m
Attached deposits, grease from 9 o'clock to 3 o'clock, 20% cross-sectional area loss, start

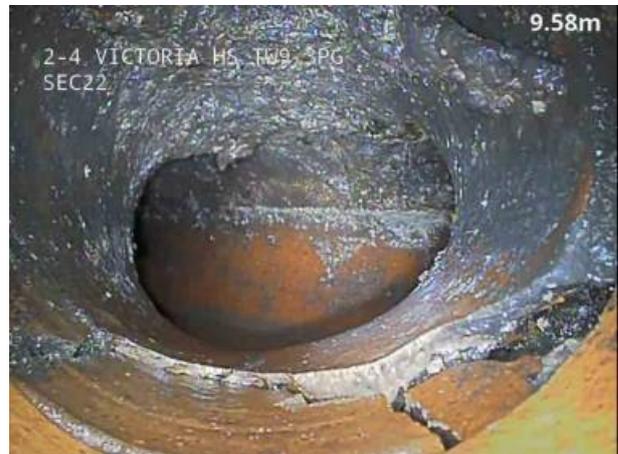
15, 00:02:46, 9.70 m
Fracture, circumferential at joint from 4 o'clock to 10 o'clock

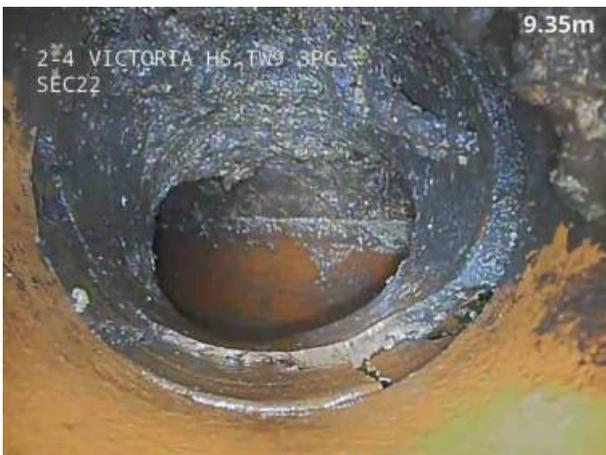
16, 00:02:48, 9.70 m
Hole in drain or sewer at 4 o'clock

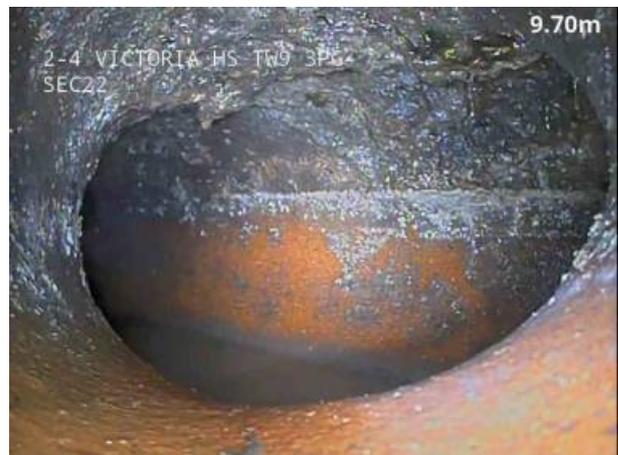
17, 00:02:52, 9.70 m
Broken pipe at joint from 4 o'clock to 8 o'clock
