4 Maids of Honour Row: Phase 2, Timber condition investigation

Site note 5 for 30 August 2023, job no. 157-65

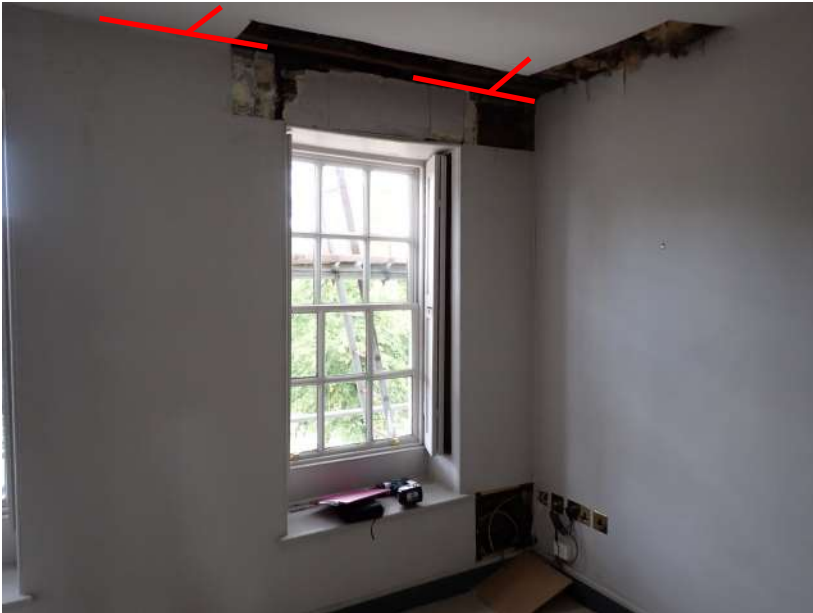
Fig 1:

Structural decay identified to multiple roof timbers in contact to the north parapet wall. Surface and deep moisture contents too dry to support active decay organisms. All decay presumed to be of historic origin relating to failure to the internal trench gulley and parapet gutter leadwork. Decayed items included;

- East tie beams north bearing end structurally decayed for ~150mm
- Rafter plate structurally decayed to 2no. areas for a total of 1.25m
- 2no. common rafter feet decayed for <100mm

P11, roof; showing general view towards the north-east timber roof structures adjacent to the external main rainwater downpipe. Note structural decay detected to 2no. areas to the rafter plate and to historic common rafter feet in this location as indicated by the red lines

Structural Engineer to comment upon the condition to the visibly unstable parapet masonry to the north-east area. Provisionally allow for the making good to the affected masonry structures in conjunction to (opening) works to repair identified decayed timbers items. This should include for the cutting back to all decayed items and piecing in new timber of like species/dimensions to a detail approved by H+R and the Structural Engineer. Consideration should be given to supporting the primary end to the decayed tie beam with a suitable steel shoe/flitch plate under the direction of the Structural Engineer. Decayed common rafter ends may be partnered with new timbers at >800mm overlap to sound timber and bolted together with stainless fixings at ~150mm centres

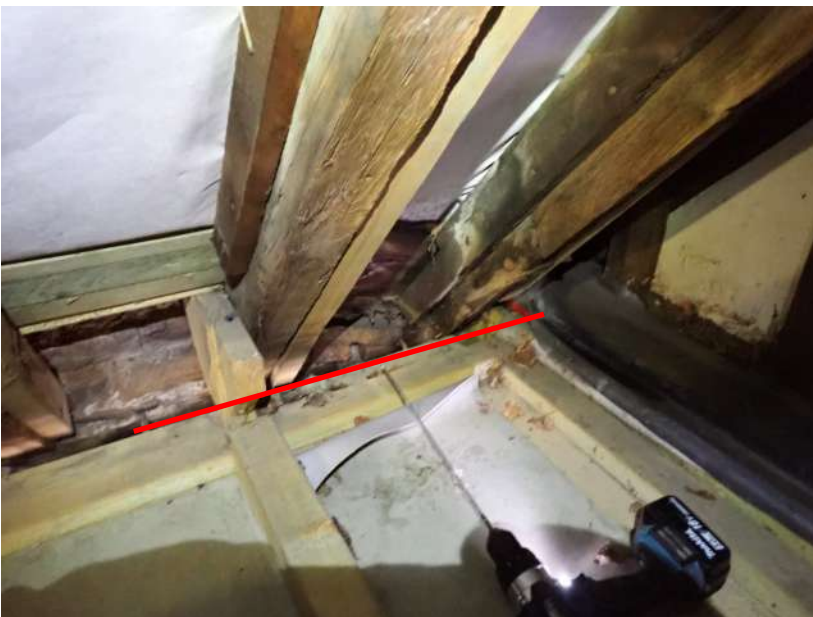
Fig 2:

Also subsequent to structural decay to partially embedded rafter plate timbers it was noted that the parapet masonry brickwork had partially collapsed/was unstable to 2no. areas due to structural settlement. See Plans at Attachment B for marked-up locations of structural decay and loose parapet masonry

P11, roof, north-east corner; showing closer view to structurally decayed rafter plates to the north-east corner for approximately 500mm. Also note subsequent destabilisation of the parapet masonry above. Structural Engineer to comment

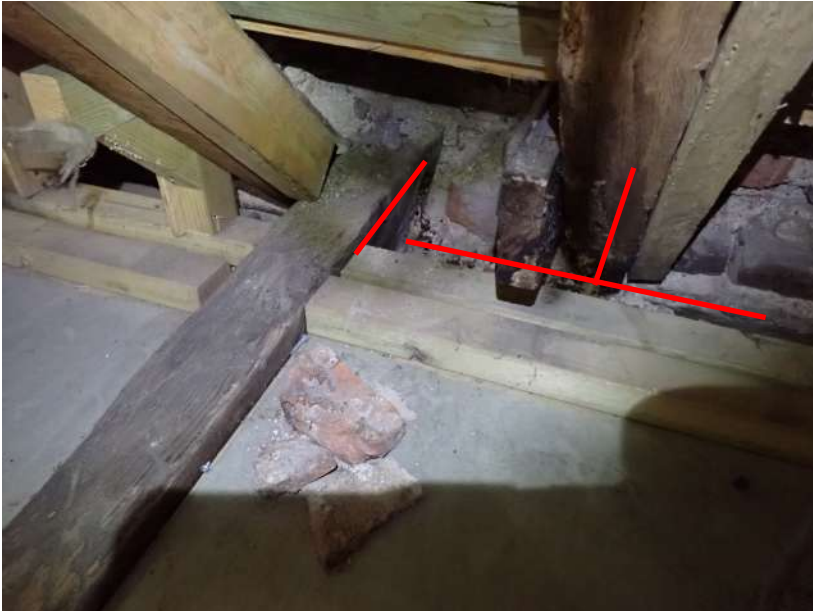
Fig 3:

P11, roof; showing general view towards the central area roof structures to the north parapet wall. Note structural decay detected to the principal tie beam north bearing end as well as to the underlying plate and 1 no. common rafter as indicated by red lines

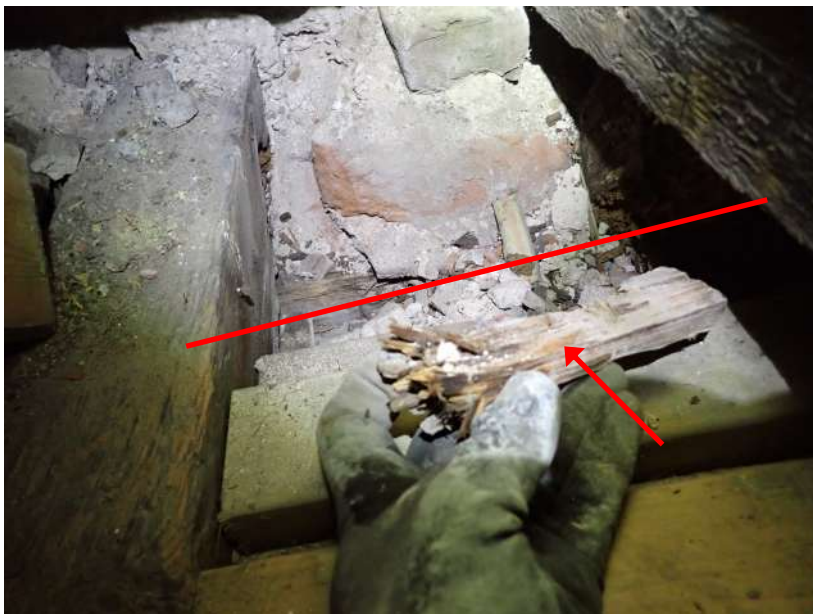
Fig 4:

P11, roof, north parapet; showing closer view to the structurally decayed embedded rafter plate also supporting the tie beam end. Note pieces of decayed timber can easily be removed by hand as indicated on site by author

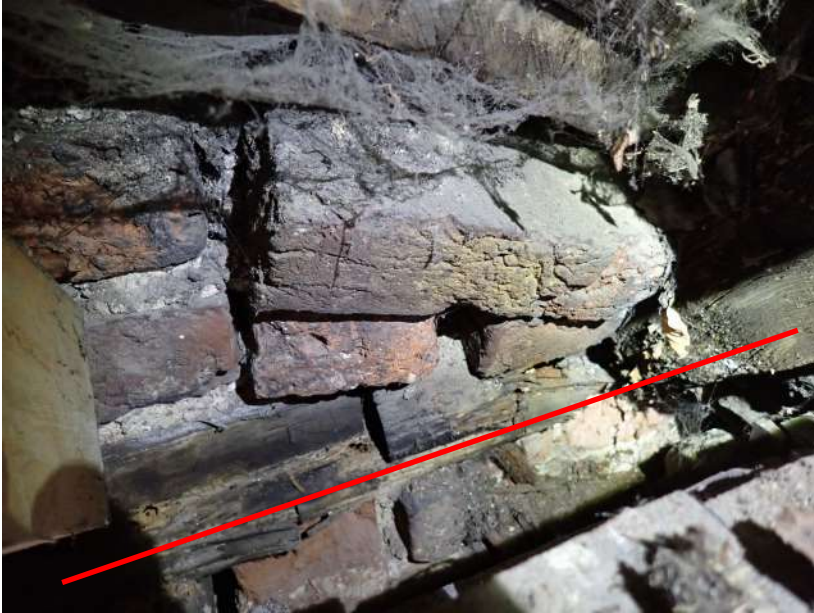
Fig 5:

P11, roof, north perimeter parapet gutter; showing area of decayed embedded rafter plate. Also note subsequent destabilisation to the masonry parapet wall head above. Structural Engineer to comment

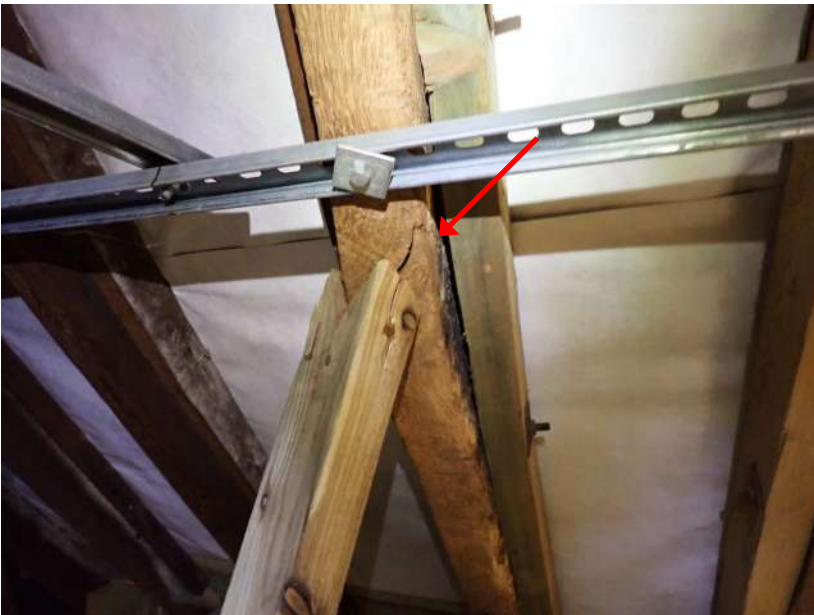
Fig 6:

Roof, north pile, north pitch roof; showing 1 no. common rafter subject to a structural fracture to its mid-span which had subsequently been remedially propped by a raking strut member. No further action required

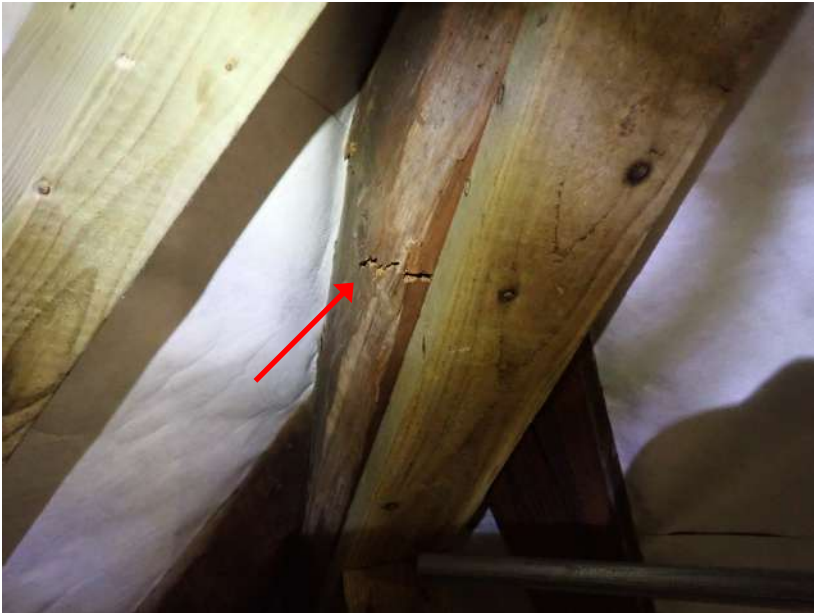
Fig 7:

Roof, north pile, north-west hip; showing significant structural failure/fracture to the hip at its mid-span. Note hip rafter had been subsequently partner repaired to its underside with new member which may not be sufficient to support envisaged structural loadings. Structural Engineer to comment

Further to identified decay issues to the prescribed area to P11, it was generally noted throughout the roof structures forming the north and south pile roofs, that apparently insufficient structural support had been provided to the roof structures with the omission of purlins, collars and struts. Consequently, much deflection and bowing to common truss assemblies was noted throughout, with numerous fractures local to knot locations and general growth/grain defects. Subject to approval by the relevant Conservation Authorities, the Structural Engineer and the Architects, H+R therefore suggest that consideration is given to the introduction of a new internal superstructure feature purlins and queen post struts so as to shore-up the existing historic roof structures. H+R can provide further assistance if instructed

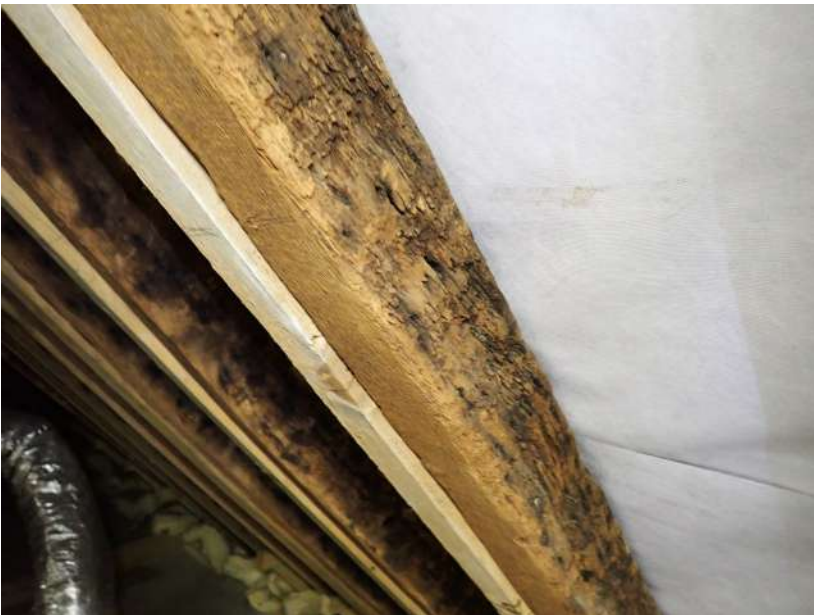
Fig 8:

Roof, north pile, north pitch; showing representative historic oak common rafter which had presumably been re-used/salvaged to its current location due to the evidence of multiple generations of roofing batten fixings corrosion and weathering to its side face indicating the historic common rafter had been rotated for its re-use to its current position. Also note evidence for purlin 'square' cleft oak pegs also identifiable

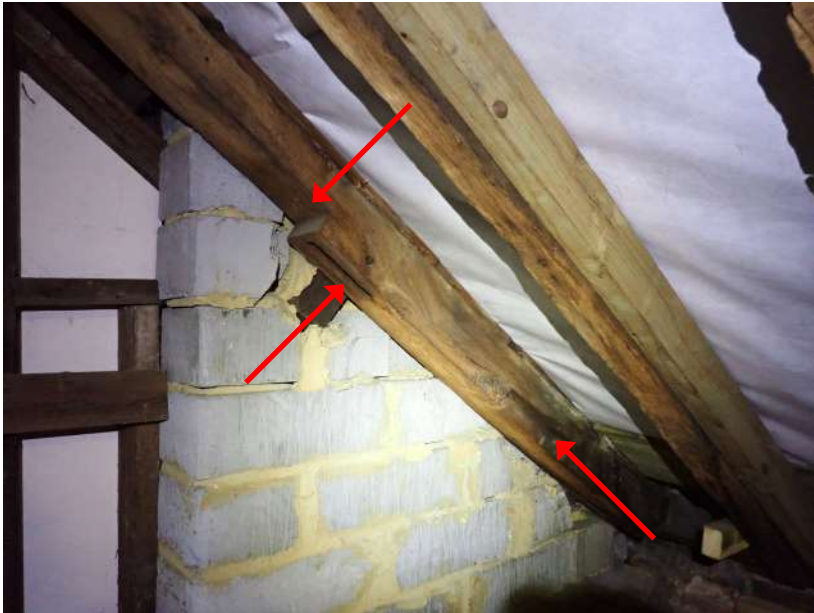
Fig 9:

Roof; showing representative image to a presumed historically reclaimed timber element to the north pile roof east internal party wall. Note historic oak member presumably once formed a principal rafter with a clasped purlin queen strut arrangement with a side mortice to house an historic wind brace

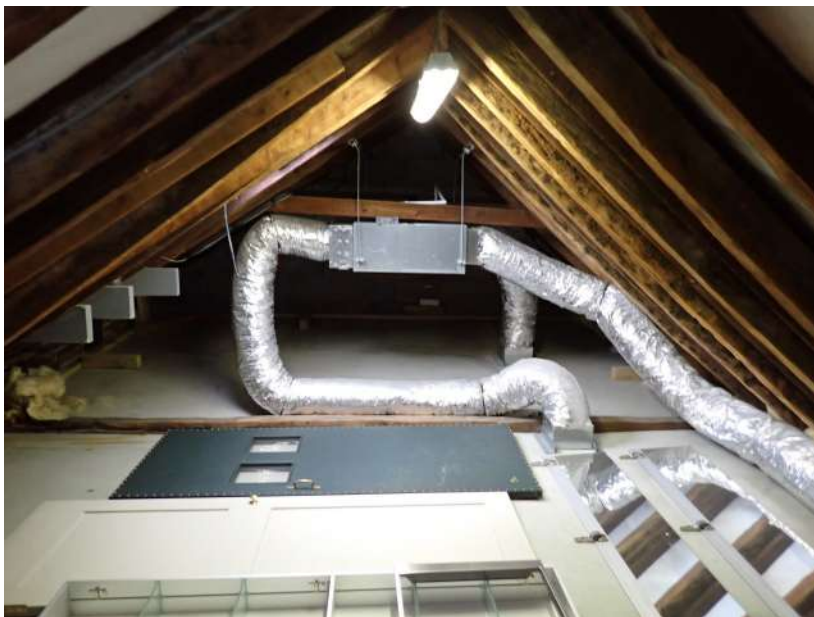
Fig 10:

Roof; showing general view to the south pile roof. Note all roof structures were without a continuous ridge, purlin members, collars or struts. Roof structures solely formed by common rafter arrangements with lapped or tenon joints at their ridge apex. No lateral support is provided to the roof build-up with much subsequent evidence for inwards bowing/deflection to the common rafter assemblies under the existing roof loadings and presumably outward raking at the eaves junctions. Structural Engineer to comment. Provisionally allow for the introduction of new purlin members, collars and raking struts to strengthen existing historic roof structures to support ongoing envisaged loadings

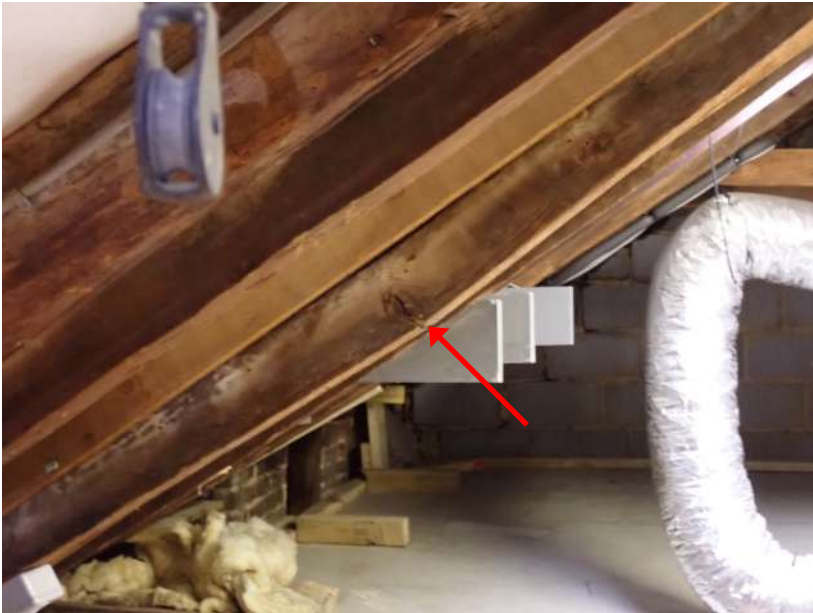
Fig 11:

Roof, south pile, north pitch; showing representative historic softwood roof member subject to severe structural fracture at its knot location to its mid-span due to inadequate support/no provision for support from purlins, collars or struts. Structural Engineer to comment

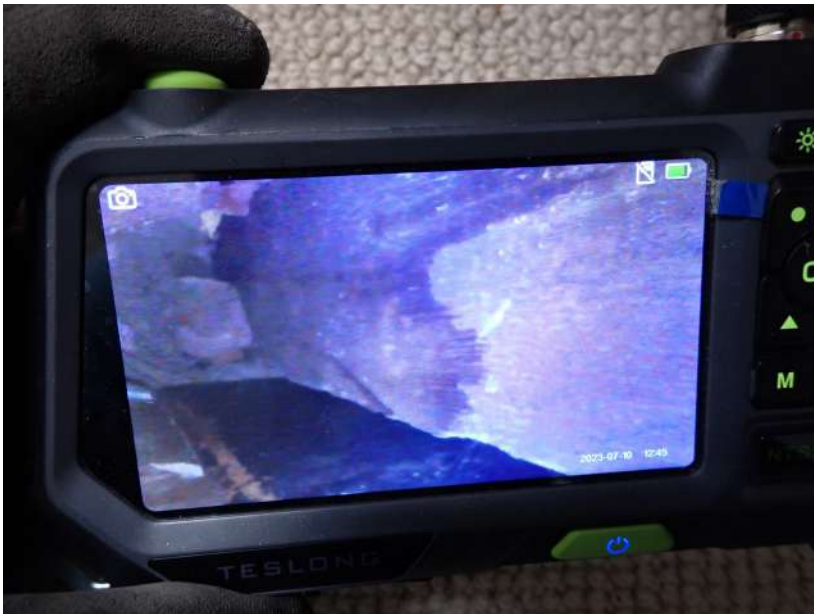
Fig 13:

P15, second floor; showing a videoscope image to the most vulnerable floor joist embedded into the north-east corner. Note visible evidence for damp staining due to historic water penetration from failed roof finishes above in the past. However, no significant decay issues detected or presumed.

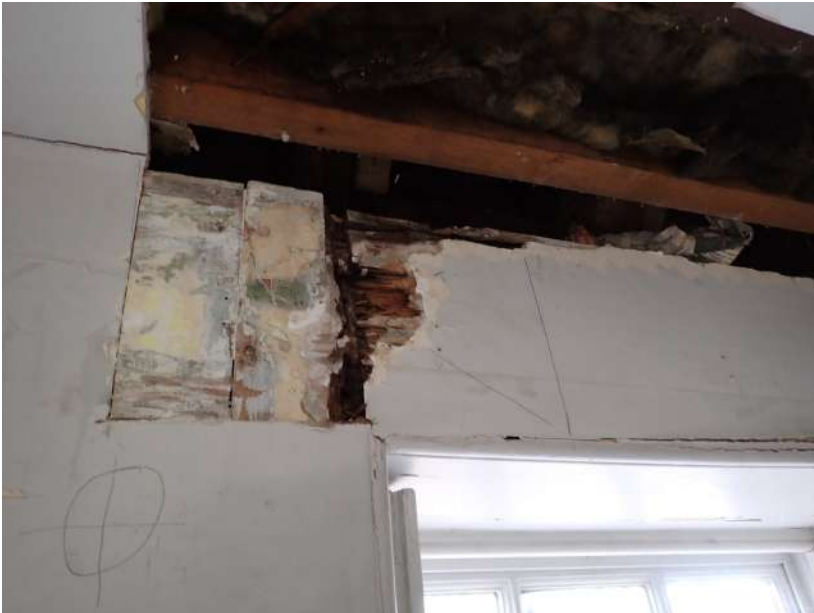
Fig 15:

P11, second floor, north-east lintel; showing superficial decay to the upper window reveal/fascia which was not concealing a lintel due to no structural loading bearing onto this point. Main lintel formed of embedded rafter plate above/to the rear

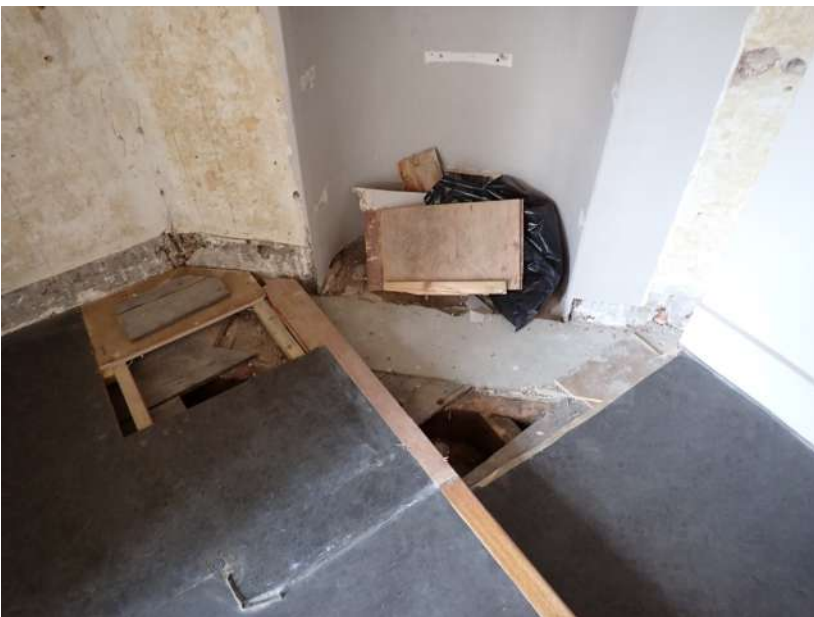
Fig 16:

P12, second floor; showing general view towards the exposed floor structures adjacent to the north-west hearth location. Historic floor structure existing beneath the overlaid modern softwood timber floor. Accessible and representative timbers were deep drilled and moisture probed. No decay or structural issue detected

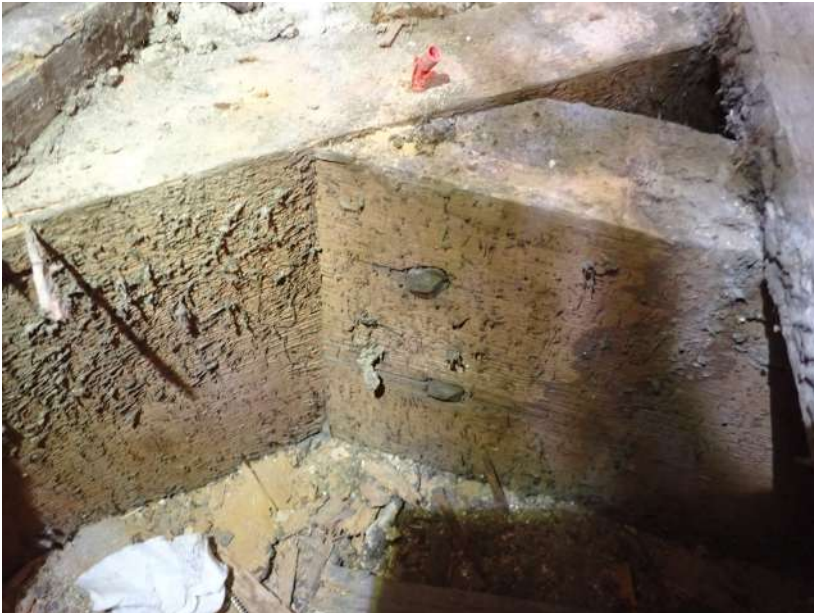
Fig 17:

P12, second floor; showing representative view to a common floor joist jointed to the diagonal half trimmer with a basic mitre joint and fixed with 2 no. large apparently hand forged ferrous fixings. No defects identified

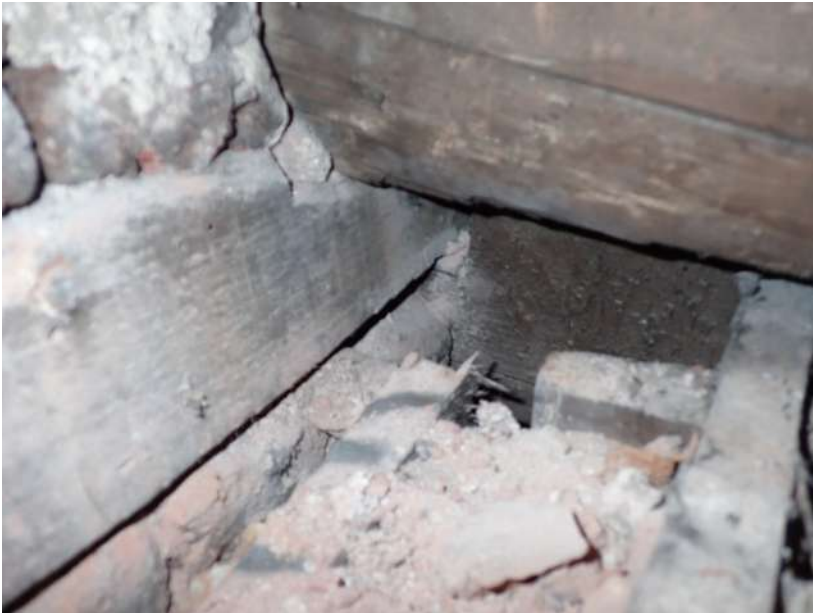
Fig 21:

Second floor, north-east corner; showing construction detail towards the north-east corner junction where the perimeter floor joist embeds into the external west flank wall. Note that the floor joist was embedded onto a perpendicular horizontal floor plate, which was apparently of oak and had no visible water staining damage or apparent decay issues

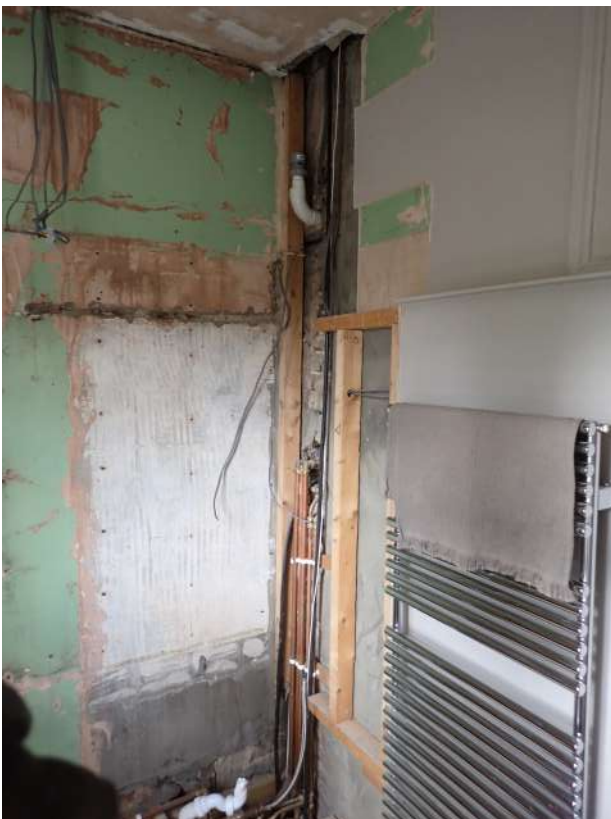
Fig 22:

P8, second floor; showing general view towards the partially exposed flat roof and floor structures to the south area. Available embedded bearing ends to the flat roof joists and floor joists were resistance drilled and deep moisture probed. No decay detected. All deep moisture contents below 8% which is too dry to support active decay organisms at the time of investigation

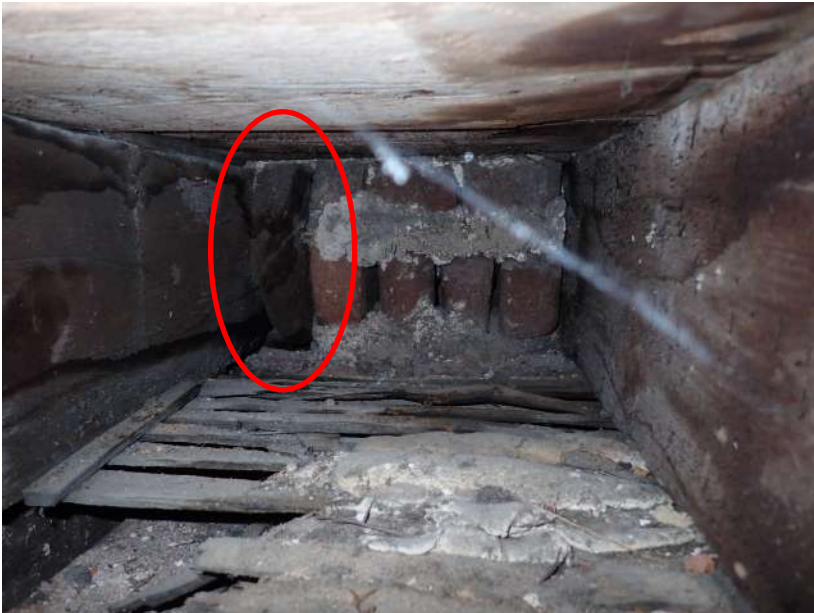
Fig 25:

P6, first floor; showing view to the floor void looking east towards the internal party wall. Note east-west orientated floor joists apparently embedded directly into the wall without provision for a longitudinal wall plate beneath. Also note that the floor joists apparently partner to the party wall floor joist which penetrate the full depth of the party wall masonry and are presumably nailed together

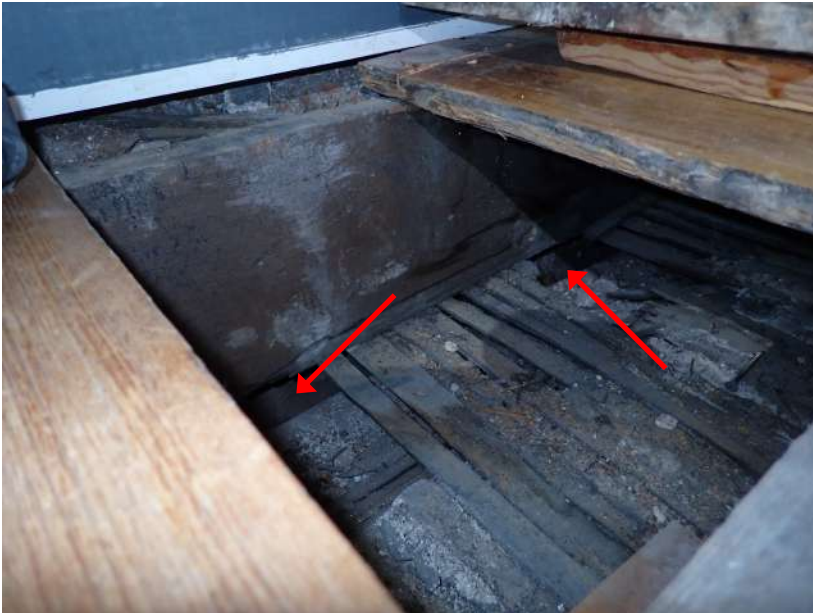
Fig 27:

P6, first floor; showing view towards the north perimeter wall. Note the visible softwood timber lintel to the ground floor structures beneath over the north-east window aperture. Accessible for deep drilling and moisture probing from the first floor level as indicated by red arrows

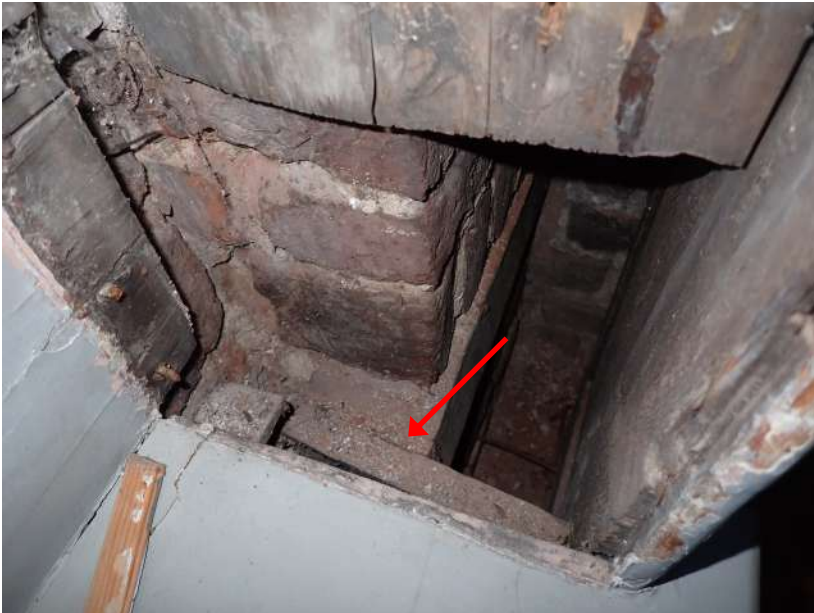
Fig 29:

P7, first floor, north-east corner; showing general view of opening into the window reveal showing the timber panelling build-up. Note visible evidence of a continuous embedded bonding timber formed in oak, which would have originally spanned the window aperture during the curing process to the masonry during the original construction phase. It had subsequently been cut short and used as a grounding location for a timber panel support slat

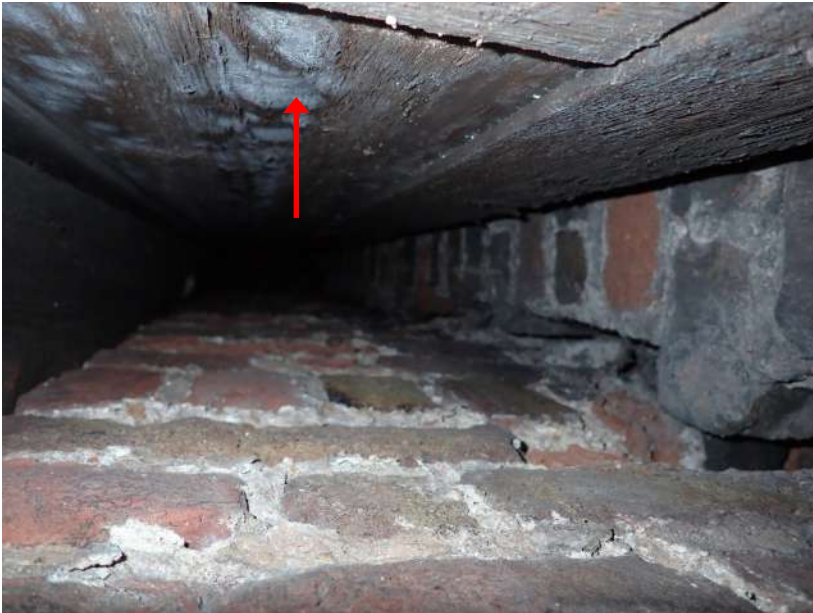
Fig 31:

No structural or concerning decay was identified to accessible areas to the panelling or embedded bonding timber structures. Surface and deep moisture contents were too low to support active decay organisms. However, some visible mould spores were seen to the rear face to panel members likely relating to previous failure to the external downpipe creating interstitial condensation issues within the unventilated void. Mould issues were generally assumed to be inactive at the time of investigation. Further to this, it was noted that the north façade elevation had separated from the east internal division masonry wall by up to ~40mm, although this movement was deemed to be of historic occurrence

P7, first floor; showing view of void to the north-east corner between the external north façade masonry wall and the internal panelling. Note evidence of mould spores to the rear face of the historic panelling indicative of moisture penetration issues to the area from the failed external rainwater downpipe in the past and present allowing interstitial condensation to form within the unventilated void. However, no significant structural decay detected to available timber elements and timbers benefitting significantly from the increased ventilation channels to the existing exposed areas

Structural Engineer to comment on opening/partial separation between the north façade and internal east division wall. No further action required in regard to decay issues providing no further water penetration is allowed to occur. Allow for mould affected surfaces to be cleaned. This may be achieved by first vacuuming the affected area prior to wiping down with a dilute solution of water to bleach at 10:1 mixture before swabbing dry. A consistent regime of background heating and ventilation is advised to the property in general during periods of reduced occupancy. It is recommended that removed areas of panelling remain open to allow for increased ventilation for the duration of 2023

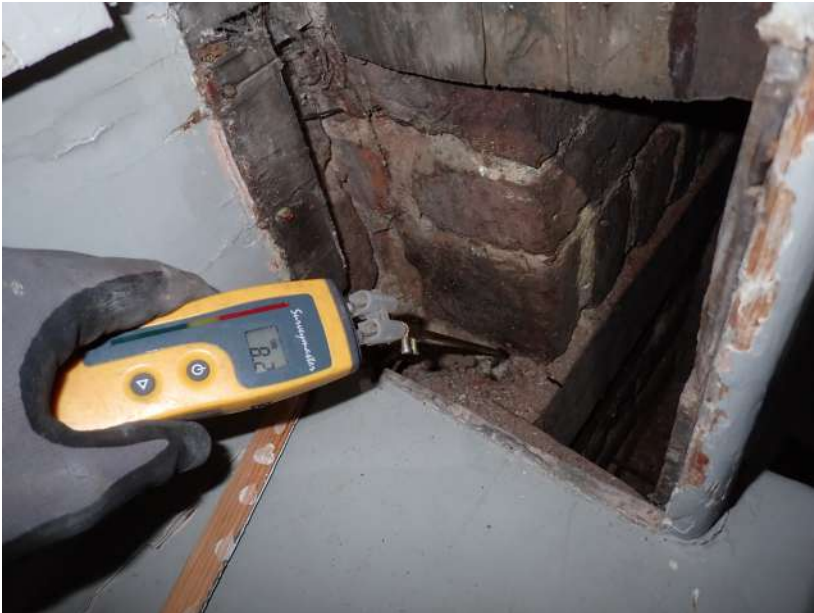
Fig 33:

P7, first floor; showing a representative deep moisture content to the embedded oak bonding timber recorded at 8.2% which is too dry to support active decay organisms at the time of investigation

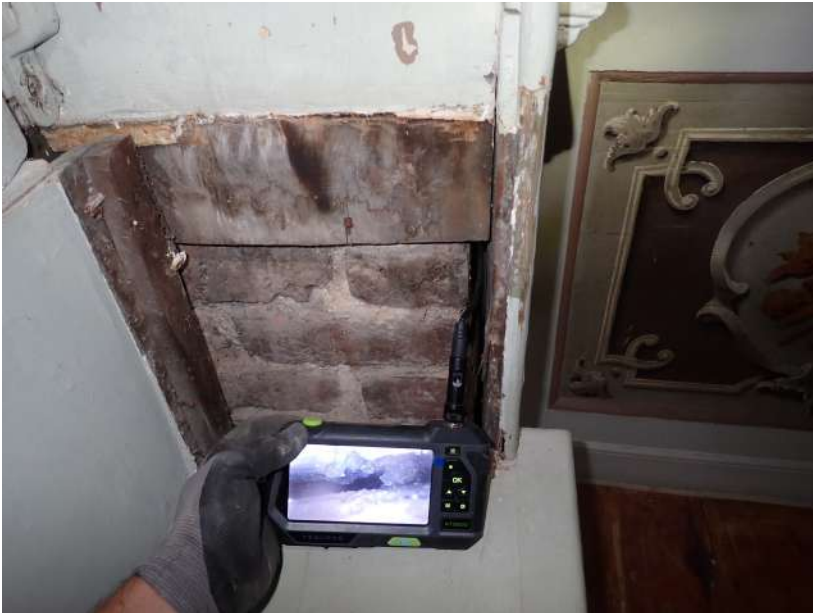
Fig 35:

P5, ground floor; showing a sample area of panel cavity void investigated by video borescope inspection. No significant decay detected, although superficial surface mould growth identified to the back side of all panel elements in this area indicative of intermittent water penetration from the failed external downpipe

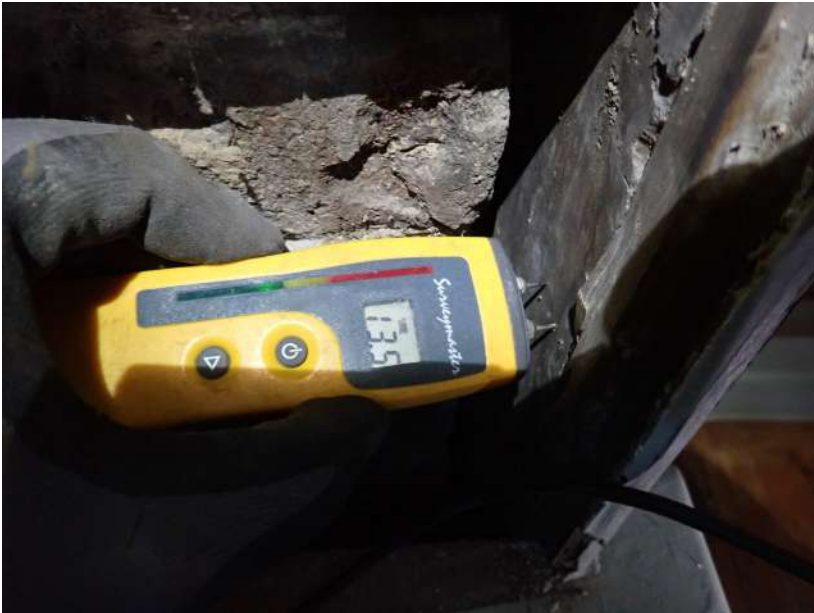
Fig 37:

P5, ground floor; showing a representative surface moisture content reading to the rear side to a wall panel at 13.5%

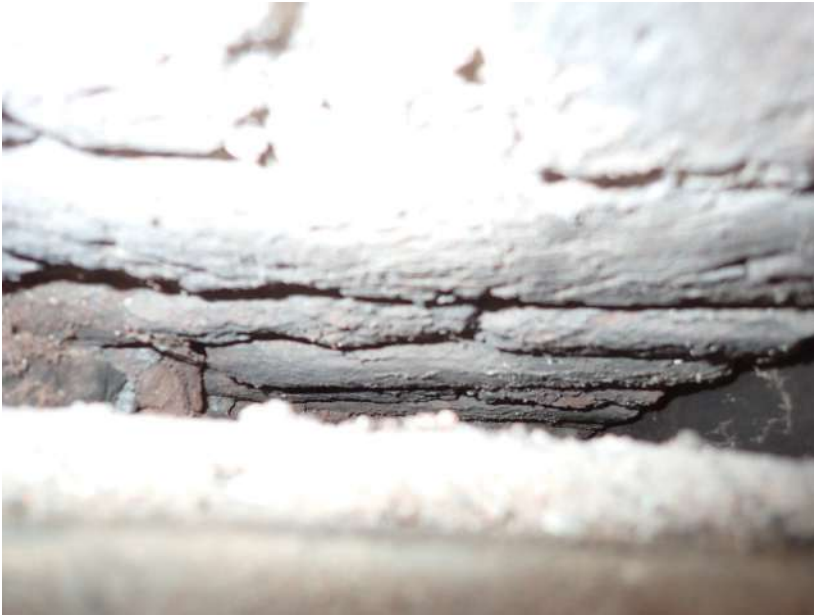
Fig 39:

P5, ground floor; showing view to the partially exposed void between the north-east window reveal and the north facade masonry wall. Note no visible evidence for an embedded bonding timber in this area as identified at first floor structures above

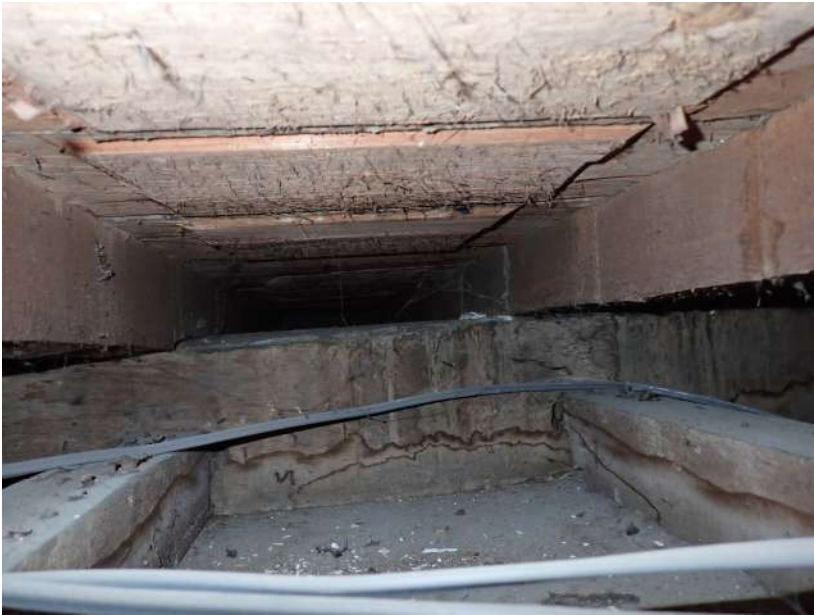
Fig 41:

P4, ground floor; showing representative view toward the floor void looking west. Note construction arrangement of floor structures in a 'double-floor' arrangement whereby the secondary floor beam supported independent parallel floor and ceiling joist elements

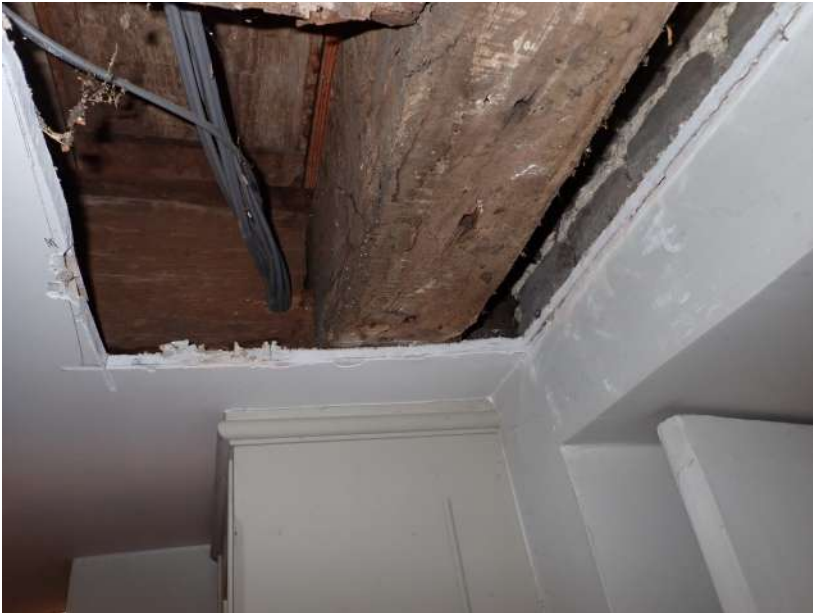
Fig 43:

P4, ground floor; showing view to the junction between the north façade perimeter secondary beam bearing onto the north-south running primary beam. The north primary beam bearing end was deep drilled and moisture probed. No decay detected. Deep moisture content at <10%

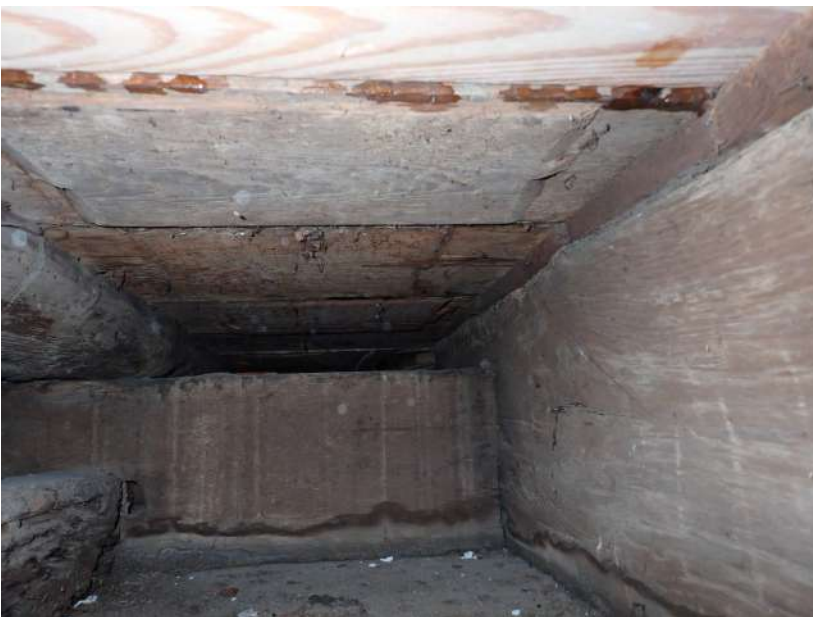
Fig 44:

P4, ground floor; showing a representative view towards the floor void looking south where the central secondary beam meets the primary north-south running principal beam. No defects identified

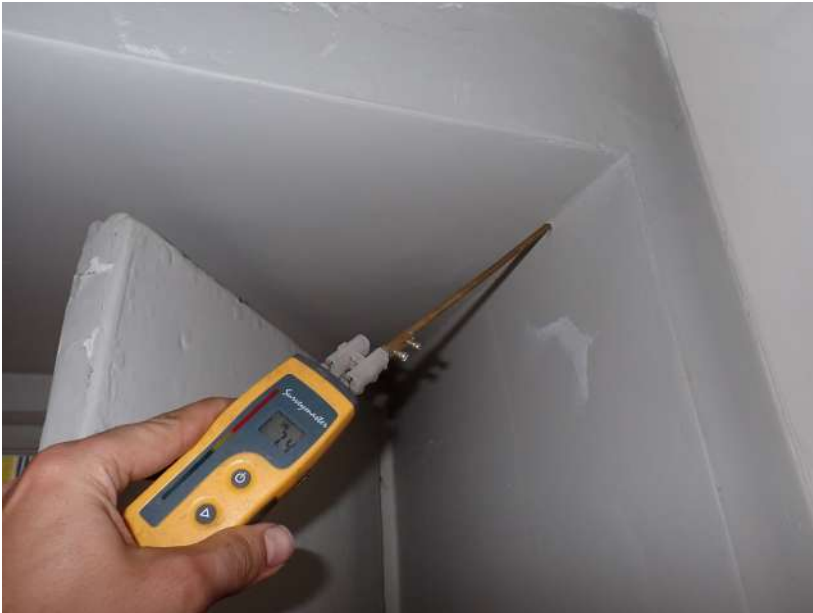
Fig 47:

P4, basement; showing a deep moisture content reading to the micro bore resistant drill holes to the north-east timber lintel at its south bearing end. Deep moisture content recorded as dry at 8%

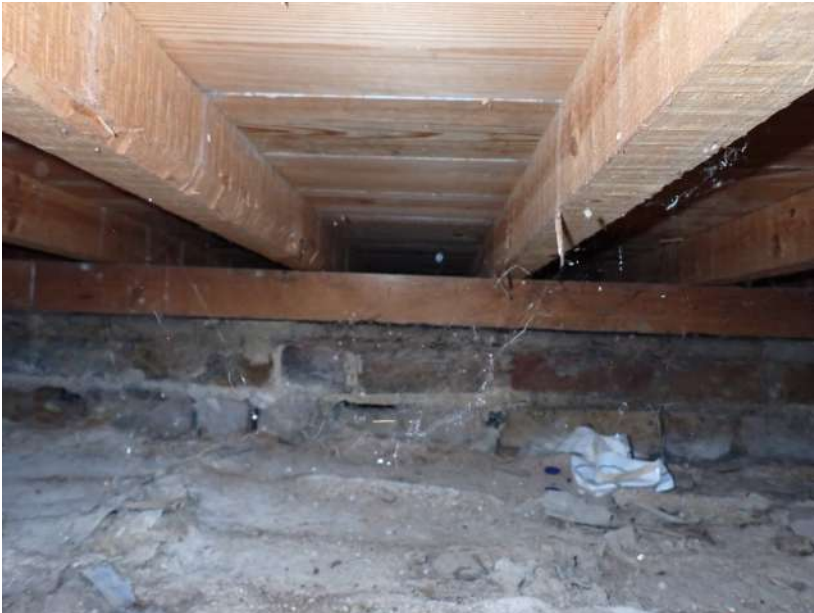
Fig 51:

P2, basement; showing representative view towards the floor void looking west. Note central division north-south orientated wall plate supported onto the historic brick plinth wall and provided with a suitable DPM. No decay organisms identified or presumed

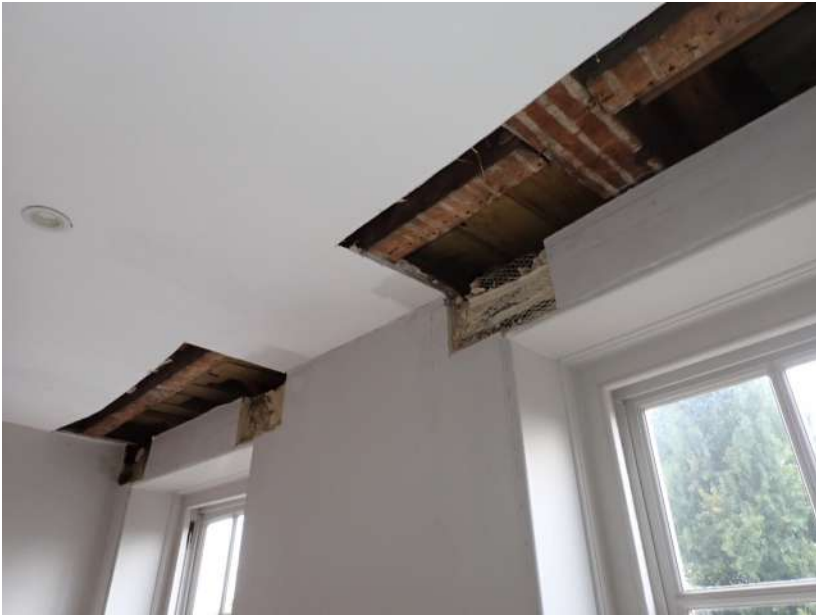
Fig 53:

P10; showing general view towards the exposed south pile roof structure from second floor level to the south-east corner. No decay or structural issues identified

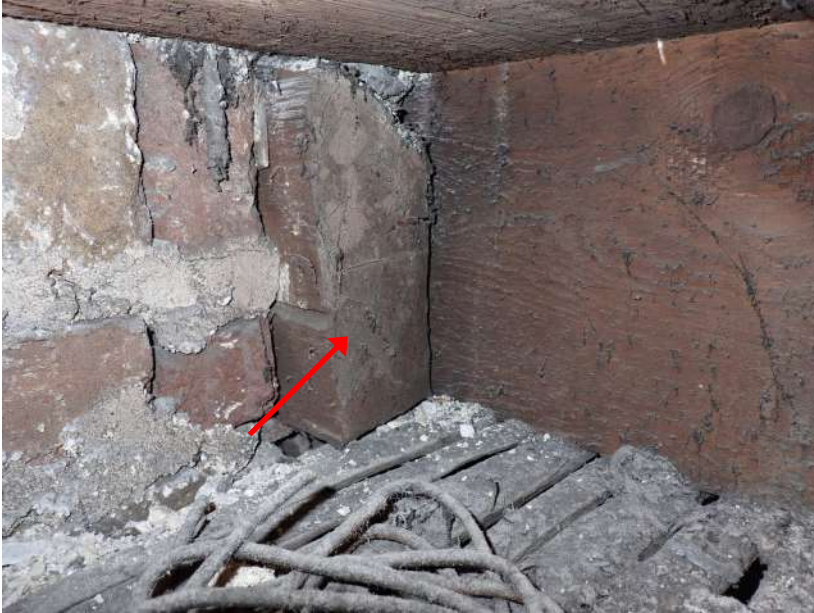
Fig 55:

P9, second floor; showing a detailed view of the floor joists embedded into the internal division party wall to the south-east corner. Note like constructional detail as identified at first floor level, whereby the party wall floor joist apparently penetrate the full extent or depth of the party masonry wall and are partnered to the neighbouring properties floor joists
