4 Maids of Honour Row: Phase 2, Timber condition investigation

Site note 5 for 30 August 2023, job no. 157-65

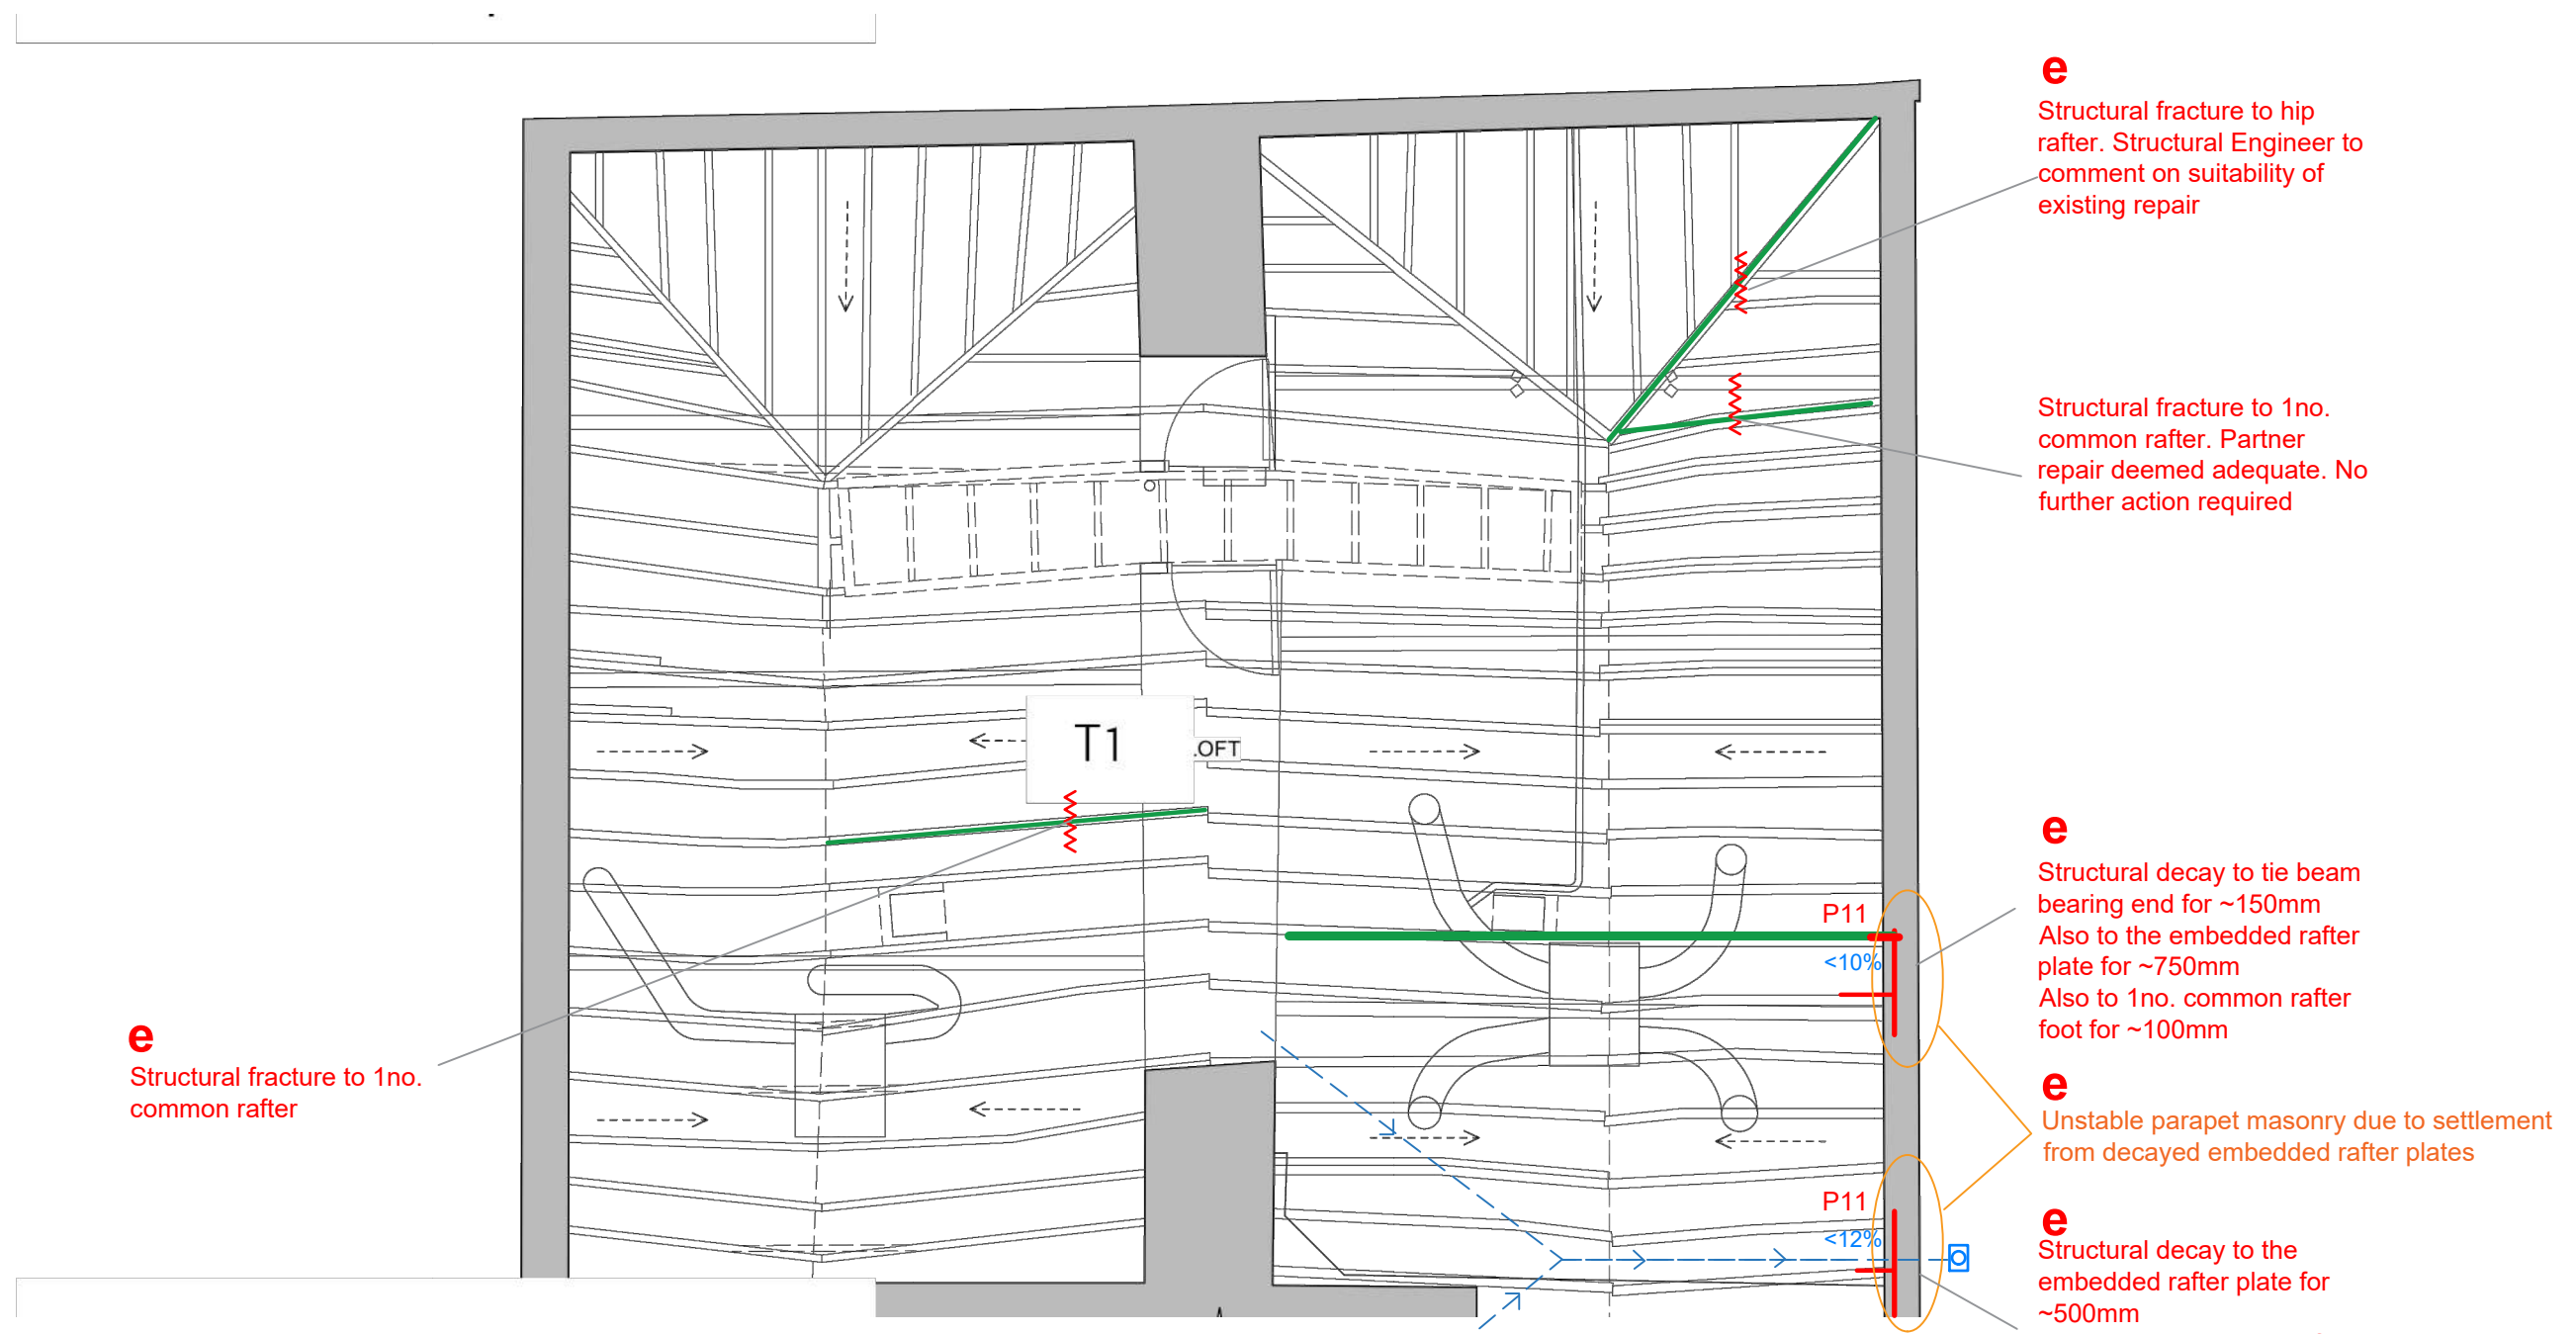
e
Structural fracture to 1no. common rafter

e
Unstable parapet masonry due to settlement from decayed embedded rafter plates

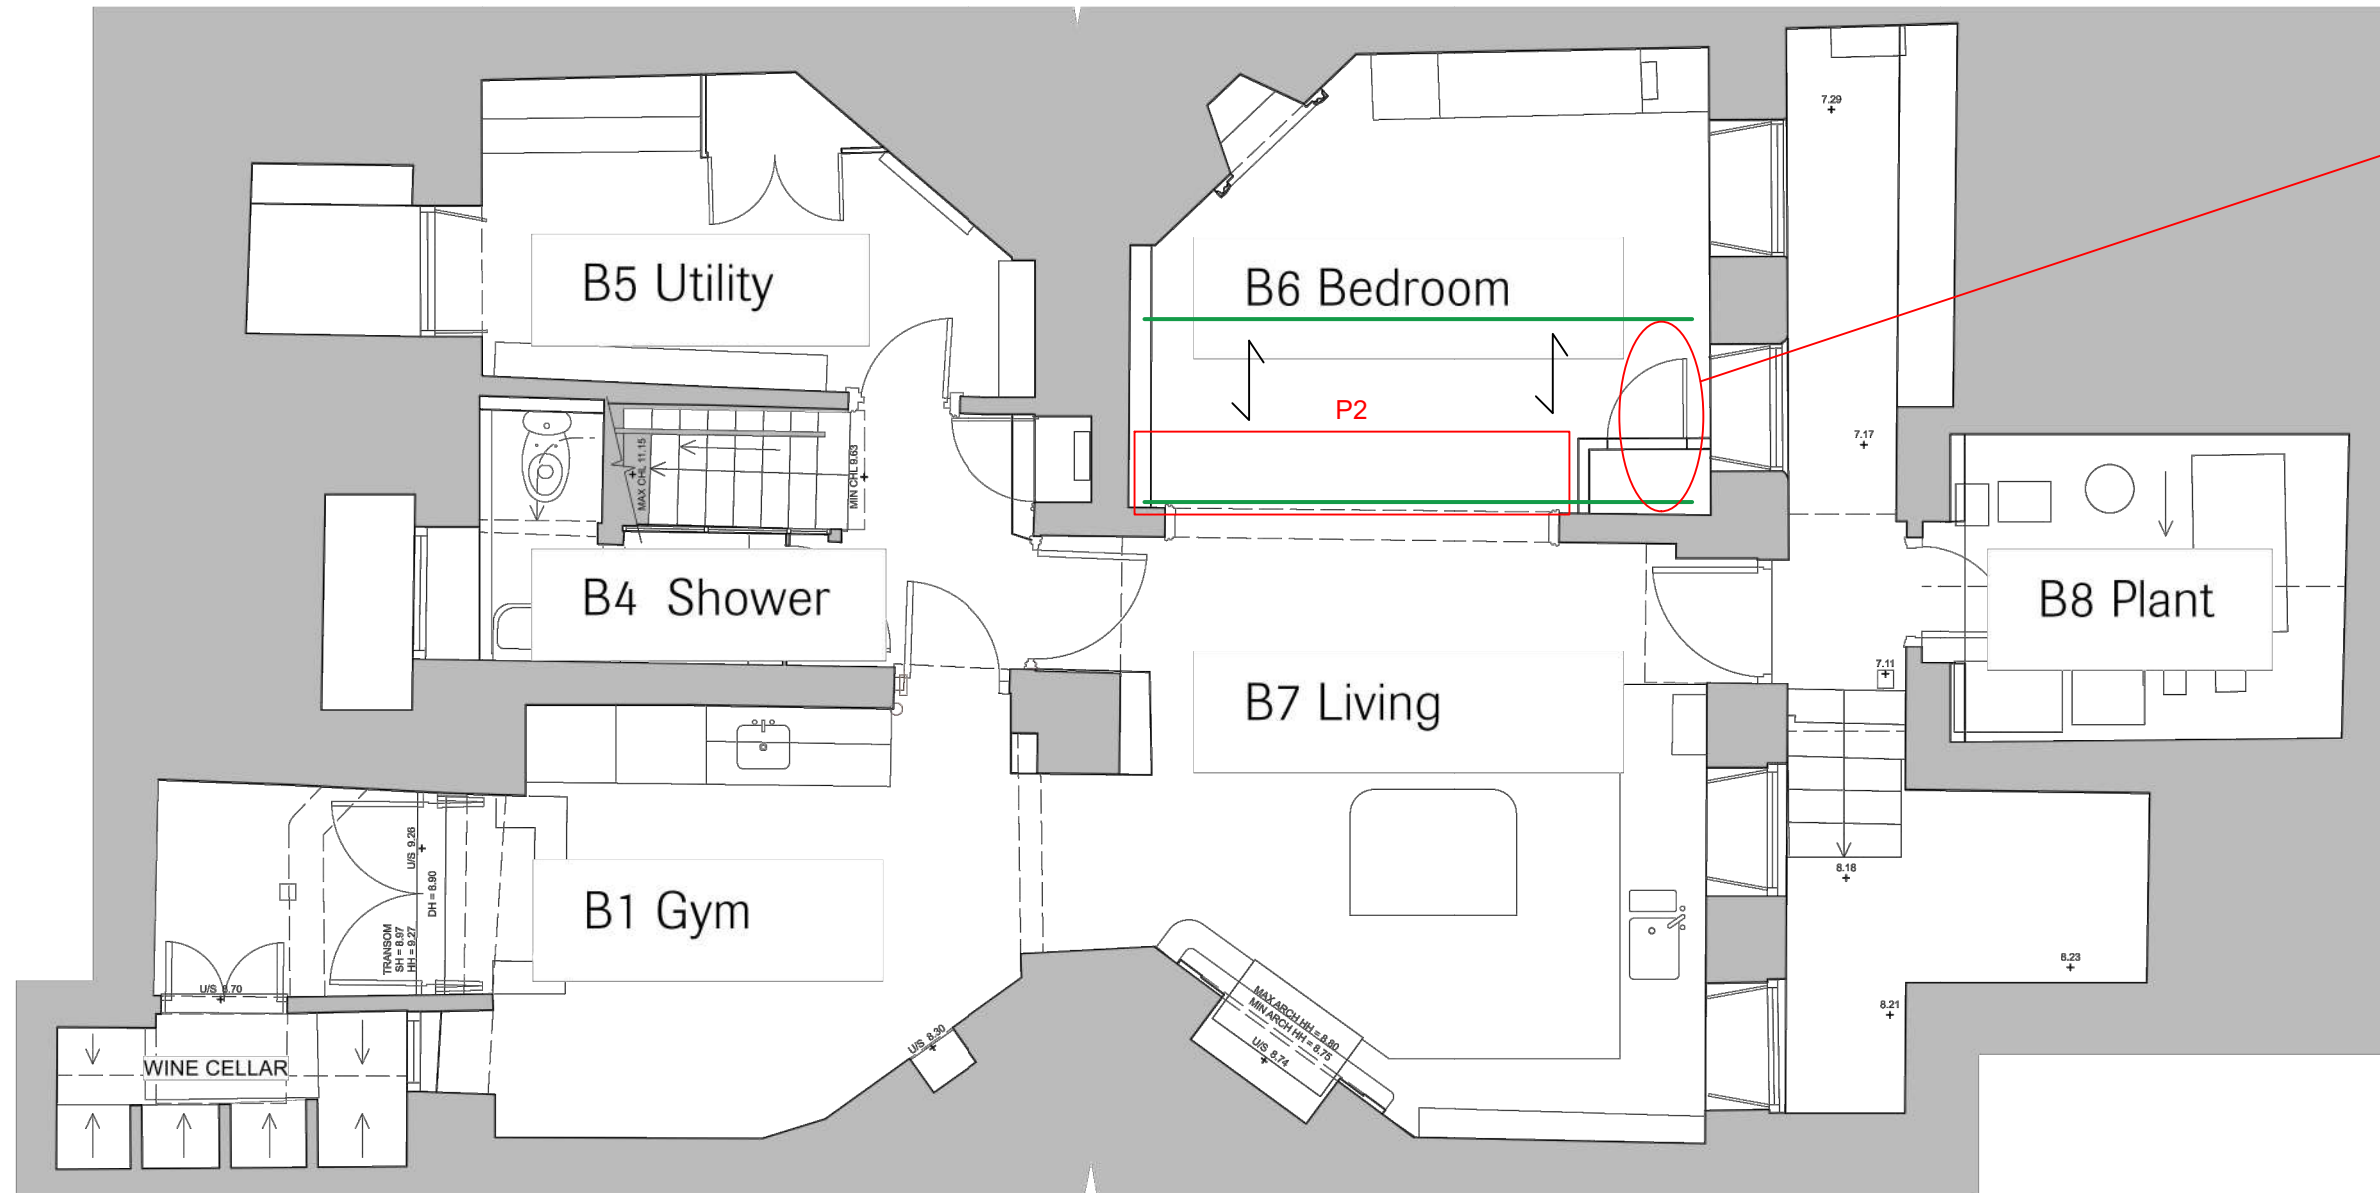
No decay identified or anticipated to inaccessible areas. Existing damp proof membrane still effective and well within its remaining service lifespan. Surface and deep moisture contents too low to support decay organisms. However, floor void towards the external north perimeter wall visibly subject to excessive building debris which may be restricting suitable ventilation as well as potentially bridging moisture between the damp compacted earth and the timber floor plate

Debris build-up within floor void potentially bridging DPM and reducing ventilation/drying to vulnerable floor plates
