Resistograph Test of T02 Cedar of Lebanon (Cedrus Libani).

Tuesday 05th November 2024

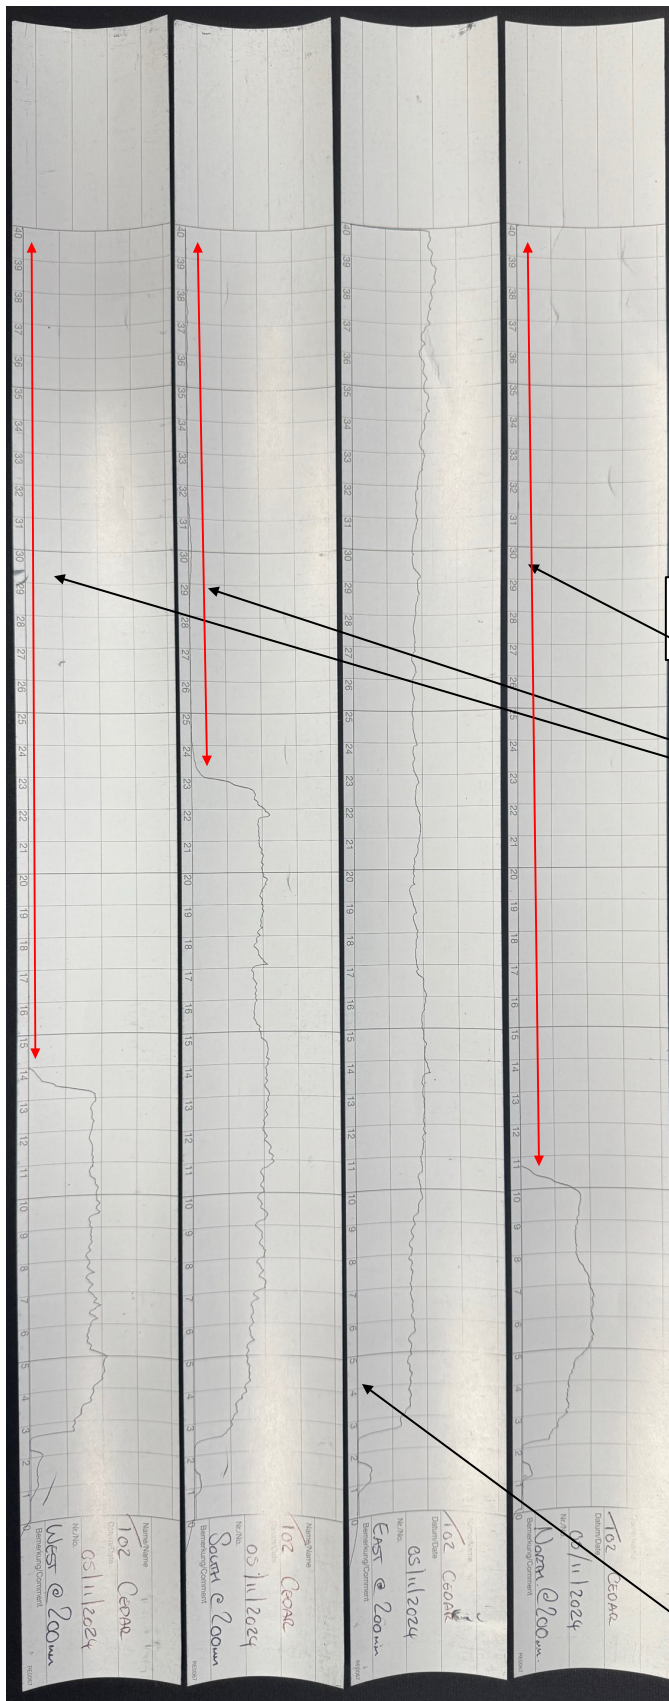
Drilling Around the main stem.

1. North at 200mm on the main stem from ground level.
2. East at 200mm on the main stem from ground level.
3. South at 200mm on the main stem from ground level.
4. West at 200mm on the main stem from ground level.

The readings do show a significant reduction in wood strength in the central main stem from the bark layer heading into the centre of the main stem of tree as shown in appendix 1.

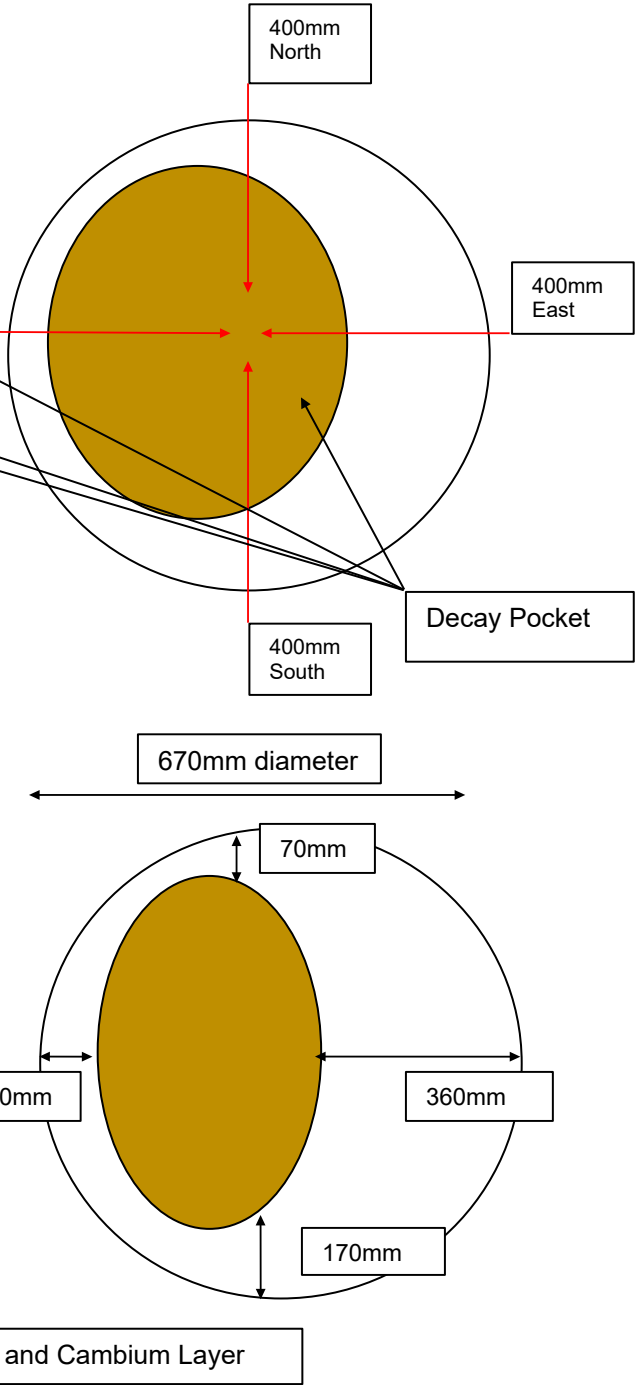
No:1 No:2 No:3 No:4

Recommendations are based on findings from the drillings and observations on the day of the inspection. Using the data from the drilling investigation and Claus Mattheck mathematical approach to trees and decay, and under guidance of British Standards, the level of decay found within T02 Cedar is as shown in the below diagram. With evidence of heartwood decay computational assumption, it is deemed unacceptable to remain without any remedial safety works.

- 4.1 On forming an opinion in regard to this tree I have tried to balance the requirements of the client to retain the tree, Health, and Safety obligations and that of the Local Planning Authority. Knowledge of decay organisms as well as a balanced knowledge of the species.
- 4.2 There is extensive decay in the main stem of the tree as can be seen in Appendix 1 the Resistograph carried out in the main stem.
- 4.3 The crown has just had the low lateral branches lifted to give sufficient height clearance over the walkways. The smaller upper twigs do not show signs of clawing that would indicate root and or systemic problems attributed to the decay.
- 4.4 Following interpretation of the data from the test drillings I would and can only recommend. Carefully felling this tree to near ground level.

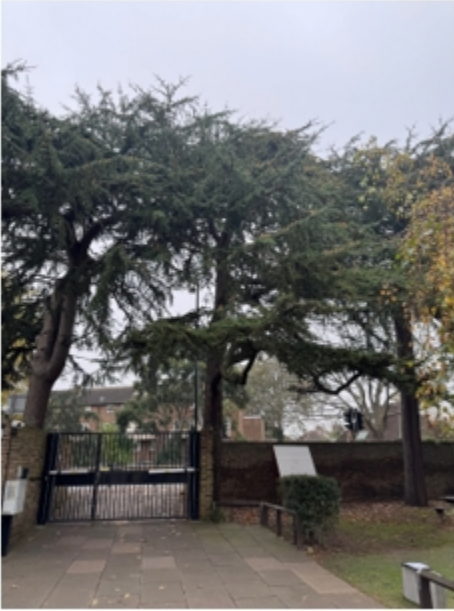
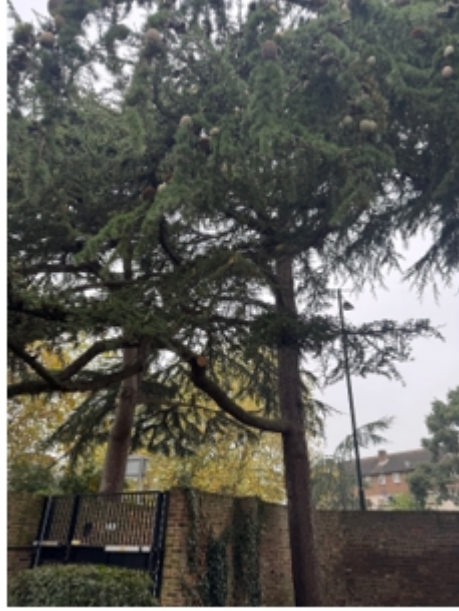
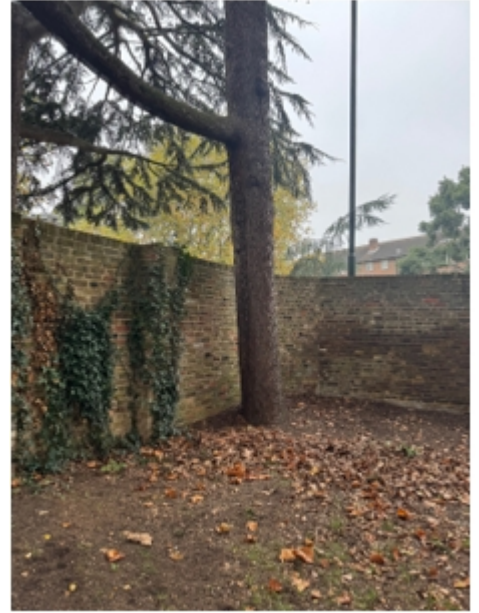
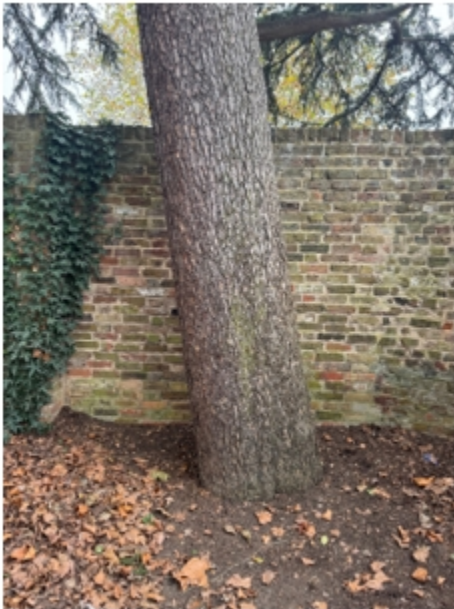
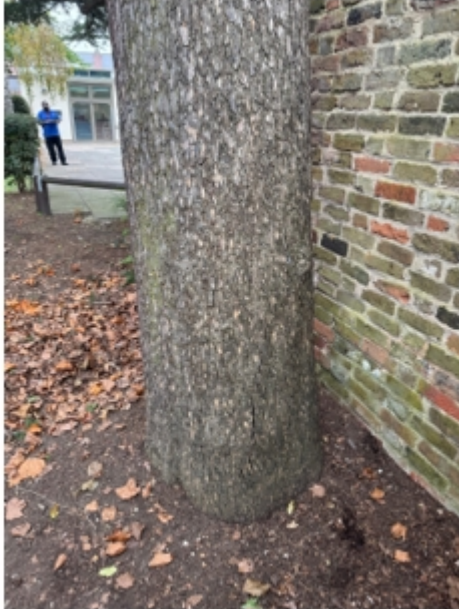
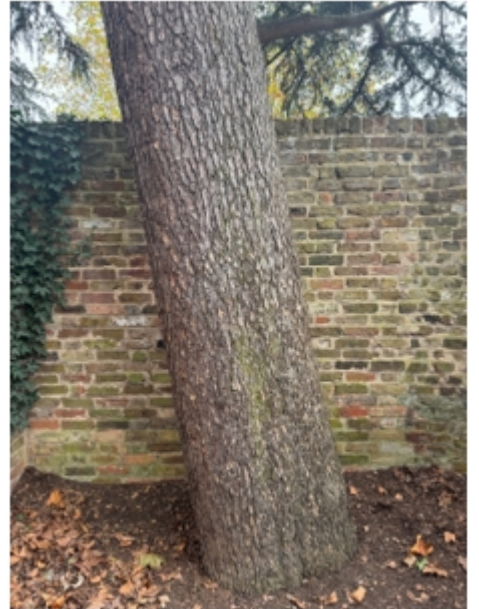
Photos taken from site visit:

- 1.1 Treeline Services Limited were asked to investigate further T02 Cedar of Lebanon (*Cedrus Libani*) that was initially inspected by Julian To of Strictly Education Ltd using a Visual Tree Assessment "VTA" where there were concern for decay due to a section of loose split bark on the north side of the main stem, Upon further inspection was noted a hollowing sound from the acoustic test carried out using a nylon sounding mallet to listen out for any change in tone and note whilst gently tapping around the main stem. It was therefore recommended for a resistograph test and report to ascertain the levels of decay within the main stem.

- 2.3 Tree species: Cedar of Lebanon (*Cedrus Libani*).
- 2.4 Height: 15.6 metres
Stem size: 670cm at 0.5m from ground level.
- 2.5 The Cedar of Lebanon (*Cedrus Libani*) is located to the north boundary within the school site internal seating area adjacent to the school's main pedestrian entrance. Noted on the north side of the main stem can be found two sections of split loose bark, Also following this inspection was highlighted a 13-degree measured from 2m off the main stem a lean to the south towards the main school buildings.
