**TREE SURVEY AND ARBORICULTURAL
IMPACT ASSESSMENT IN RELATION TO
PROPOSED DEVELOPMENT AT
319 & 319A RICHMOND ROAD,
TWICKENHAM,
TW1 2PB.**

Clive Fowler, Dip.Arb (RFS), F.Arbor.A, Tech. Cert.Arbor.A

Tree Survey and Arboricultural Impact Assessment in Relation to Proposed Development at 319 & 319A Richmond Road, Twickenham, TW1 2PB.

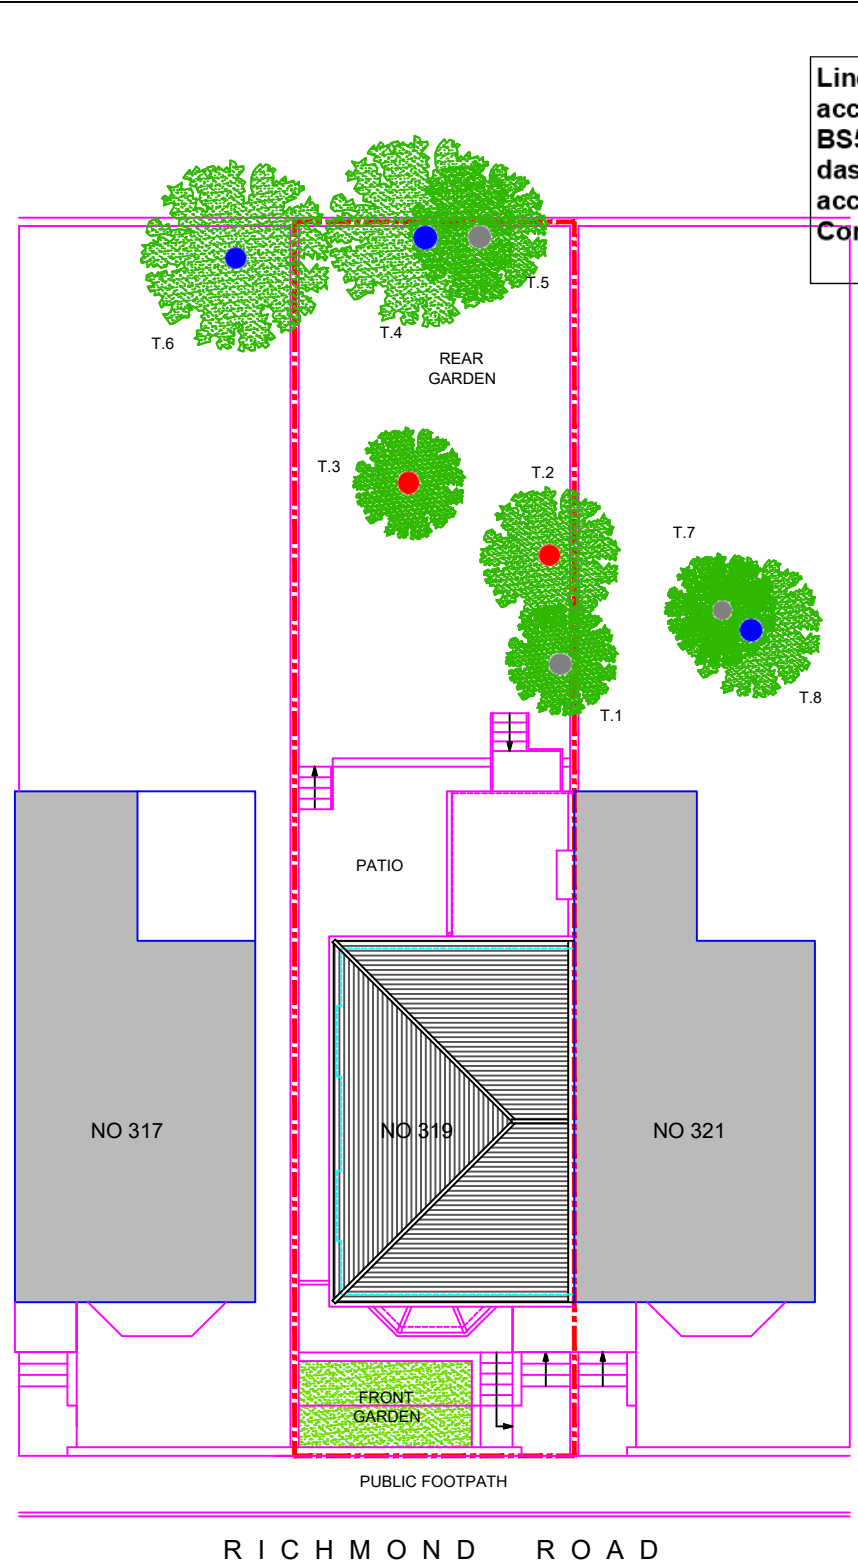
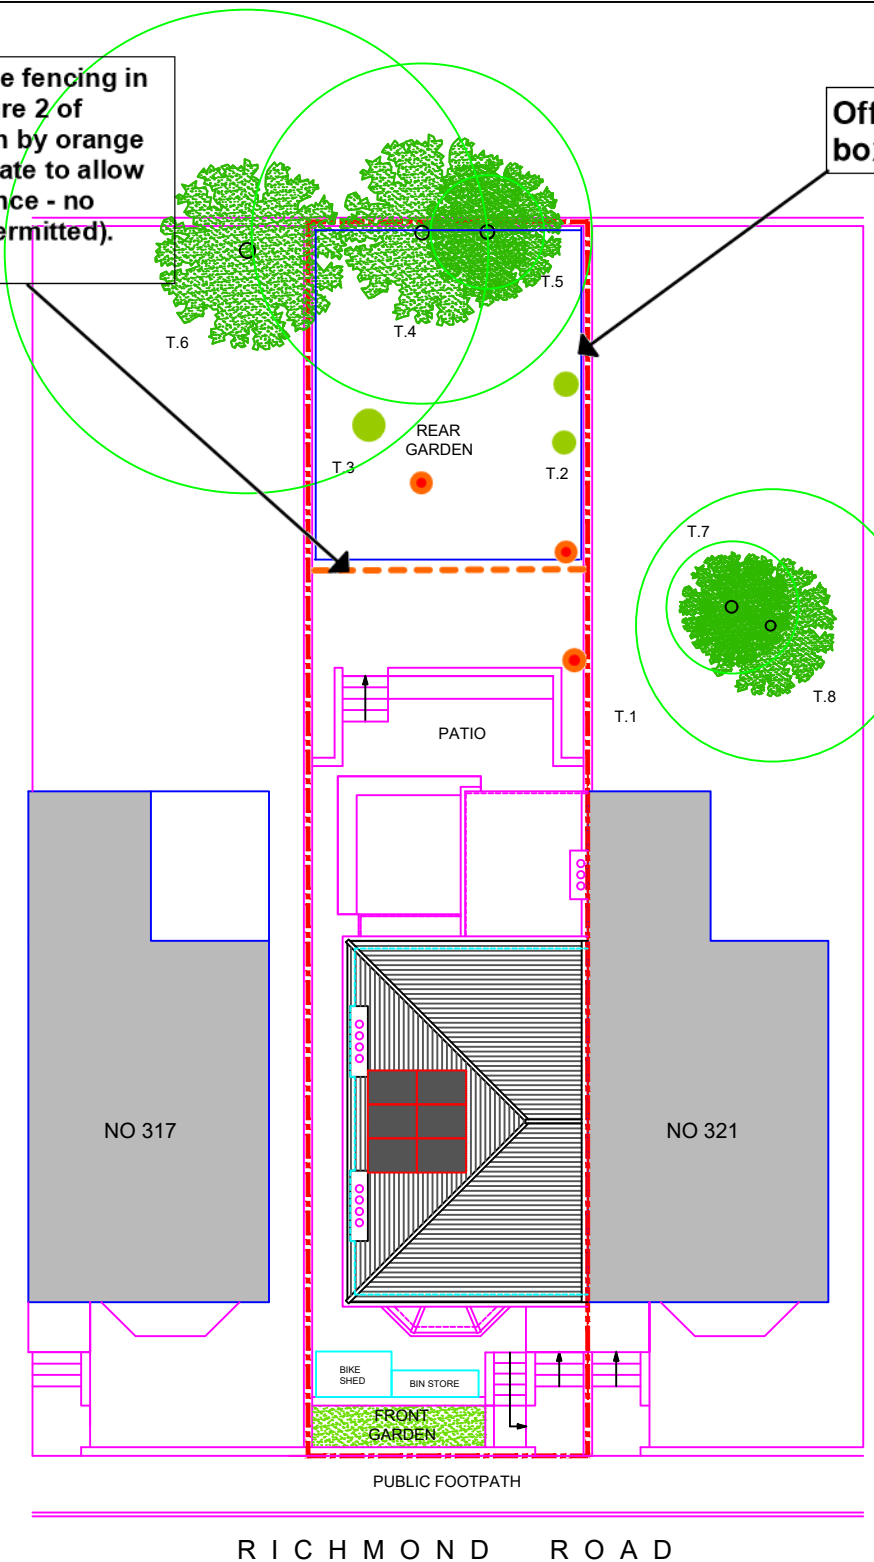
Appendix 'b'
Tree Location & Protection Plan

Line of tree protective fencing in accordance with figure 2 of BS5837:2012 - shown by orange dashed line (with a gate to allow access for maintenance - no Contractor access permitted).

Offset RPA shown by blue box.

● = Trees to be removed.

Tree RPA's shown by green circles.

● Approximate location of replacement trees (species - to be agreed with the Local Authority) of a minimum size of 'Standard' and using containerised stock.
