55 HIGH STREET, HAMPTON, MIDDLESEX, TW12 2SX

TREE CONDITION SURVEY, ARBORICULTURAL IMPLICATIONS ASSESSMENT AND PROTECTION RECOMMENDATIONS

December 2024

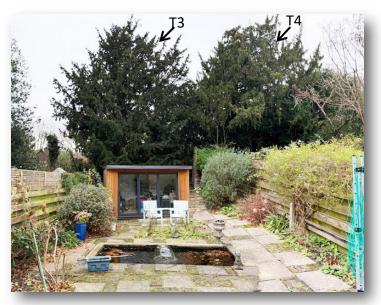
Trees T3 and T4 are substantial, well foliaged Yews. Tree T3 is located along a footpath behind the rear fence to 55 Hight Street. Tree T4 is the larger of the two Yews and is located on the verge of an access road to garage units. The east and south crown spreads of these trees are overshadowing the summer House and is likely to overshadow it further in the future. Crown reduction may be desired by the property owners at a future date although this does not affect the main building extension proposal. Their RPAs and crowns will be protected by the specified tree protection fence as shown on drawing nrs. 464/01 and 464/02.

Image 3: View of rear garden looking north west with pond and summer house visible with trees T3 and T4 to the rear
