ENVIRONMENTAL SITE ASSESSMENT

Woodlawn Service Station 644 Hanworth Road Hounslow Middlesex

Esso Petroleum Company Limited

September 1995

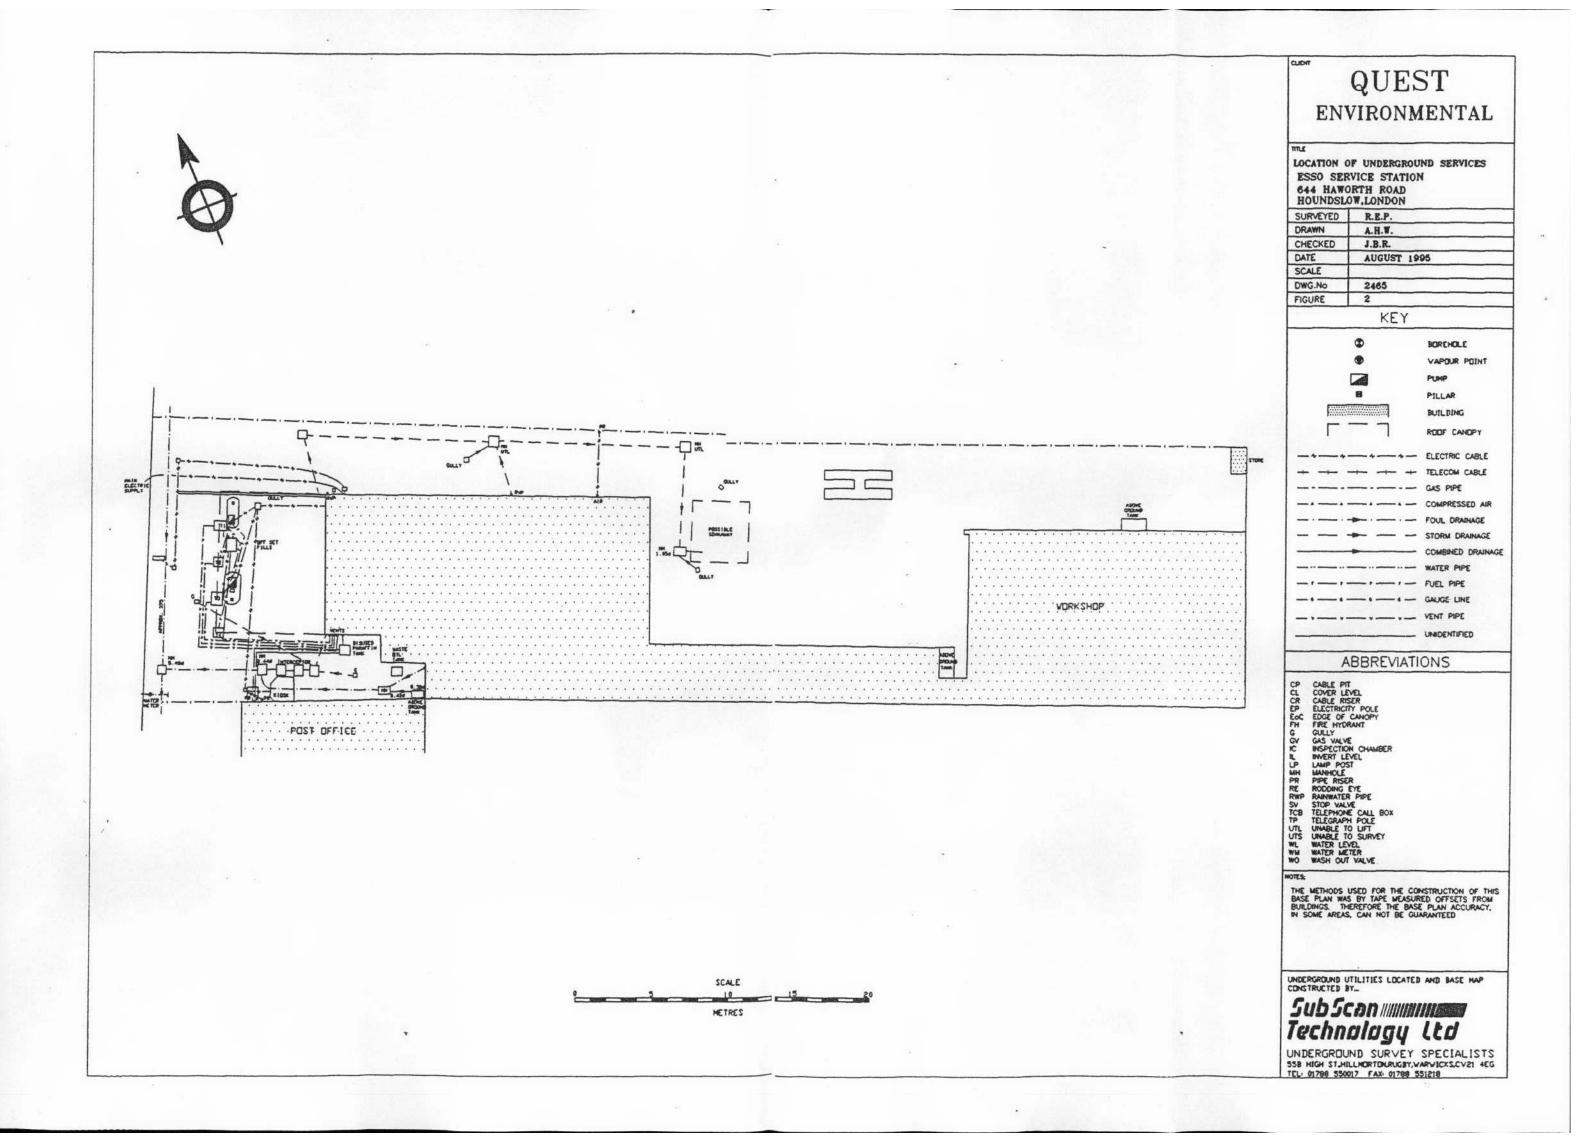
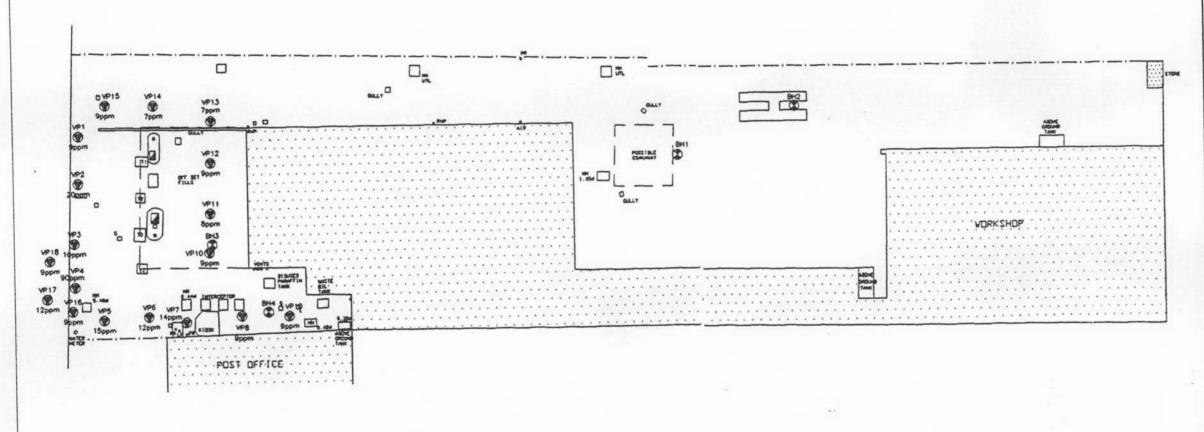
VAPOURPOINT LOCATIONS & CONCENTRATIONS & BOREHOLE LOCATIONS ESSO SERVICE STATION

The findings of the investigation identified localised elevated concentrations of volatile petroleum hydrocarbons in soils in the vicinity of the underground kerosene storage tank located to the southeast of the dispensing forecourt, and in the vicinity of the vehicle lubrication ramp located towards the rear of the site.

The field headspace analysis of soil samples recovered from borehole BH2, located in the vicinity of the vehicle lubrication ramp, recorded elevated concentrations of volatile petroleum hydrocarbons believed to be associated with kerosene and lubricating oils, in a zone between approximately 1.6 and 2.5 metres below ground.

Soil samples recovered from borehole BH4, located in the vicinity of the disused underground kerosene storage tank, also recorded significant concentrations of volatile petroleum hydrocarbons, considered to be associated with kerosene, to the maximum depth drilled of 2.8 metres below ground. Soil sample S4.7, recovered from 2.8 metres below ground, recorded the site maximum concentration of 360 ppm.

The soil vapour survey encountered elevated concentrations of volatile petroleum hydrocarbons present in the sub-surface at sampling point VP4, located to the west of the dispensing forecourt on the site boundary with Hanworth Road, which recorded 90 ppm.
