# THE LASS O' RICHMOND

8 QUEEN'S ROAD, RICHMOND UPON THAMES,  
GREATER LONDON TW10 6JJ

## Conservation Report

April 2010

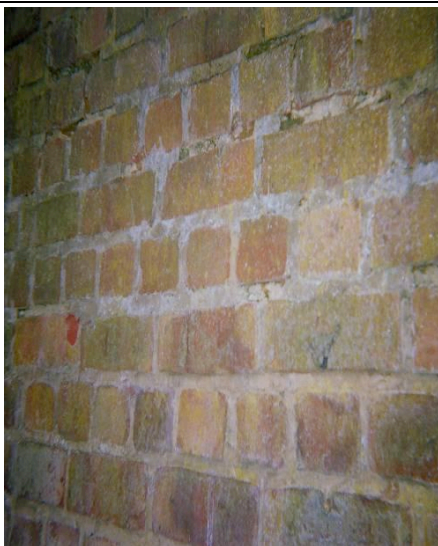
The condition is generally good with much ivy and other biological growth present on the wall, a good deal of the pointing has failed and is no longer serving its purpose. The formed capping bricks are in good order with 90% of pointing washed out, there are also some metal nails and fixings which held creeper plants in the past. There are no structural issues obvious and all proposals will be to best conservation practice using lime based mortar. We understand that Royal Parks have a "Freebord" of 5.03 metres along the wall which is a strip of Crown land from the base of the wall. This freebord land is treated as park land and access and use of it is subject to a license granted by the Royal parks office.

Fig. 8: A close up of the brick and failed pointing to the Park side

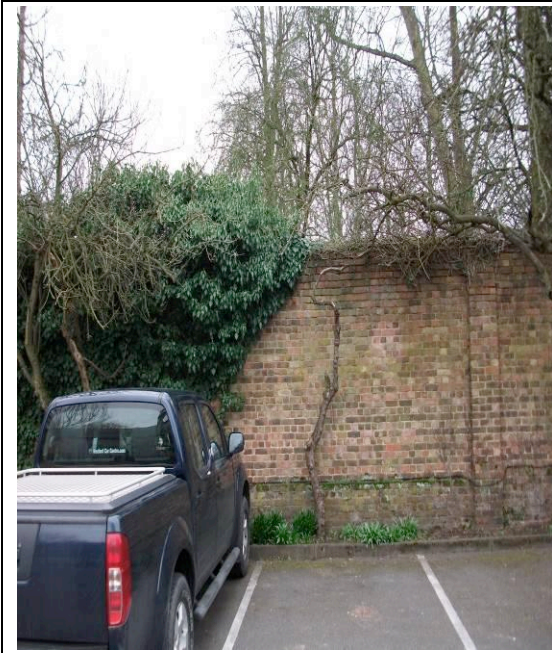
Fig. 10: A section of the wall from the car park side showing heavy Ivy

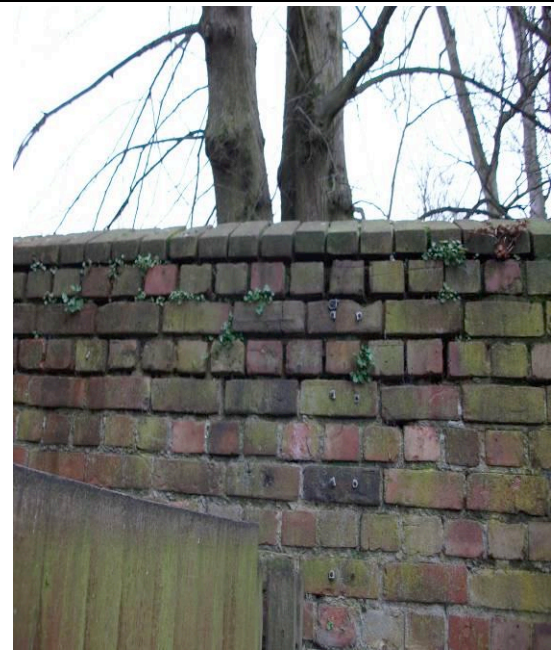
Fig. 11: A section of the wall from the Car Park side showing serious loss of pointing.

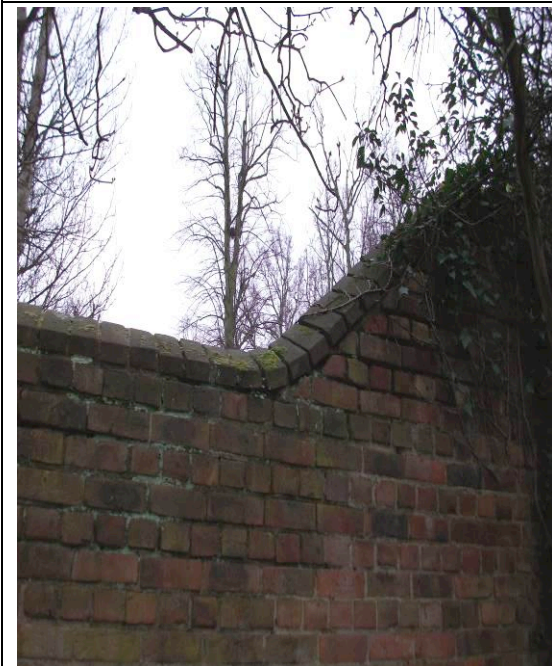
Fig. 12: A close up of the brick and failed pointing to the Car Park side

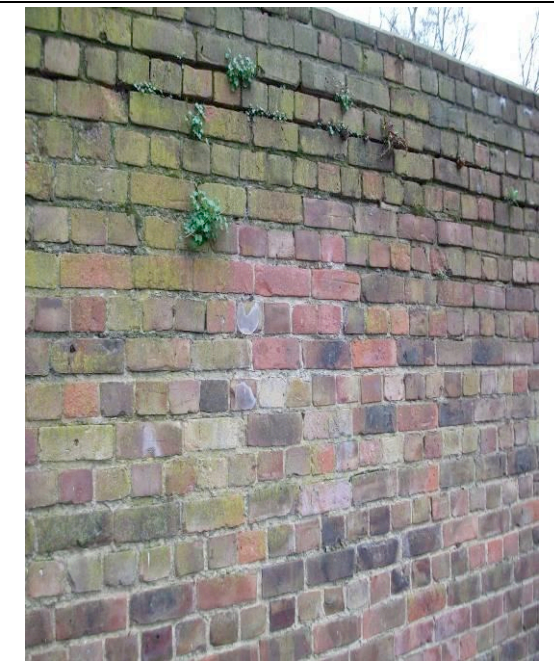
Fig. 13: A section of the wall from the car park showing loss of pointing, biological growth and a recent repair.

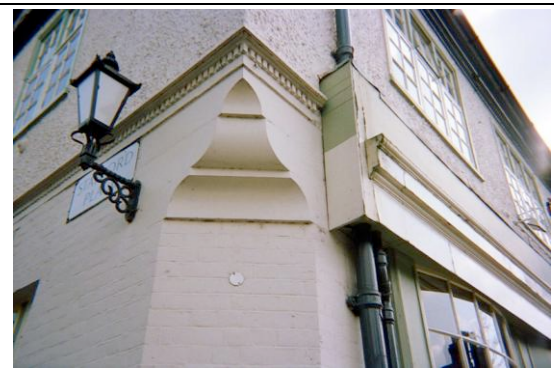
Fig. 24: Detail of section of denticulated stringcourse. Note where cornice has been truncated to allow for later fascia

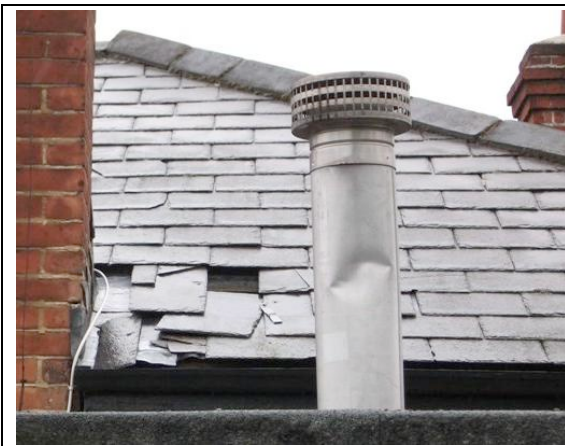
The natural slate roof to the original building is in poor condition with some slipped and missing slate. Cracked and broken slates were also noted to the roof. It is highly likely that the building will have to be re-roofed with as much slate salvaged as possible. Replacement slate will be Bangor blue.

Fig. 44: Section of roof to south showing slipped and broken slates

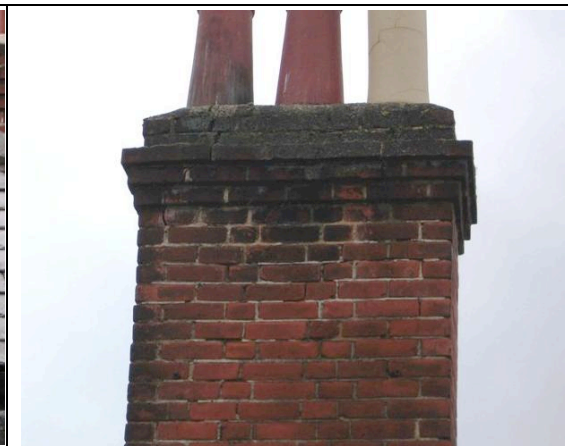
Fig. 45: Chimneystack to southeast with damaged capping and loss of mortar

The chimneystacks are in the main in good condition, though it will be necessary to carry out repointing to the brickwork and some capping details are in need of repair. It is proposed to re-instate the removed chimneystack to the west gable.

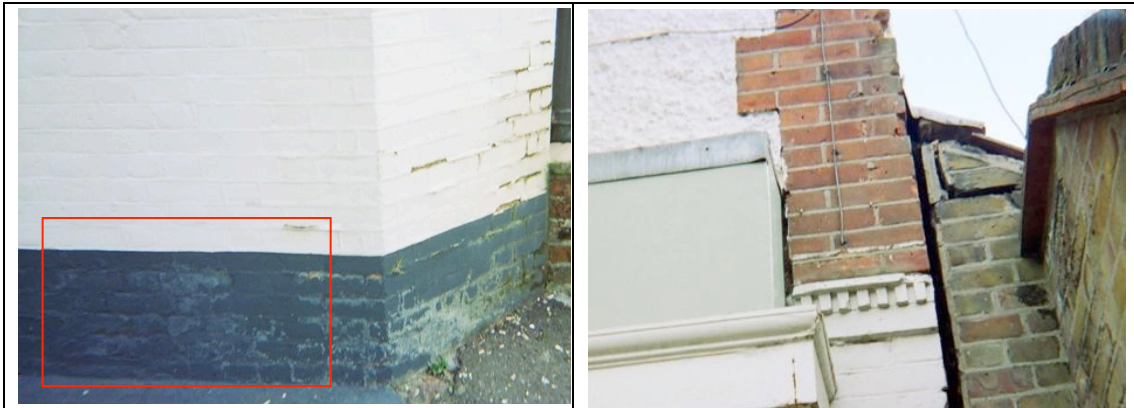
The brick to the ground floor has a number of paint coatings. Scaling and dissolution of the brickwork was noted in areas, particularly towards ground level where rising damp with moisture being retained within the bricks. Subsequent freeze-thaw action has then generated tension inside the material and against the outer masonry layer resulting in the dissolution of the brickwork.

The brickwork to the quoins at the southern end of the building is also in a poor condition, particularly along the corners where bricks have been chipped.

Fig. 46: Spalled brickwork at ground level

Fig. 47: Damaged brickwork to quoins

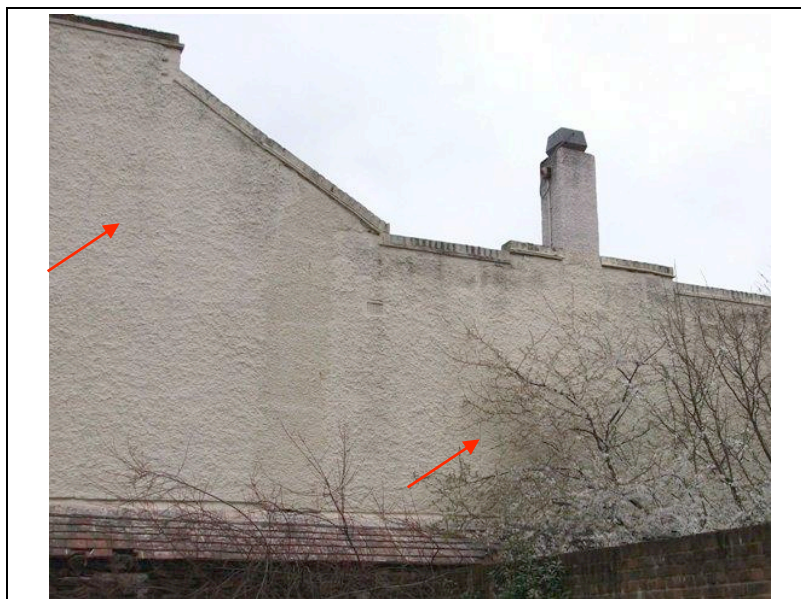
The roughcast render appears to largely be in good condition, however, two cracks were noted to the west elevation running vertically down the gable.

Fig. 48: Cracks to render of west elevation

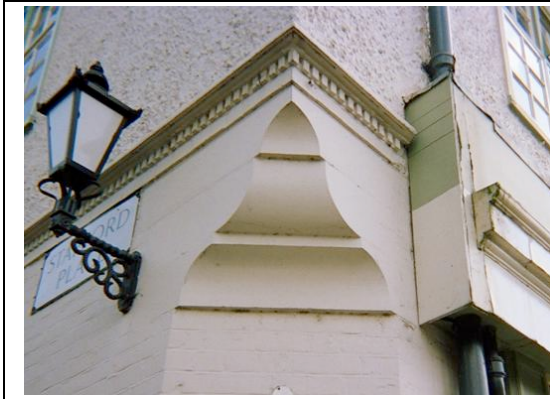
The denticulated stringcourse which runs along the east and east elevations appears to have been at the least truncated to allow for the addition of the later timber fascia to the north elevation. The section along the east elevation appears to be in good condition and has retained its crispness. Once the fascia has been removed it will be necessary to reinstate the stringcourse where it has been removed and carry out repairs where necessary.

Fig. 49: Northeast corner showing truncation of stringcourse

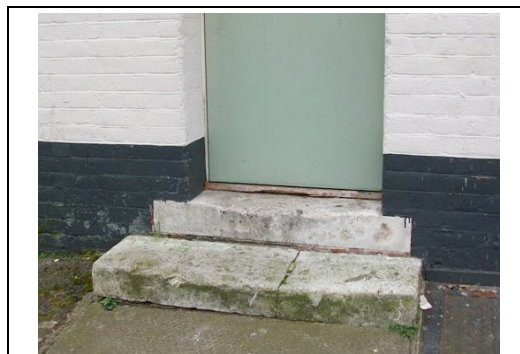
Fig. 50: Portland limestone steps to east elevation

The Portland limestone steps to the east elevation are to be retained, repaired and cleaned.
