Planning Application Submission – February 2014

# Arboriculture Development Report

Latchmere House – Scheme 2

LATCHMERE HOUSE, RICHMOND  
ARBORICULTURAL DEVELOPMENT REPORT

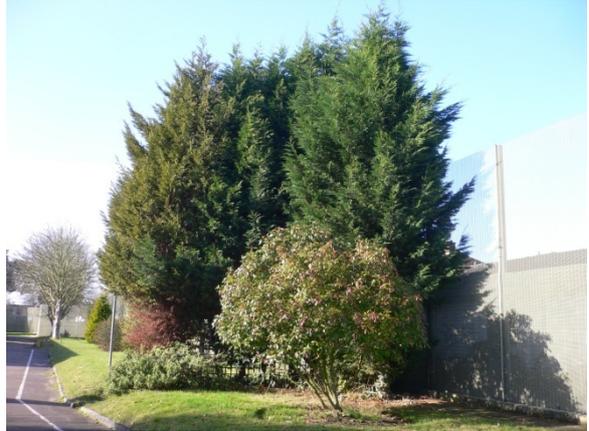
1. General view of group of ubiquitous Cypress forming screen adjacent prison security fence.

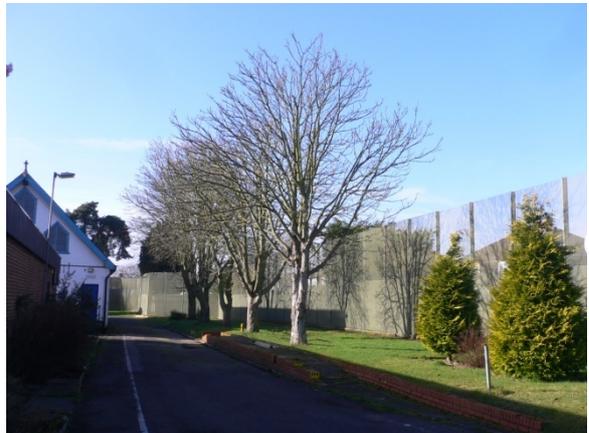
to off-site residential gardens, they are of varied condition with trees T3 to T5 of poor structural form. The two Pine (T9 & T27) are of fair health, however, both trees are located in close proximity to existing buildings. These two trees are of some visual amenity within the local and wider landscape, however, the trees have been significantly influenced by the existing buildings and are likely to display constrained and asymmetrical root patterns.

- 6.2.7 The three Horse Chestnut (T4 to T6) to the west boundary form part of a linear group, together with a 'U' category and 'B' category Horse Chestnut (T3, T7) respectively. Two of these trees are located 1m from a low retaining wall with the remaining trees displaying girdled roots, trunk defects, bleeding canker and poor crown architecture. As a collective group, they have a limited useful life expectancy and it is therefore proposed to remove these trees to enable efficient land use with mitigation proposed to strengthen the boundary planting.

2. General view of linear group of Horse Chestnut T3 to T7. Whilst of visual amenity, with the exception of T7, the trees are of poor structural form.

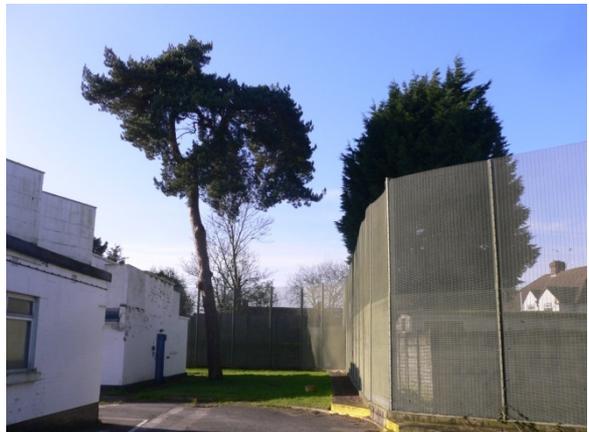
3. General view of Scots Pine (T9) located in close proximity to building.

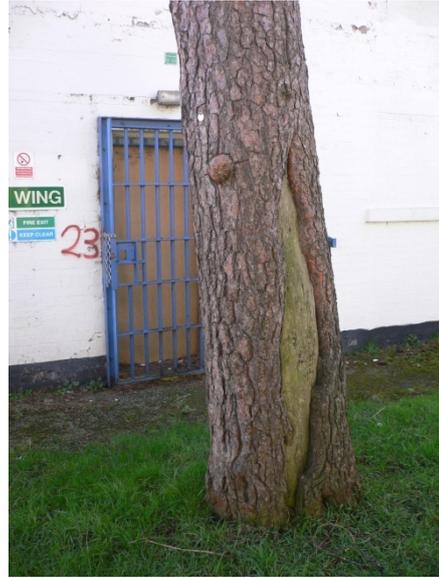
4. Detail view of lower trunk of Scots Pine (T9) displaying lower stem defect.

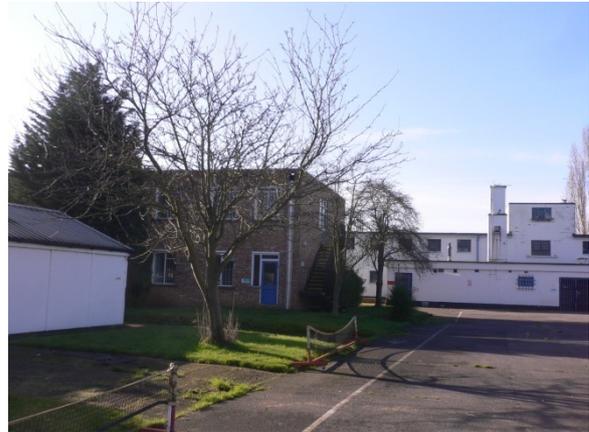
5. General view of internal trees within prison grounds of ornamental and domestic scale.

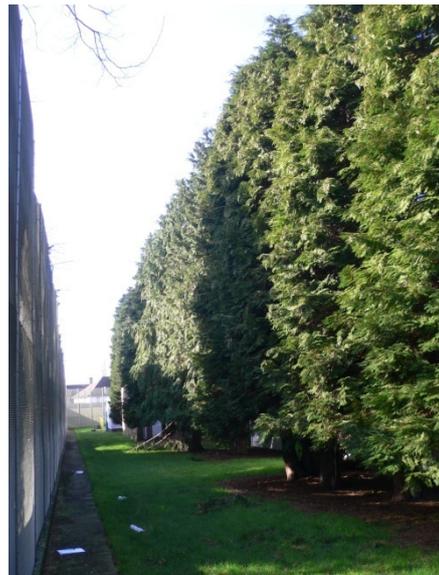
6. General view of Cypress groups forming screening to existing buildings.

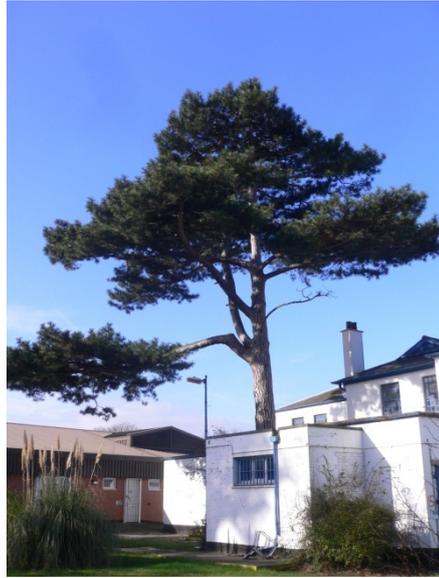
7. General view of Corsican Pine (T27) forming prominent tree within the site and wider landscape.

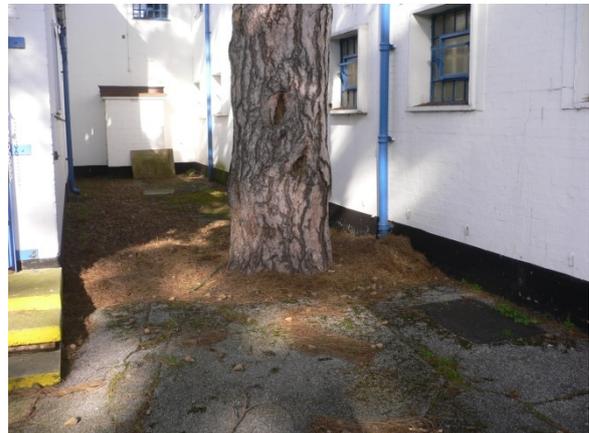
8. Detail view of Corsican Pine (T27) located between buildings with visual evidence of trenching within the rooting area.

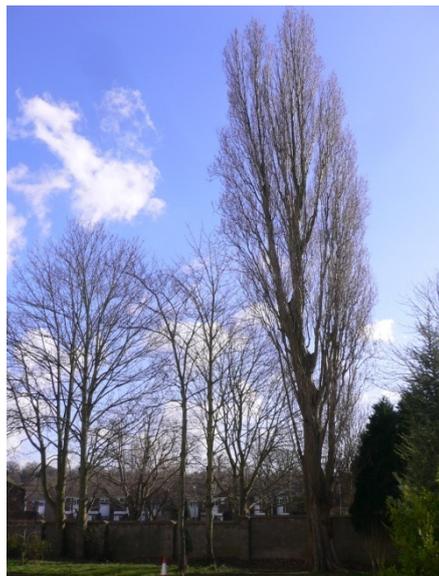
- 6.2.13 Similarly, the Lombardy Poplar (T37) is located between the existing car park and boundary wall. This tree is likely to have surface roots and therefore installation of the access road together with demolition will have an adverse impact on the trees health and stability. This tree also displays a wet vertical fissure and lower trunk defects. Due to the characteristics of the species and potential indirect impact, the tree is to be removed and replaced through appropriate mitigation.

9. General view of trees to south of Latchmere House including Lombardy Poplar (T37) right of photo .

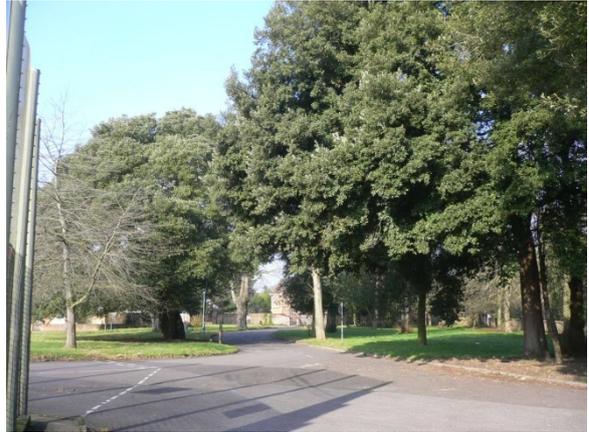
10. General view of Holm Oak to north of site on approach to Latchmere House.

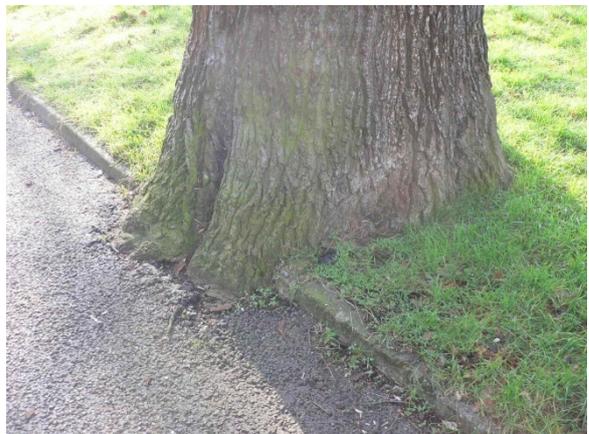
11. Detail view of basal trunk of Oak (T 70) partially within access road.

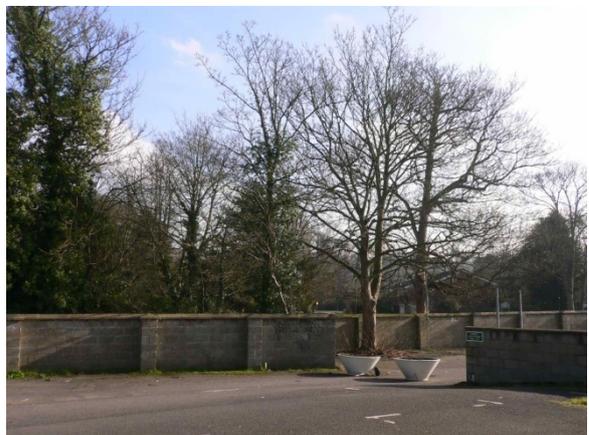
12. General view of Sycamore (T32) located to east of Latchmere House within area of hard standing .

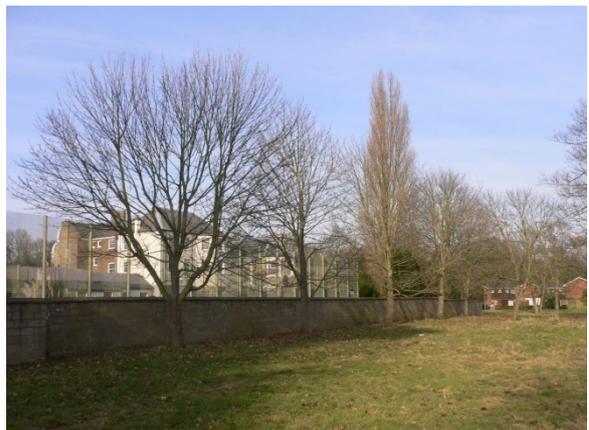
13. General view of Norway Maple (T92 to T94) located along boundary wall.

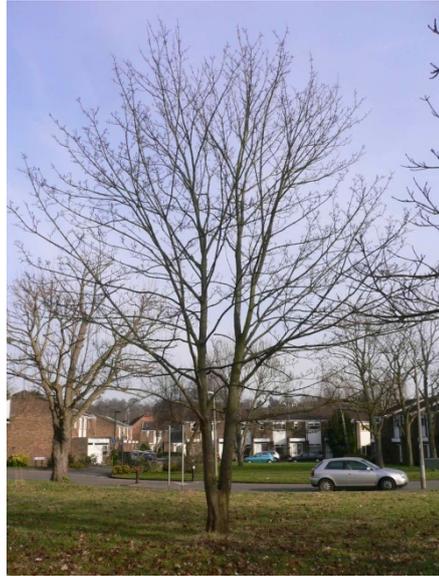
14. General view of Sycamore (T85) displaying twin-stems and of poor form.

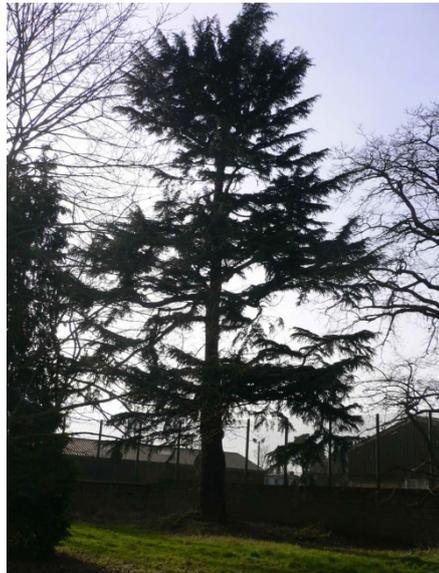
15. General view of Cedar (T99) forming a prominent feature within local and wider landscape.

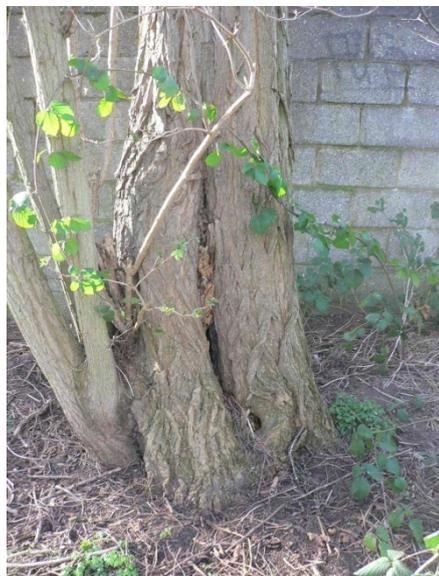
16. Detail view of lower trunk of False Acacia (G98) displaying basal cavity.
