Planning Application Submission – February 2014

# Arboriculture Development Report

Latchmere House – Scheme 1

LATCHMERE HOUSE, RICHMOND  
ARBORICULTURAL DEVELOPMENT REPORT

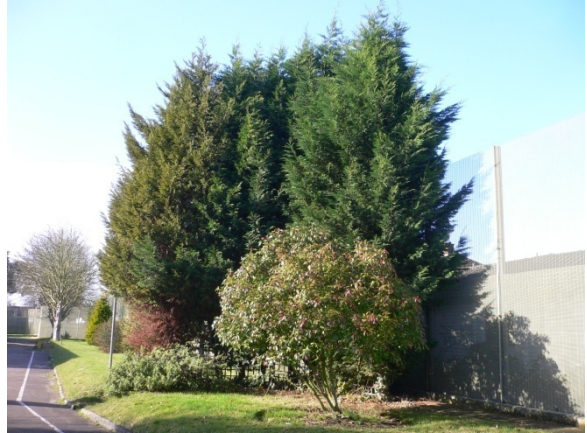
1. General view of group of ubiquitous Cypress forming screen adjacent prison security fence.

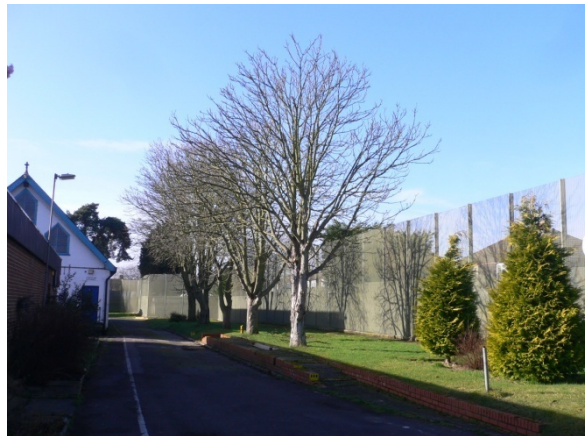
- 6.2.7 The three Horse Chestnut (T4 to T6) to the west boundary form part of a linear group, together with a 'U' category and 'B' category Horse Chestnut (T3, T7) respectively. Two of these trees are located 1m from a low retaining wall with the remaining trees displaying girdled roots, trunk defects, bleeding canker and poor crown architecture. As a collective group, they have a limited useful life expectancy and it is therefore proposed to remove these trees to enable efficient land use with mitigation proposed to strengthen the boundary planting.

2. General view of linear group of Horse Chestnut T3 to T7. Whilst of visual amenity, with the exception of T7, the trees are of poor structural form.

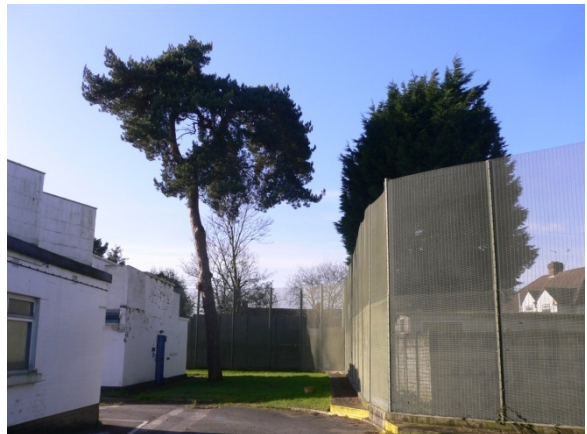
to off-site residential gardens, they are of varied condition with trees T3 to T5 of poor structural form. The two Pine (T9 & T27) are of fair health, however, both trees are located in close proximity to existing buildings. These two trees are of some visual amenity within the local and wider landscape, however, the trees have been significantly influenced by the existing buildings and are likely to display constrained and asymmetrical root patterns.

3. General view of Scots Pine (T9) located in close proximity to building.

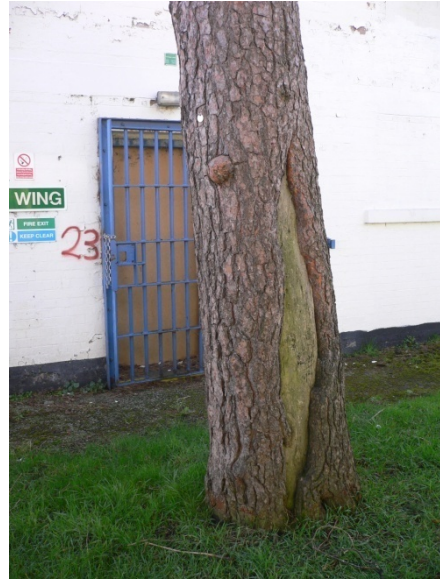
4. Detail view of lower trunk of Scots Pine (T9) displaying lower stem defect.

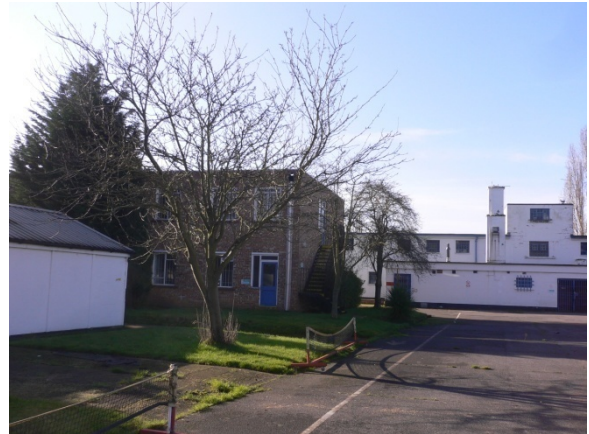
5. General view of internal trees within prison grounds of ornamental and domestic scale.

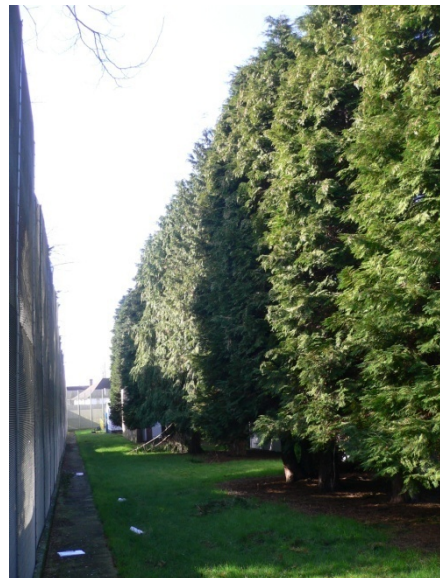
6. General view of Cypress groups forming screening to existing buildings.

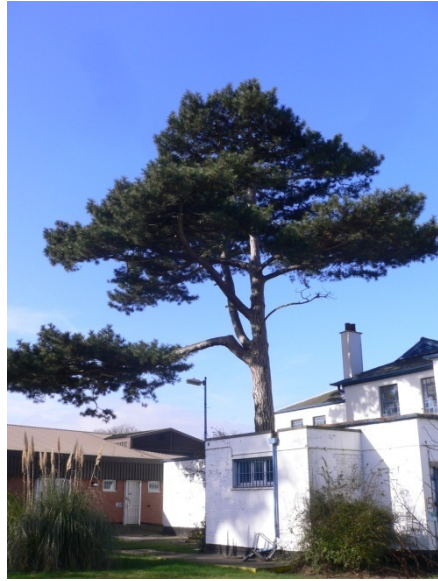
7. General view of Corsican Pine (T27) forming prominent tree within the site and wider landscape.

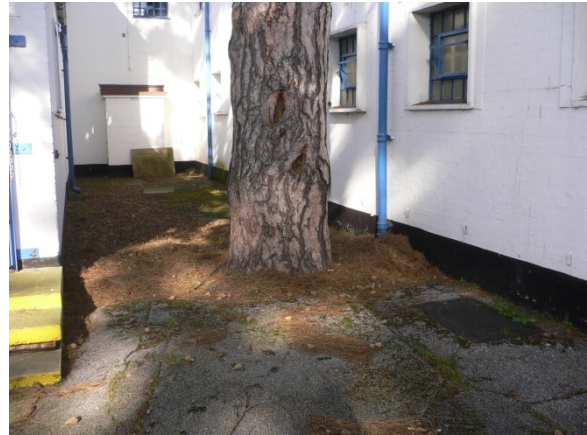
8. Detail view of Corsican Pine (T27) located between buildings with visual evidence of trenching within the rooting area.

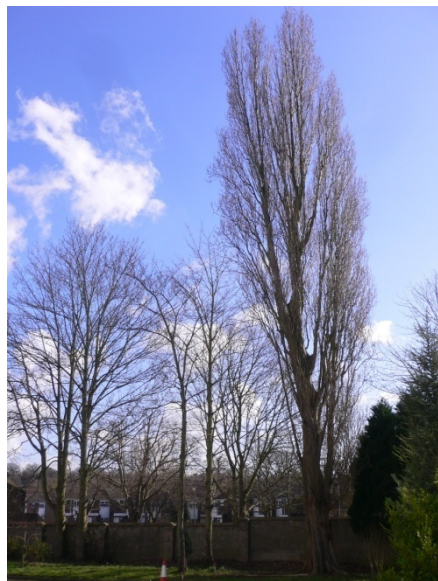
9. General view of trees to south of Latchmere House including Lombardy Poplar (T37) right of photo .

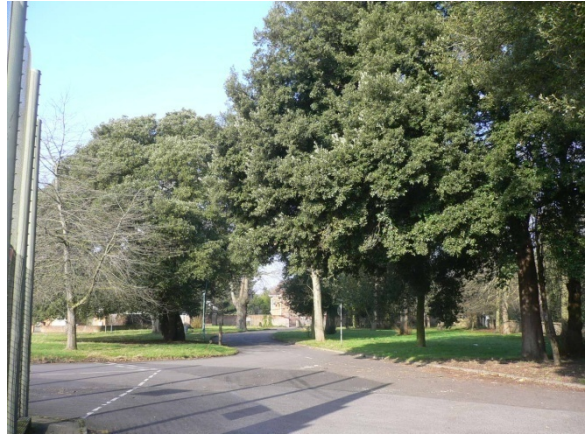
10. General view of Holm Oak to north of site on approach to Latchmere House.

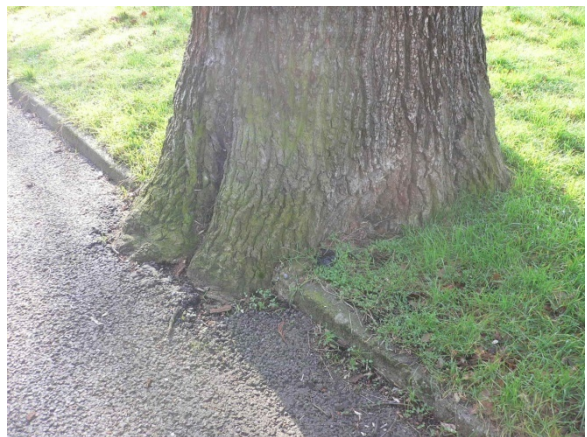
11. Detail view of basal trunk of Oak (T 70) partially within access road.

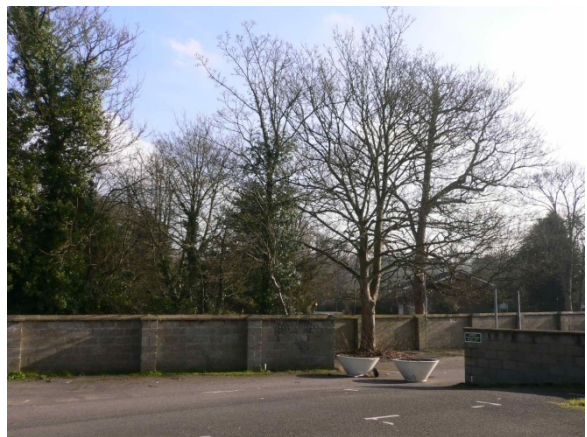
12. General view of Sycamore (T32) located to east of Latchmere House within area of hard standing .

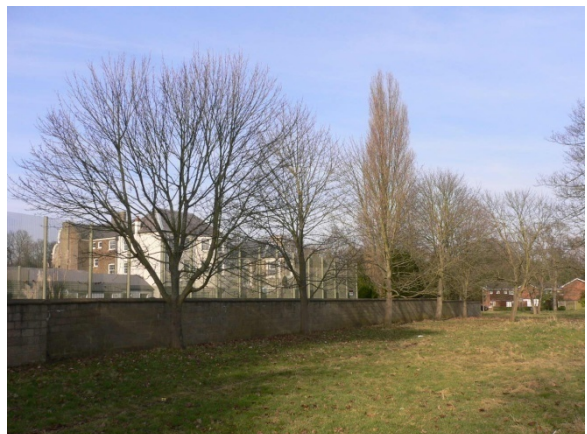
13. General view of Norway Maple (T92 to T94) located along boundary wall.

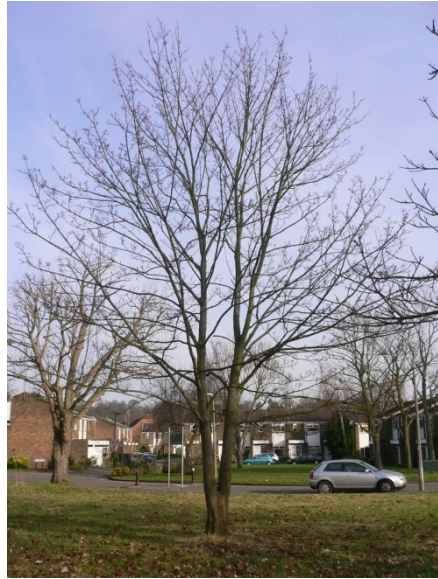
14. General view of Sycamore (T85) displaying twin-stems and of poor form.

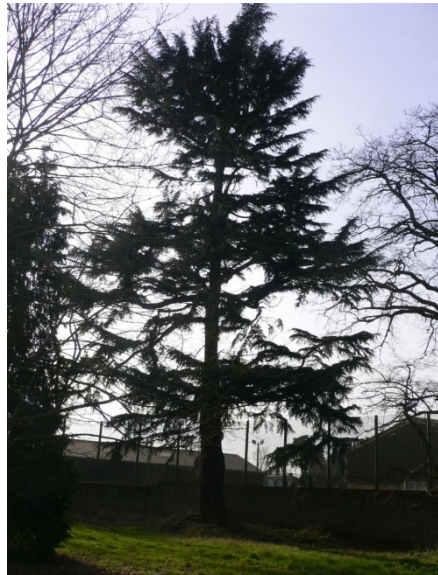
15. General view of Cedar (T99) forming a prominent feature within local and wider landscape.

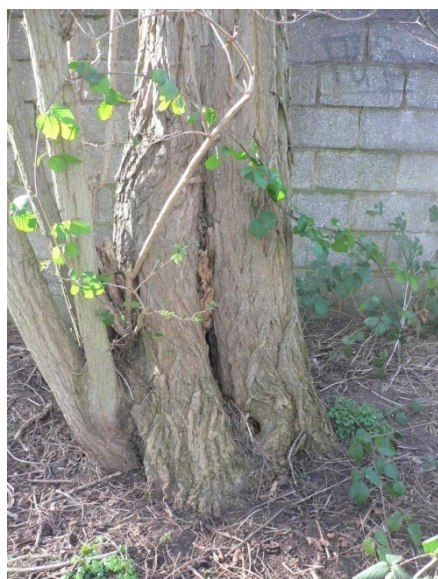
16. Detail view of lower trunk of False Acacia (G98) displaying basal cavity.
