## Latchmere House, Kingston-upon-Thames Survey of Outbuildings Proposed for Demolition

prepared by **MAA** Architects

February 2014

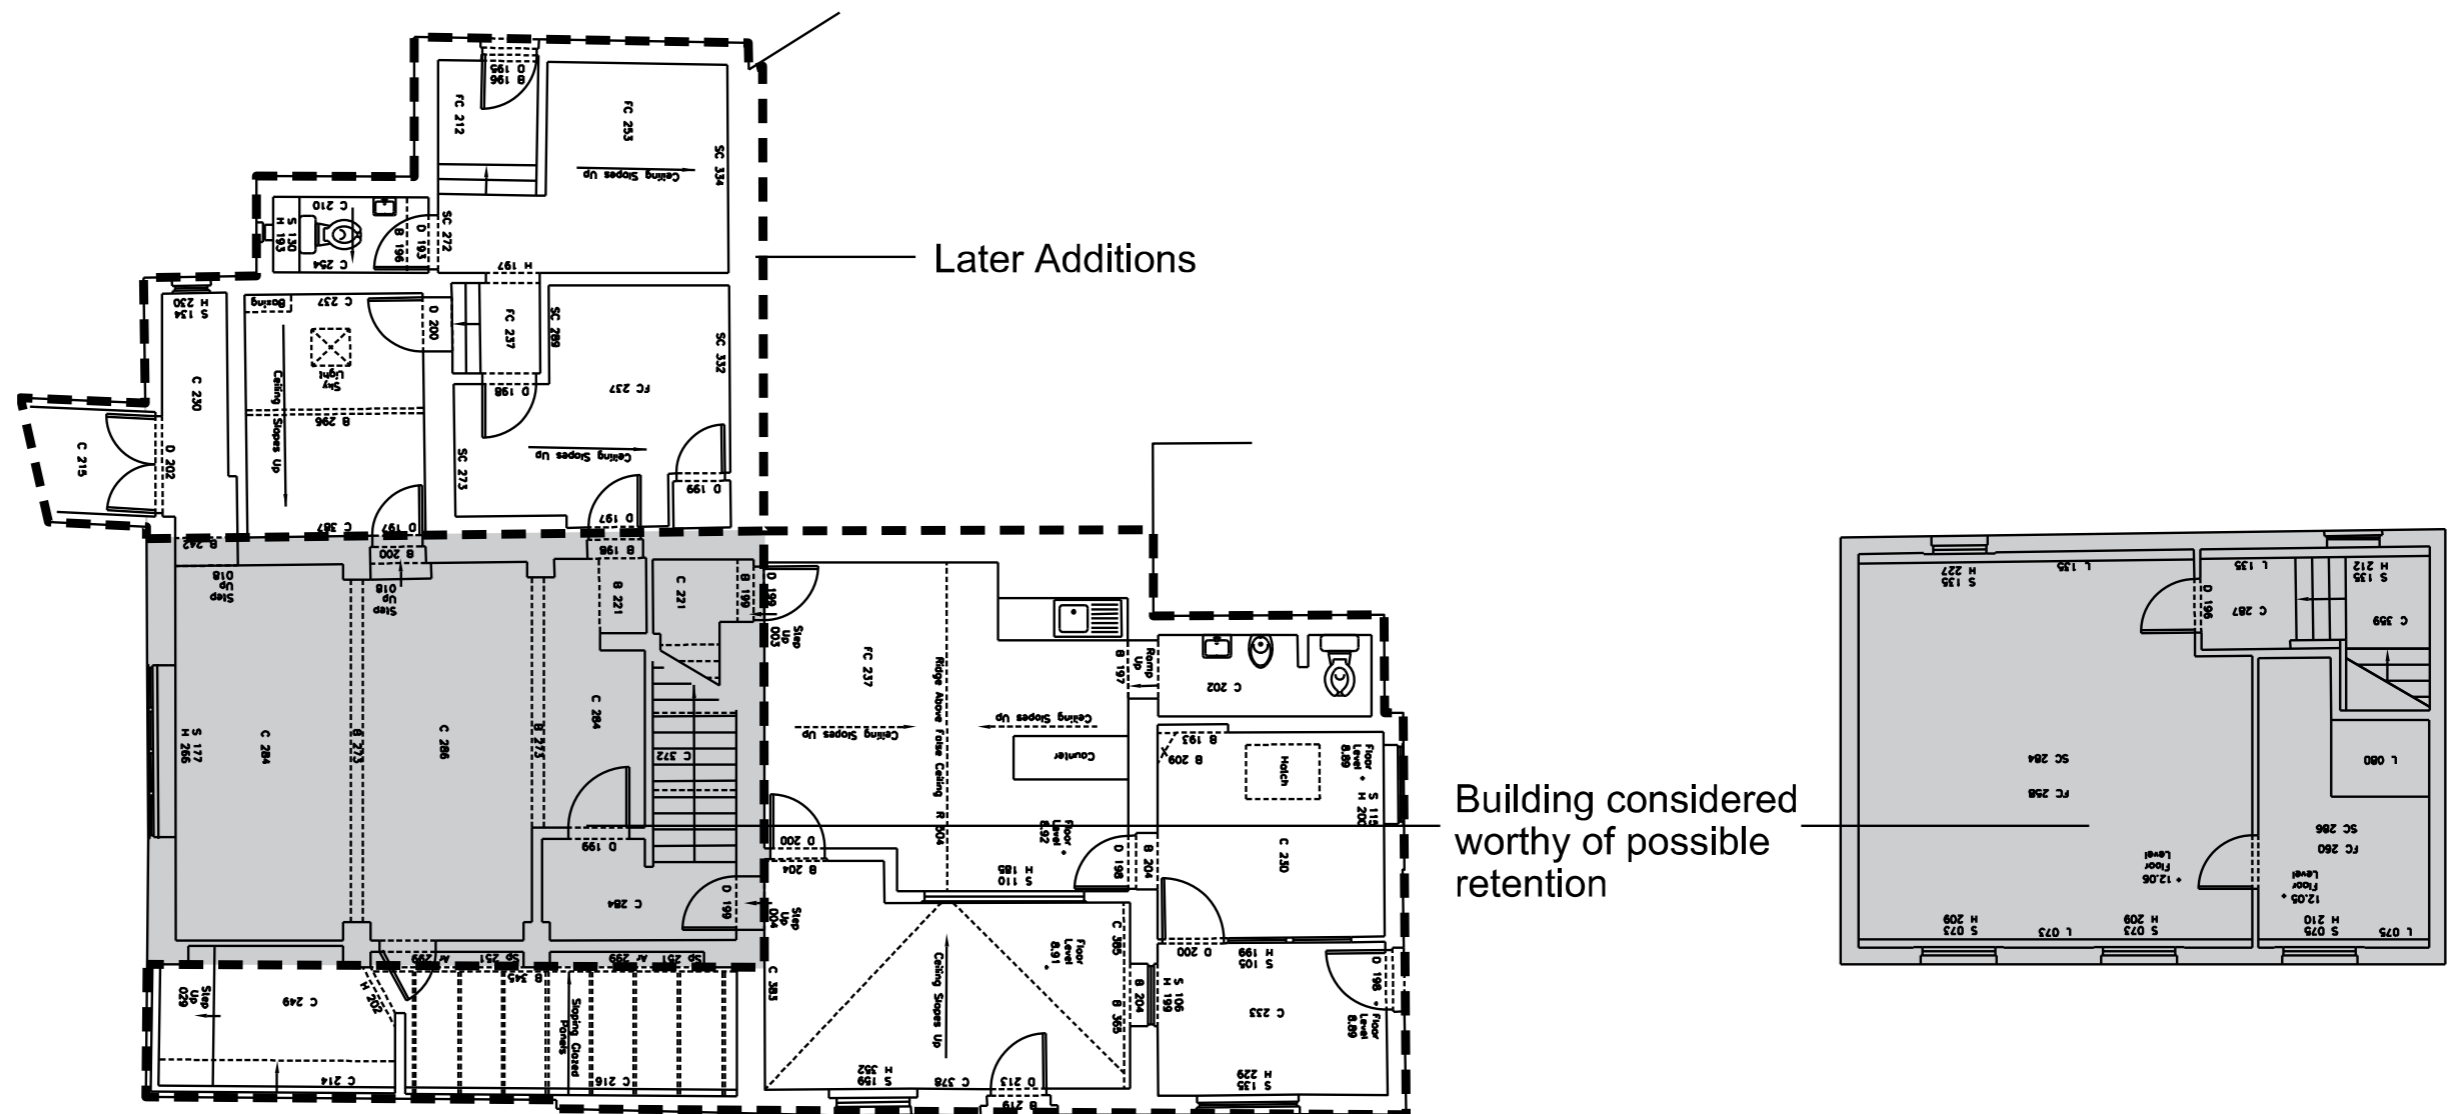
The identified building is shown greyed out on the plans below. The building is surrounded on 3 sides by later extensions. The original internal walls have been removed and new walls and concrete staircase inserted.

New openings have been formed at ground floor to connect the existing building to the surrounding extensions. At first floor all internal walls have been removed, new walls built and a concrete stair inserted.

The original brickwork on the external, now internal walls, have been rendered and painted.

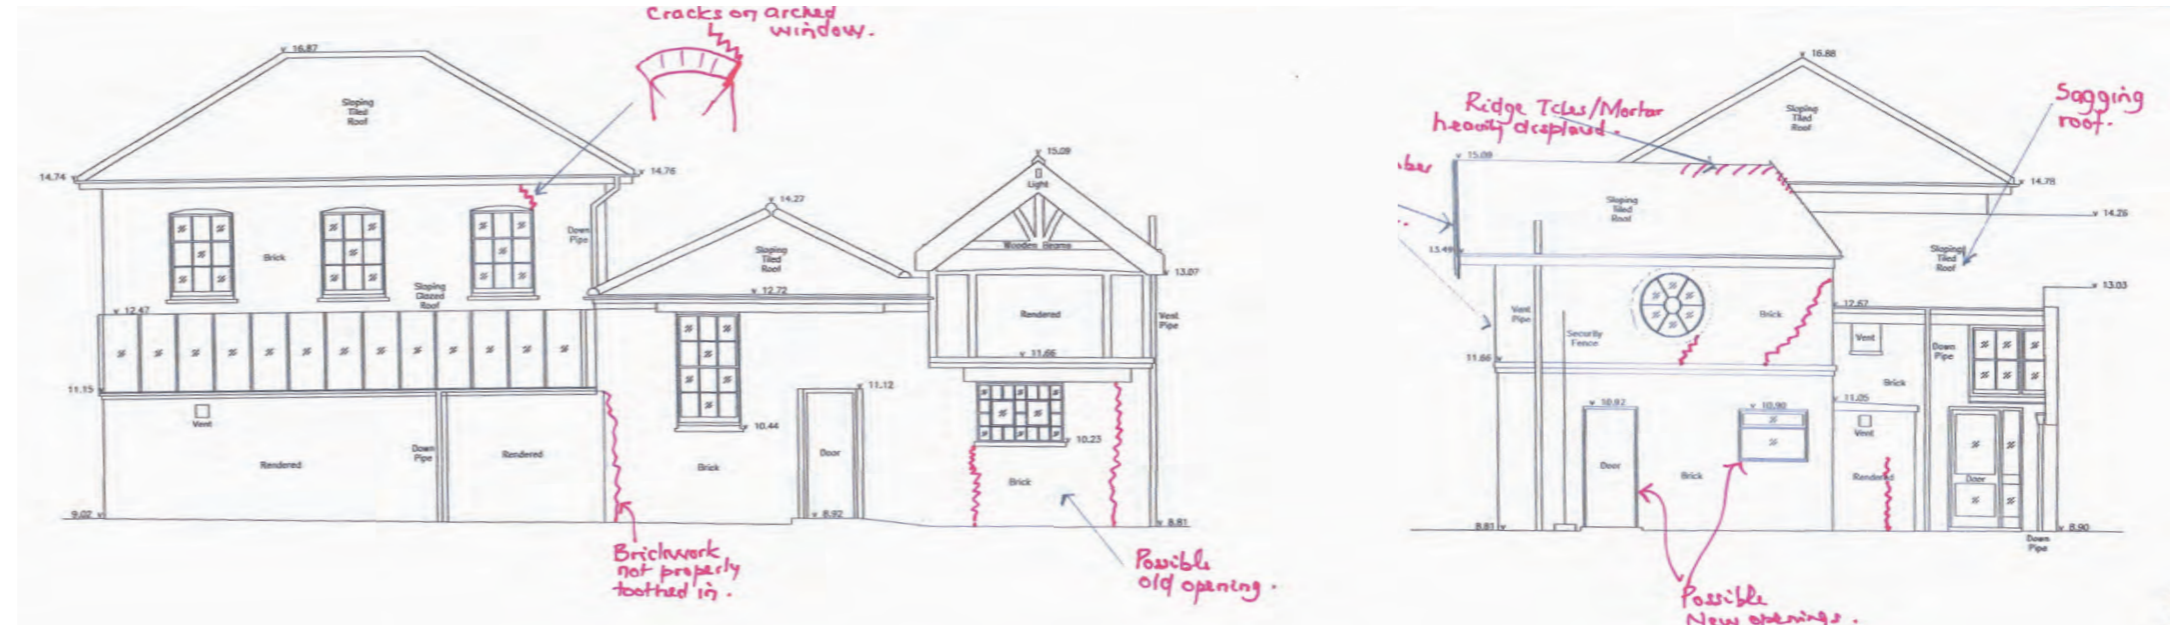
Elevation 1

Generally this section of the building appears to have gone through quite a few alterations in the form of various openings as marked on the elevations 1 and 2.

As a result of this, the structure has lost its original structural integrity and this is evident from the cracks which are beginning to appear on the elevations, particularly on elevation 2.

The ridge tiles and the associated mortar beddings are beyond repair and the roof requires complete replacement in order to achieve a decent life span. Access wasn't possible into the roof space to inspect the condition of the structural members but judging from the protruding structural members outside it would appear that they would need replacement and possibly strengthening. As is normally the case with old structures of this nature, it is highly possible that the lack of or ineffective tying at approximately at eaves level may have also contributed towards the cracking of the brickwork as shown on elevation 2 thus losing its structural integrity.

The timber fascias and the associated timber features on the elevation 1 require complete replacement.

Due to the thickness of the external walls, extreme care is required to stabilise the walls during the roof replacement, the replacement of the timber bearings and timbers referred to above. Unless adequate temporary works are provided there is a possibility that the original features may become unstable during replacement.

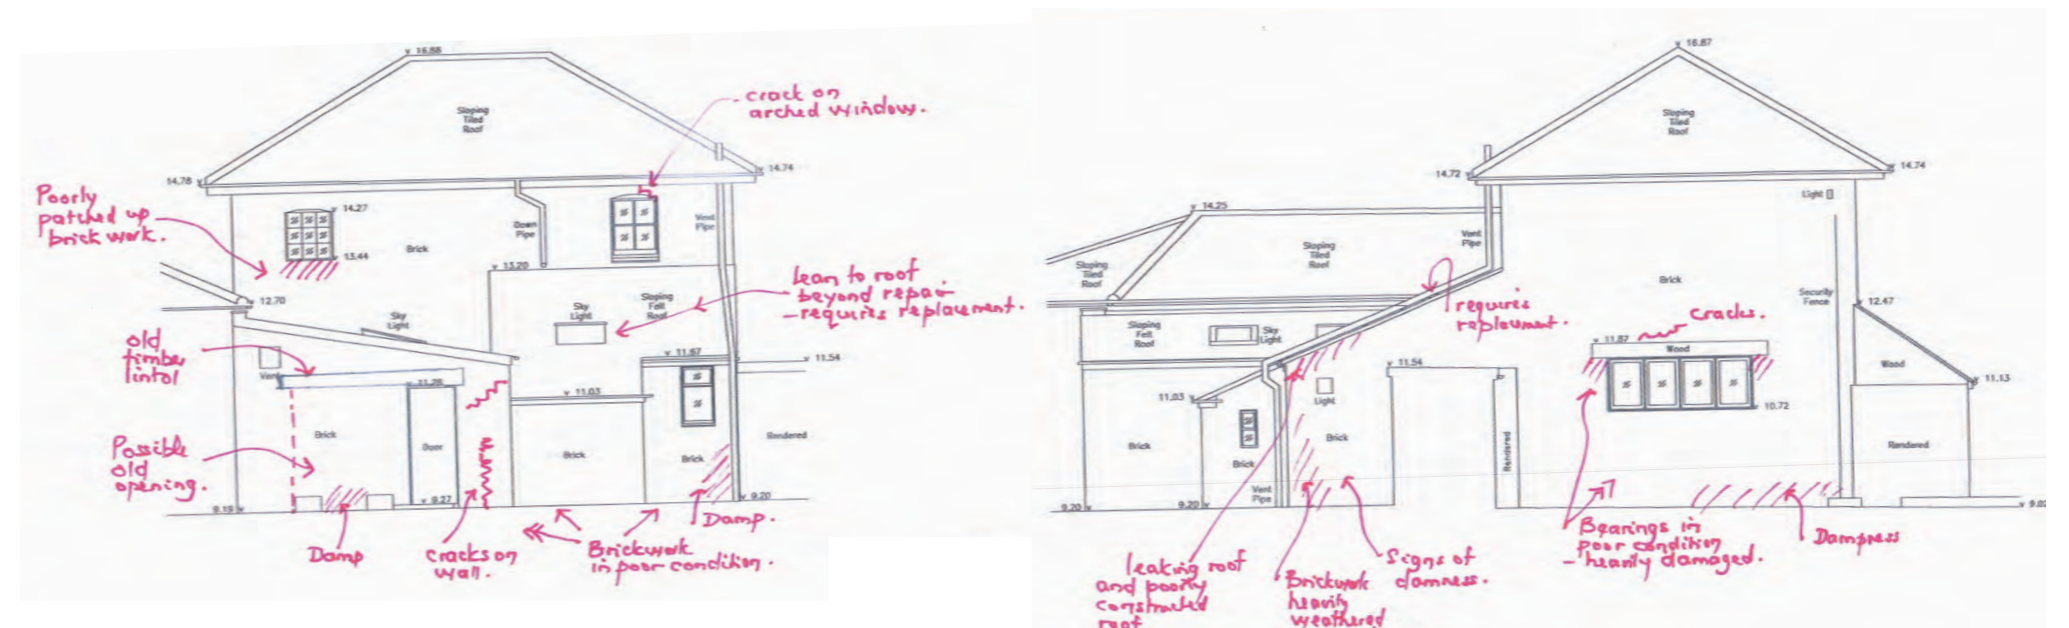
Elevation 4

As it stands, the high level arched window openings are already showing signs of distress in the way of cracks. See mark up on the elevations.

As evident from elevation 4, the bearings on both ends of the lintol has been badly disturbed to the extent that it would require propping and rebuilding. The base of the brickwork would require attention to avoid any water ingress.
