**TREE SURVEY AND ASSESSMENT IN
RELATION TO PROPOSED
DEVELOPMENT AT
LAND TO THE REAR OF
61 BELMONT ROAD,
TWICKENHAM,
MIDDLESEX
TW2 5DA.**

Tree Survey and Assessment in Relation to Proposed Development at Land to the Rear of 61 Belmont Road, Twickenham, Middlesex, TW2 5DA.

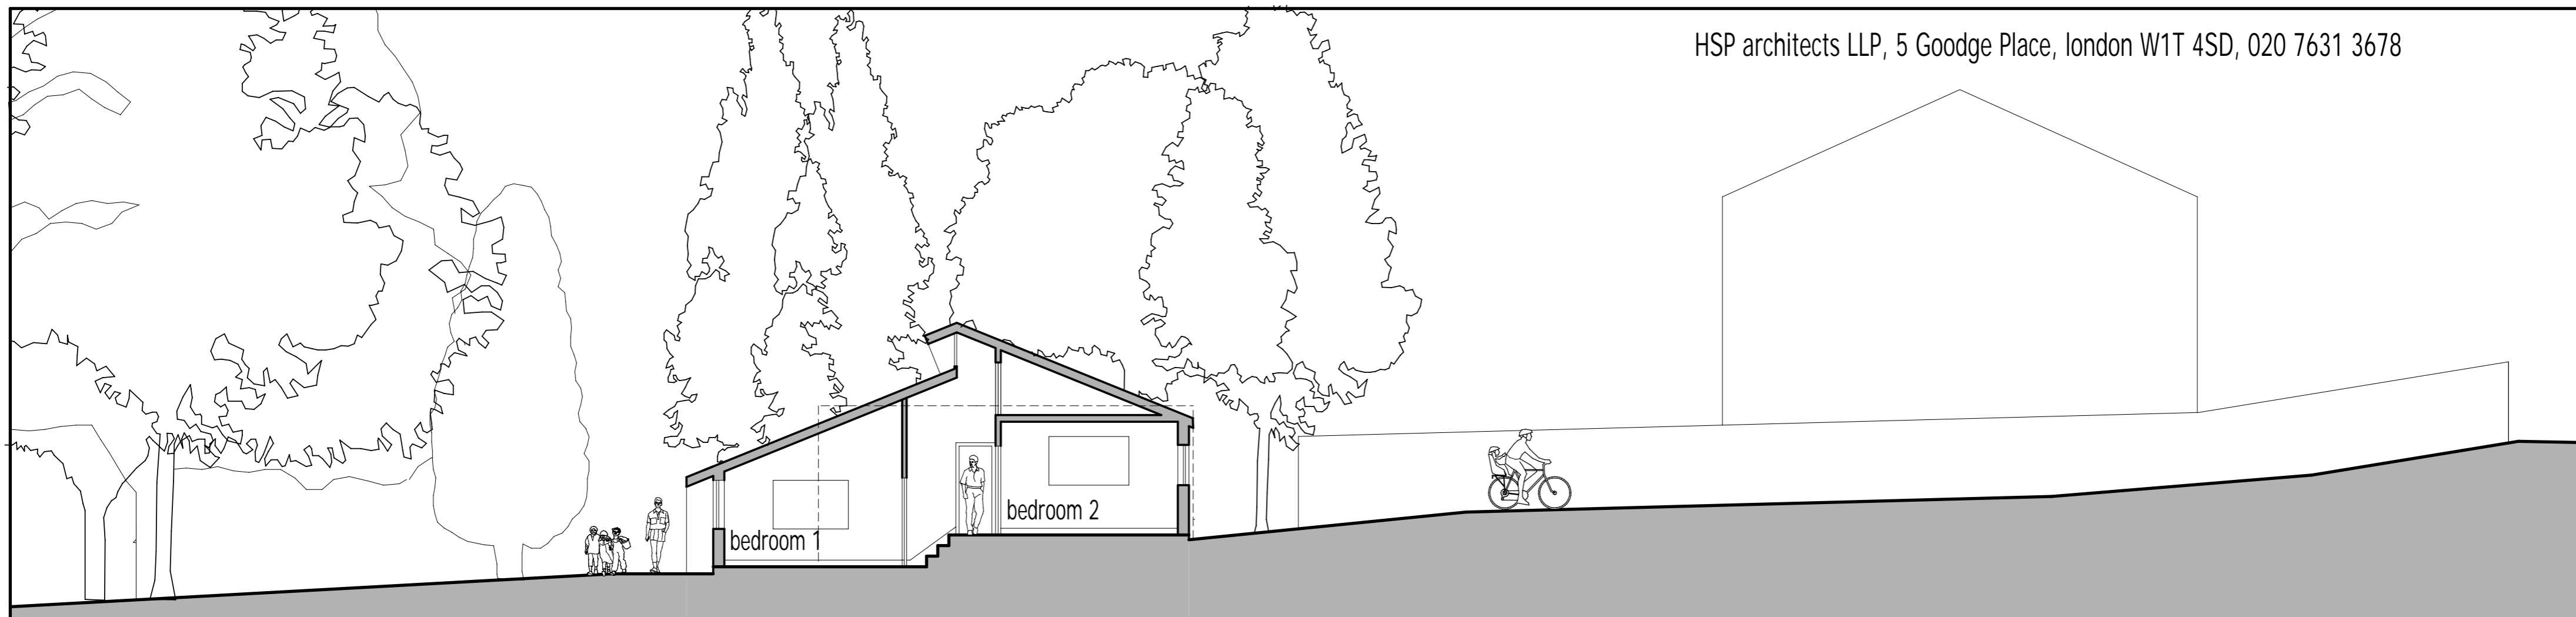
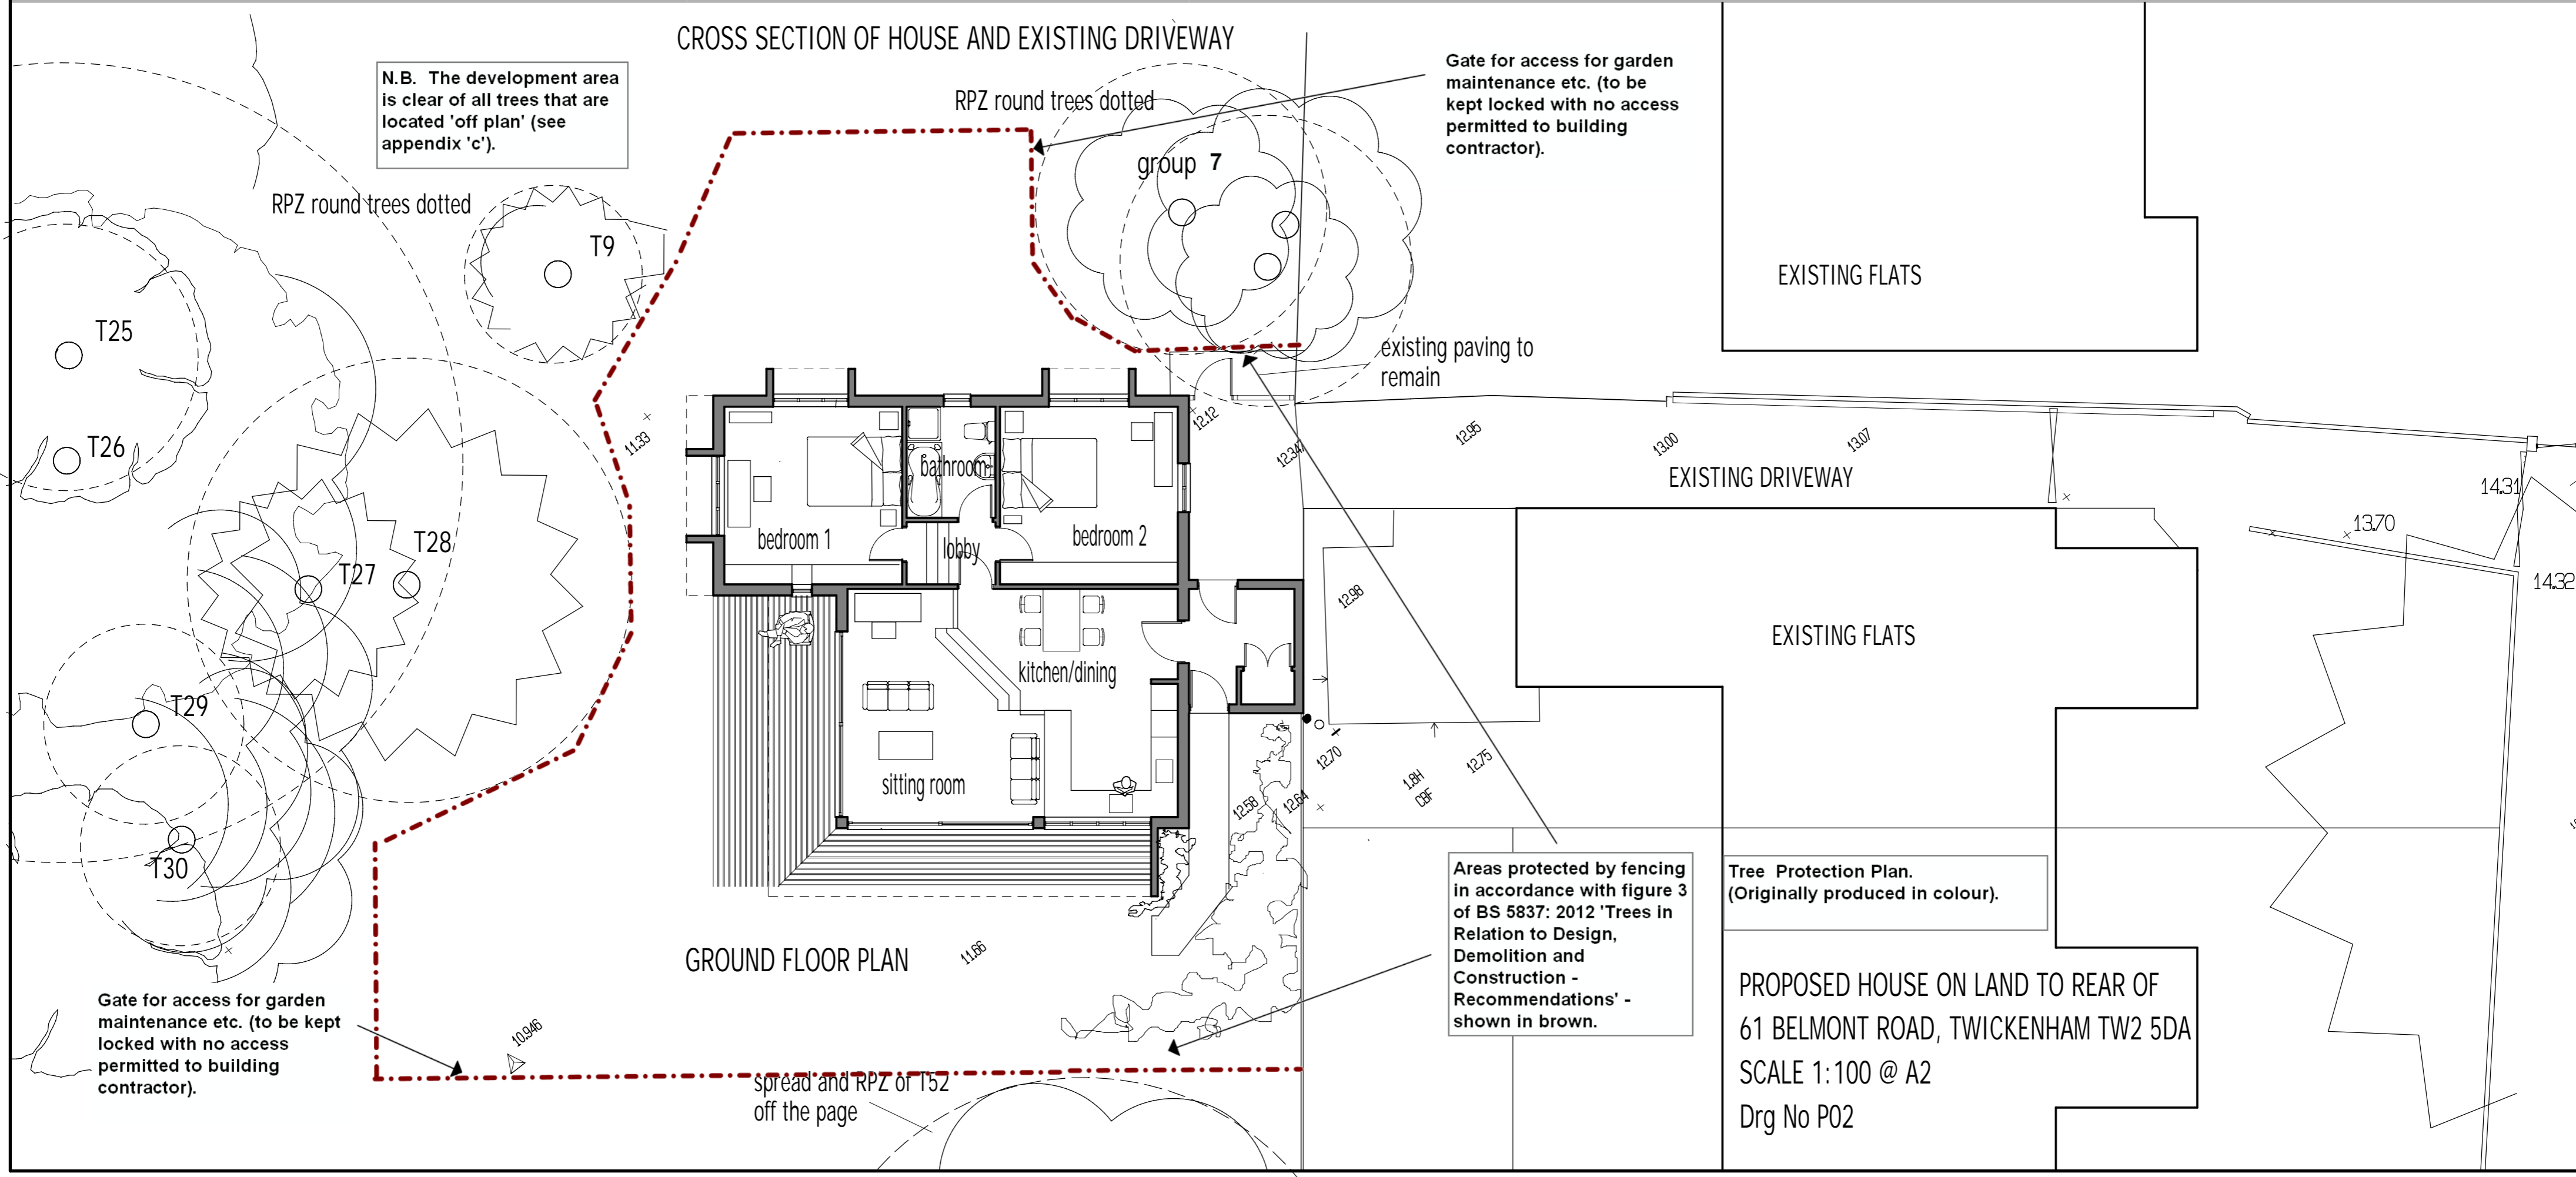
Appendix 'f'
Tree Protection Plan.

Gate for access for garden maintenance etc. (to be kept locked with no access permitted to building contractor).

Areas protected by fencing in accordance with figure 3 of BS 5837: 2012 'Trees in Relation to Design, Demolition and Construction - Recommendations' - shown in brown.
