Arboricultural Development Report

MARKETING SUITE LATCHMERE HOUSE RICHMOND

Produced for:
Berkeley Homes (West London) Ltd

March 2016

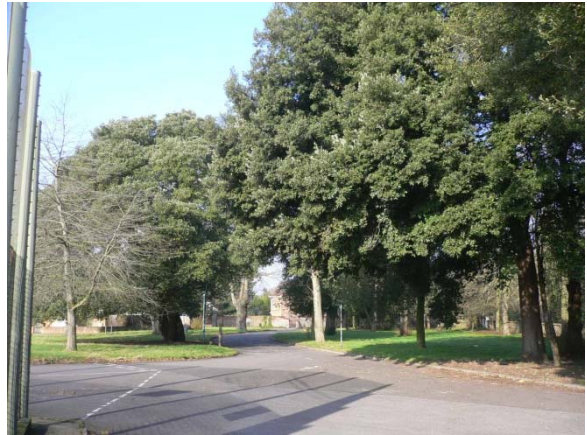
1. General view of trees located to north of Church Road with proposed area of Marketing Suite (right of photo) .

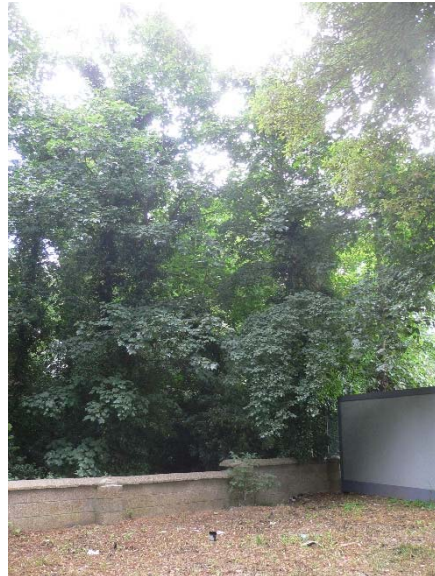
- 7.1.6 To the southeast of the marketing suite, a car park and footpath link are proposed. Whilst the car park and footpath will be located within the RPA of Holm Oak (T42), Lime (T43) and Horse Chestnut (T44) this area is relatively flat and therefore hard surfacing

can be reasonably achieved through a 'no dig' construction using a cellular confinement system (ie. Cellweb) as specified by an engineer and in accordance with the manufacturers guidelines. This will maintain the root system of adjacent trees intact and minimise disturbance of this temporary structure. The final surface will be porous.

2. General view of proposed parking area.

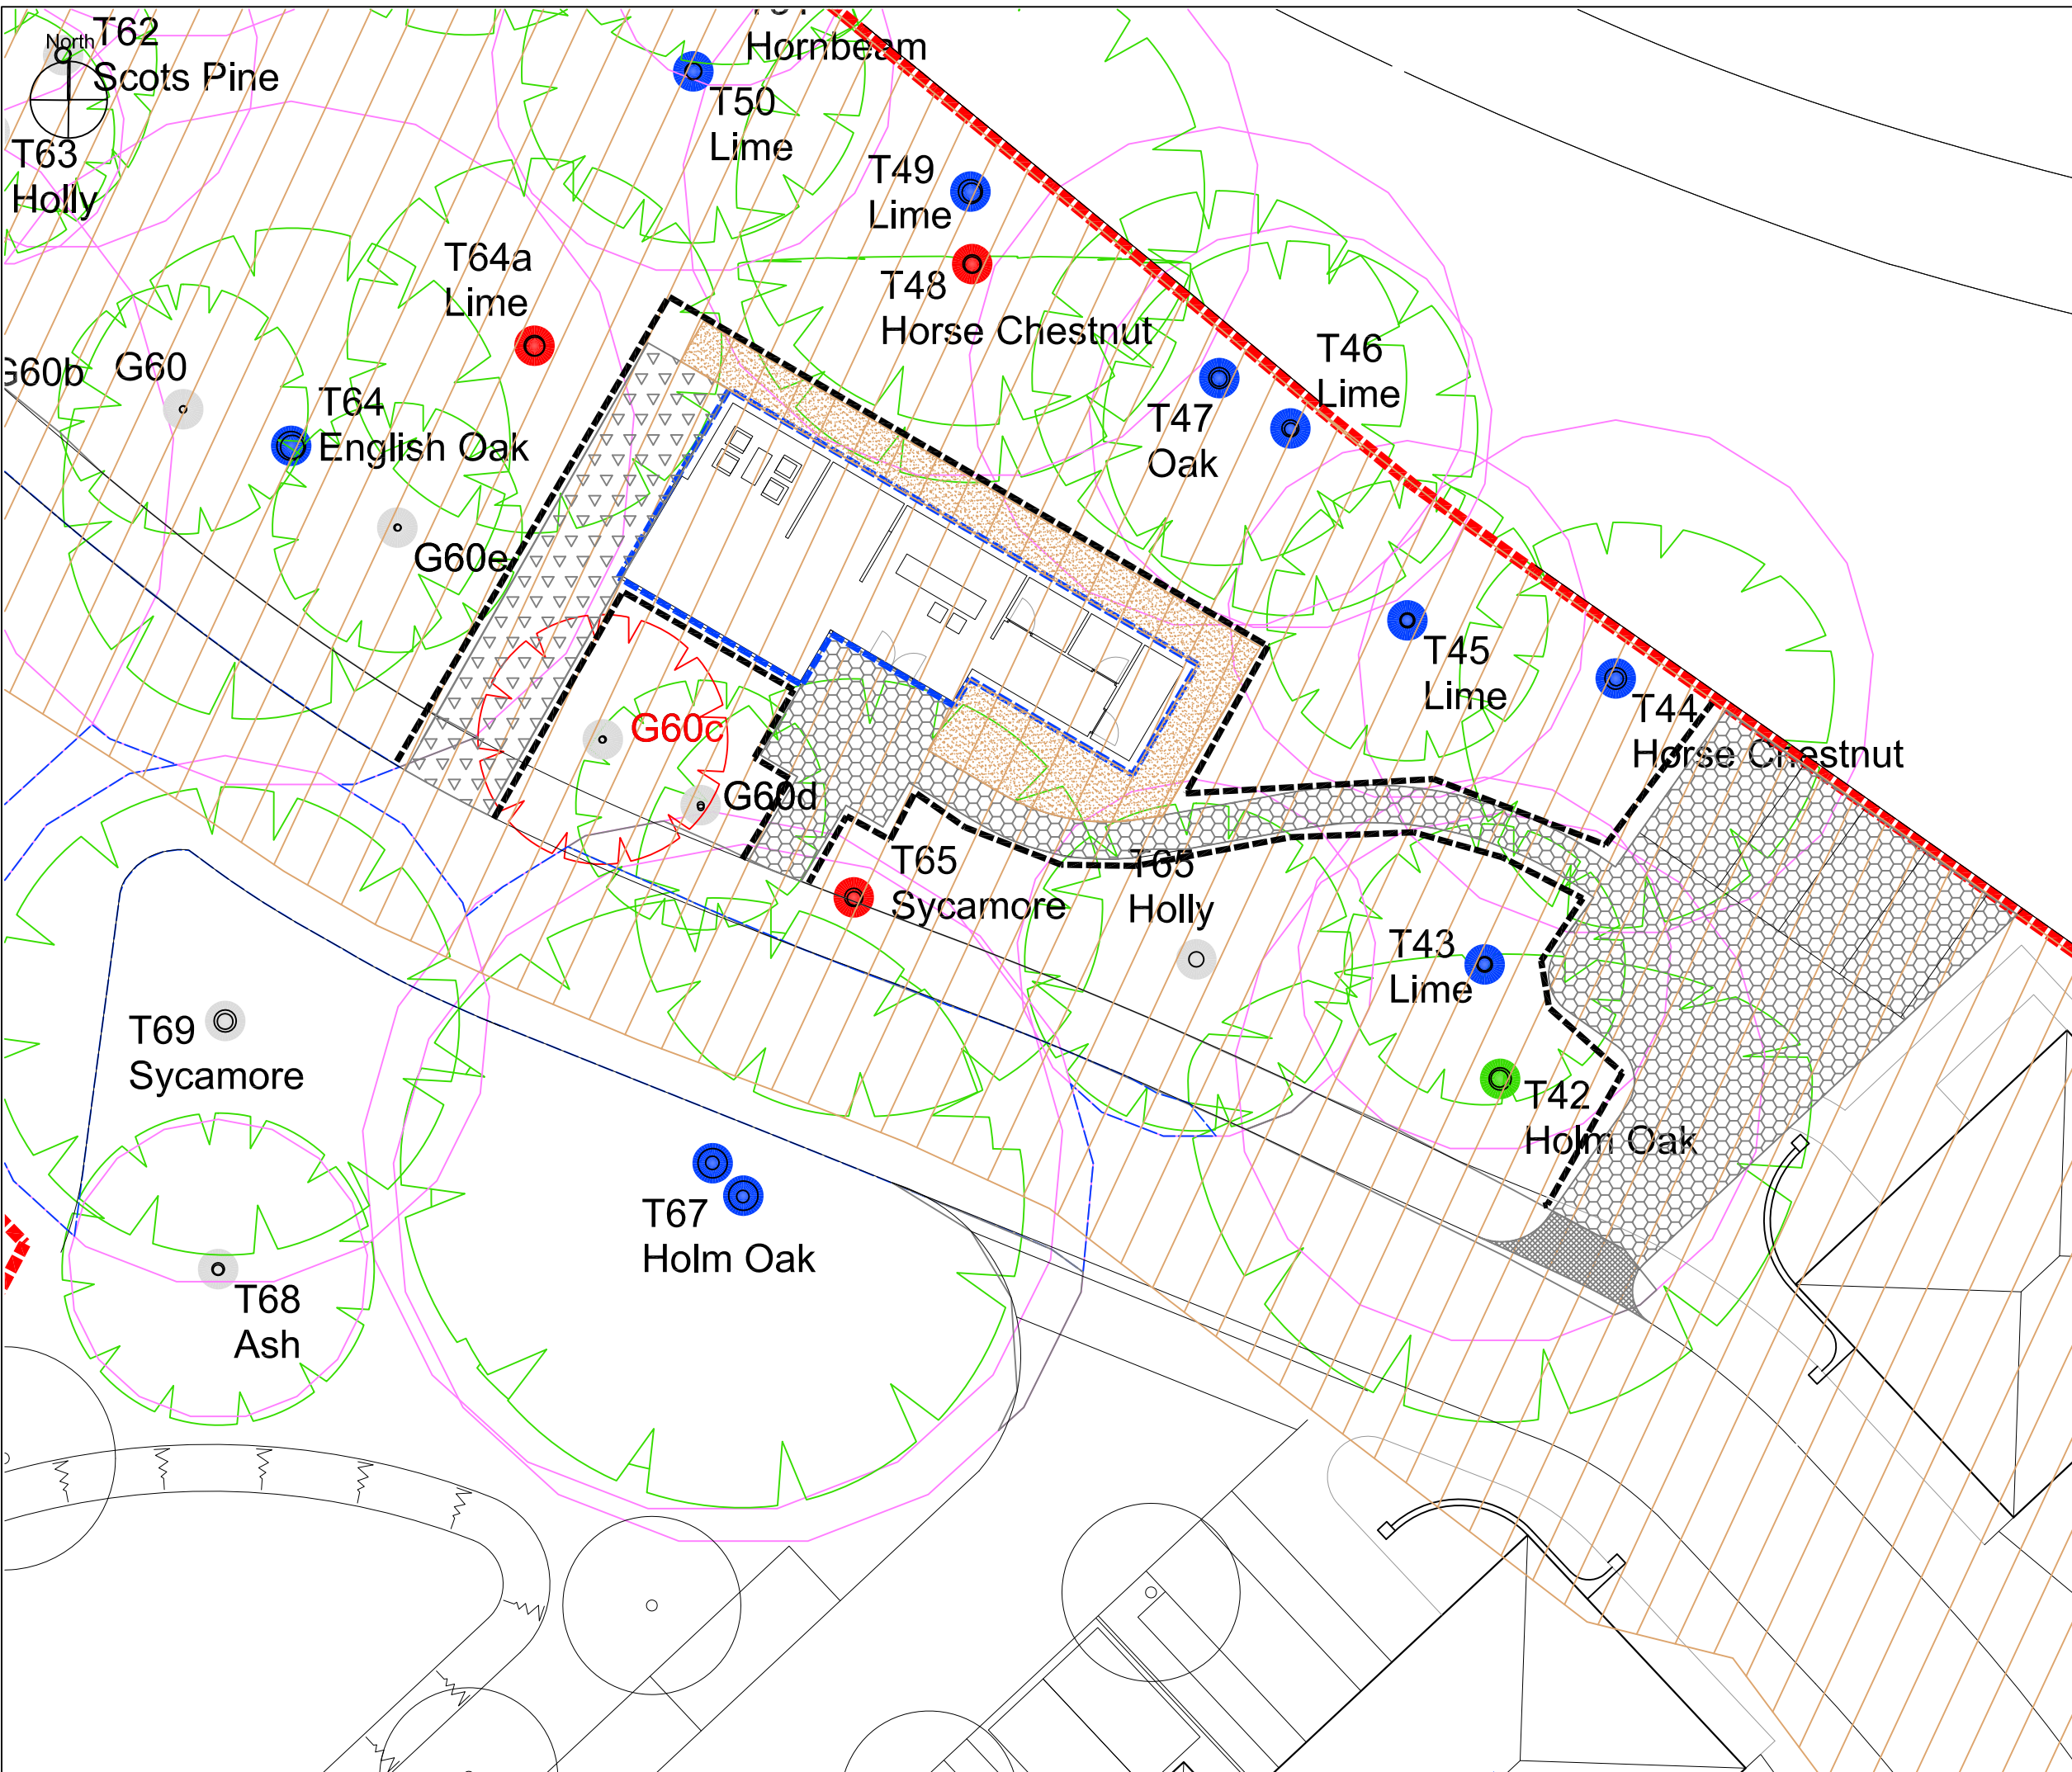
Drawing
 ARBORICULTURAL IMPACT ASSESSMENT

- 7.1.2 The impact of the proposed Marketing Suite is considered below and precautionary areas summarised within the illustrative Arboricultural Impact Assessment Plan [TF913/TPP/202] which forms Appendix 3;

- 7.1.3 The Marketing Suite is located within an area of soft ground. Whilst the footprint does not encroach within the RPA of adjacent trees, as a mobile structure, the suite can be suspended above ground level on pad foundations. Preparation of the foundations will be excavated using non mechanical tools and subject to monitoring by the Project Arboriculturist. Prior to pouring of concrete, the excavated hole will be lined with a non-porous textile to prevent leaching of toxic concrete into the surrounding soil. Where roots are encountered under 25mm in diameter these will be diverted out of the way or where this is not possible cleanly cut. Where roots over 25mm are encountered, the resultant hole will be backfilled and a new hole excavated in consultation with an Engineer to avoid the root. This will minimise disturbance and allow the continuity of moisture and gaseous exchange to be available within the existing soft ground area beneath the building.

- 7.1.5 To facilitate access during initial installation/dismantling a Holly (T60c) will be removed and replaced following completion. The Holly is subservient and trifurcated from ground level. As such, the tree is of poor quality and its removal would not have a detrimental or adverse impact on the visual amenity of the group.

- 7.2.3 In particular, provision must be made for, but not exclusively, the following;
- Location and specification for tree protection barriers and ground protection.

- Precautionary measures to be adopted during;
 - Installation of pad foundations within the soft ground area
 - Installation and removal of the structure
 - installation of the footpath link
 - proposed levels
 - Landscaping
 - Provision for arboricultural monitoring of works within the RPA of retained trees.
