**TREE SURVEY AND ASSESSMENT IN
RELATION TO PROPOSED
DEVELOPMENT AT
4 & 6 MANOR ROAD,
TEDDINGTON,
MIDDLESEX.**

Revised January 2016.

Clive Fowler Associates: Tree Survey at 4 & 6 Manor Road, Teddington, Middlesex.

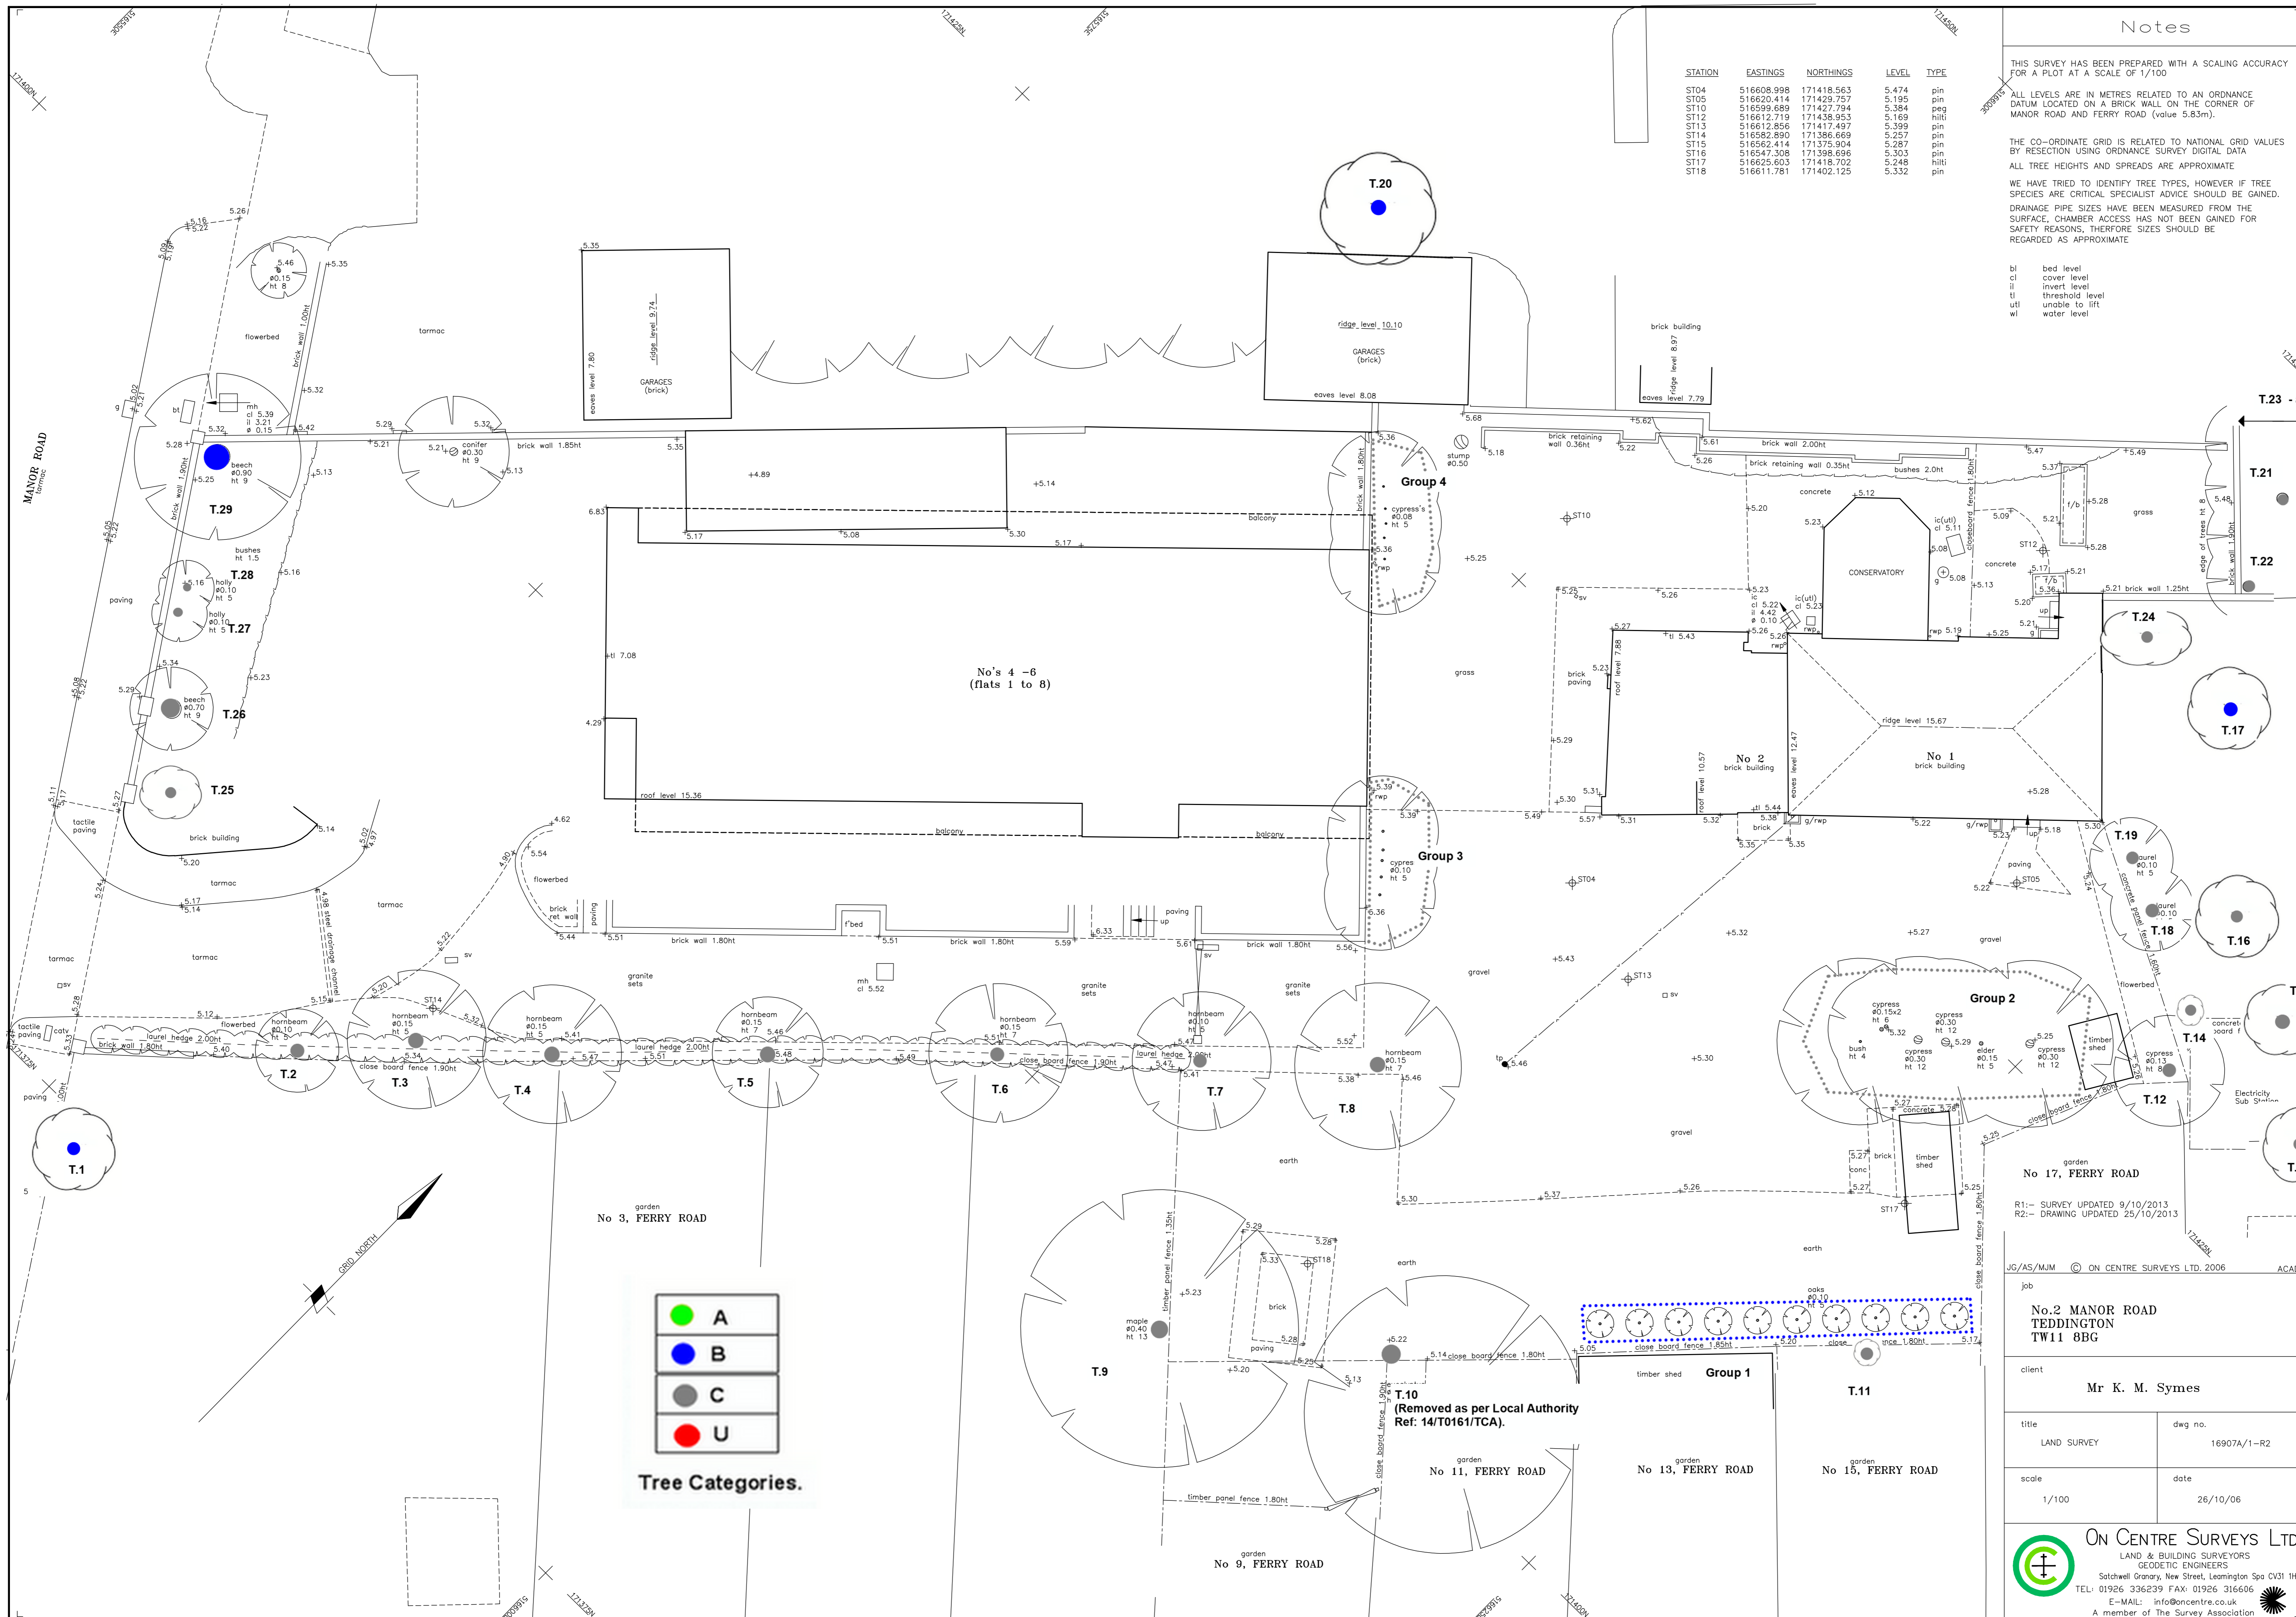
Appendix 'b'
Tree Locations.

3. I have been supplied with a copy of the existing site survey and enclose a reduced copy of this drawing as appendix 'b' to this report which indicates the position of the trees with their respective identification numbers.

5. The information contained within the schedule has been collected in accordance with recommendations given in BS 5837: 2012 'Trees in Relation to Design, Demolition and Construction - Recommendations'. I have also categorised each tree in accordance with the above Standard and they are colour coded on the enclosed site survey drawing (appendix 'b') to aid their recognition.
