RUGBY FOOTBALL UNION

Arboricultural Impact Assessment

Twickenham Stadium – East Stand Extension

June 2016

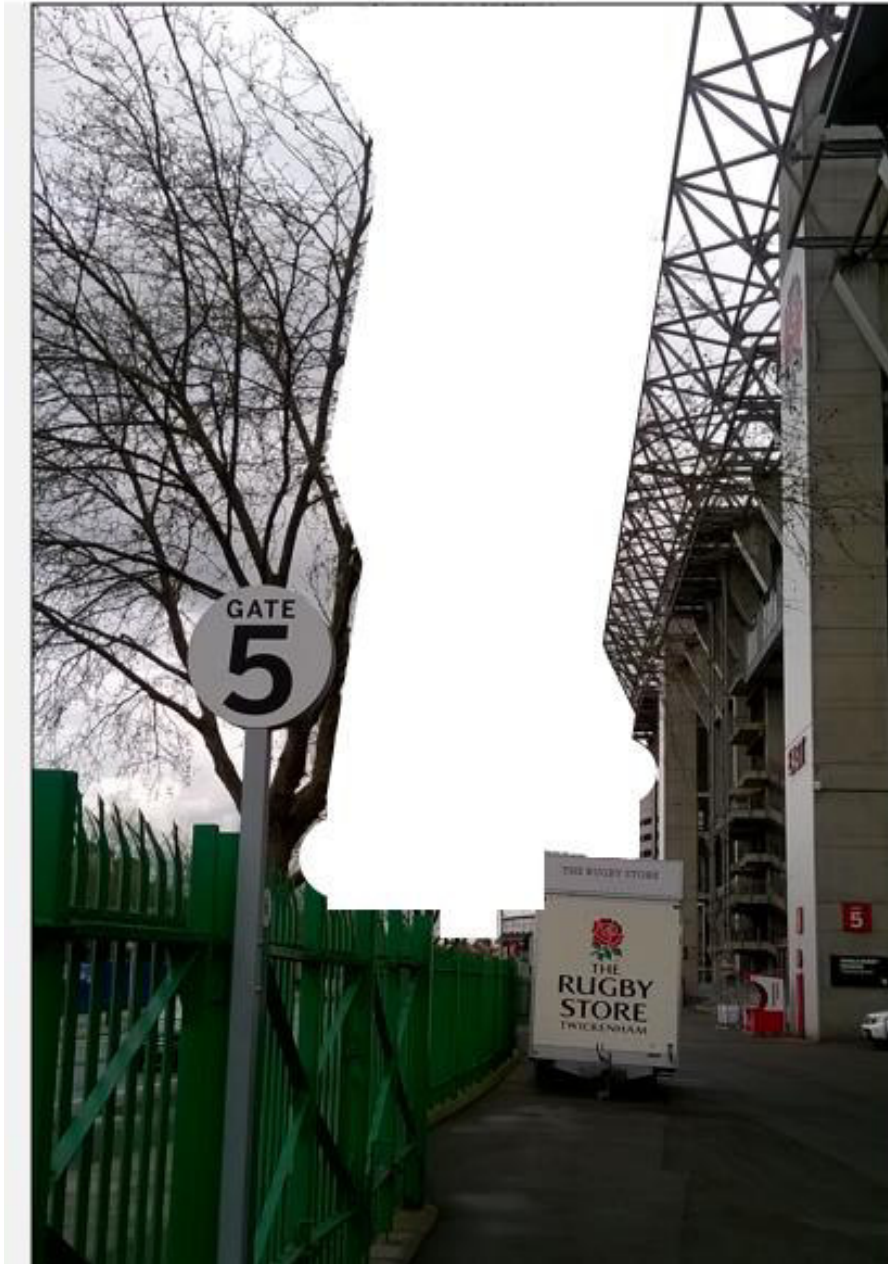
6.7 However, the maturing trees (identified as T2 and T3) stand in close proximity to / overhang the boundary palisade security fence; the proposed new extension will bring the flank wall of the Eastern side of the stadium within very close proximity to this boundary-line, thereby necessitating the reduction of all overhanging limbs if T2 and T3 are to remain.

6.8 The extent of linear crown reduction has been estimated to be in the order of between 6m and 7m on the South / South-West side of both trees (see image 1 below).

Image 1: Estimation of the extent of pruning required to reduce T2 to the boundary-line.

6.9 Whilst this work is relatively 'heavy', London Plane (*Platanus x hispanica*) is a robust species of tree

and should therefore be able to tolerate this work with no appreciable elevation in risk of instability or crown decline.

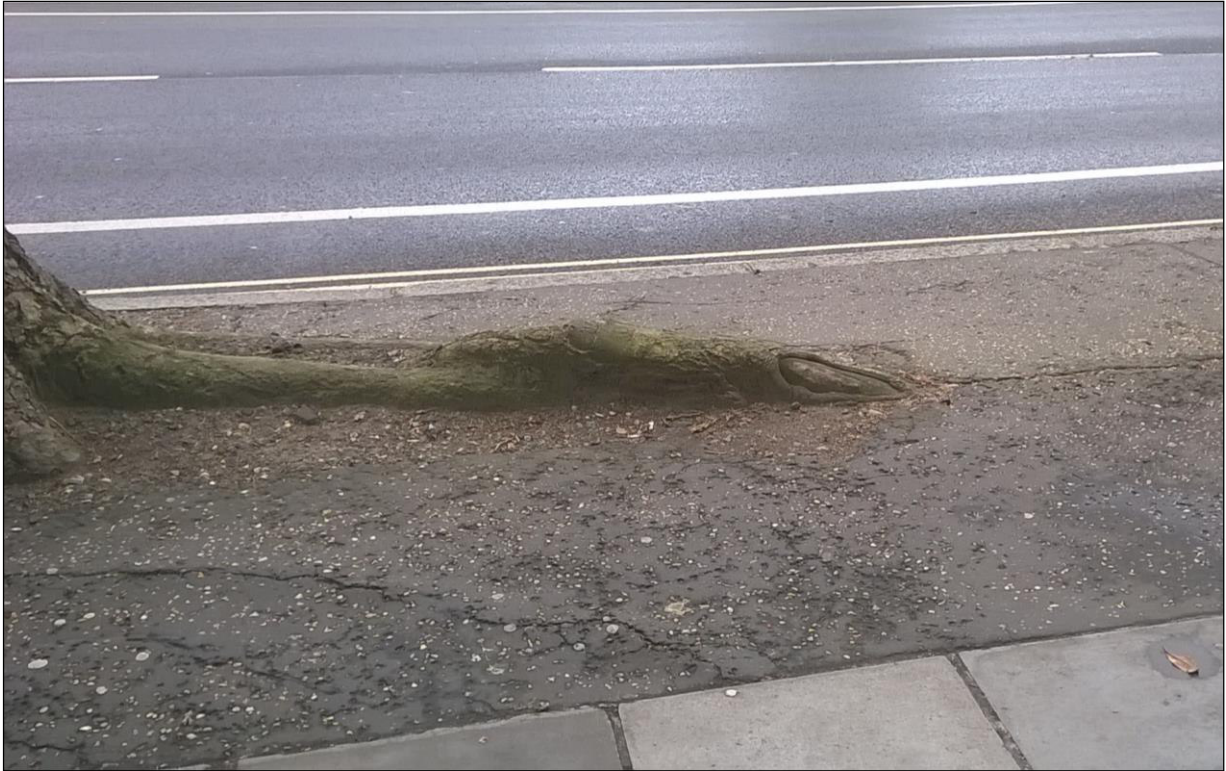
- 6.10 However, whilst this work may be sufficient to allow works to progress, it will not mitigate the obvious trip-hazards presented by the large and clearly visible surface roots (which are having an obvious / negative impact on the footpath adjacent to the gate for the East Stand (See Image's 2 and 3 below).
- 6.11 Given the high levels of anticipated pedestrian traffic during match days, these roots present a clear and obvious issue with regards to crowd safety and one which crown pruning cannot address.
- 6.12 Removal of T2 and T3 has therefore been suggested, as it will provide the most pragmatic option in this instance.

Image 2: Large surface root and obvious trip-hazard noted on T2 (Plane (London))

7.1.2 Given the high level of pedestrian traffic expected (on match days), tree removal will fully mitigate the obvious trip-hazard posed from the large and visible surface roots emanating from T2 and T3.

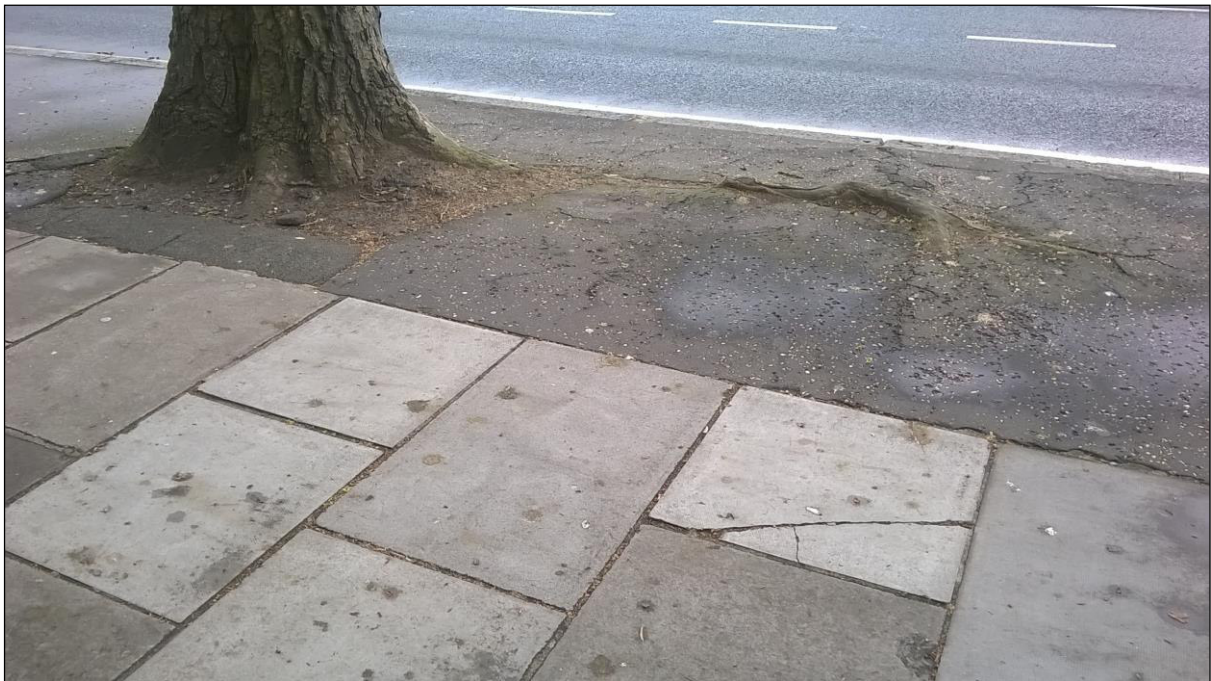
Image 3: Visible surface root and associated pavement damage from T3 - Plane (London)
