# The Firs, Church Grove, Hampton Wick, Kingston-Upon-Thames

## Ecological Briefing Note

April 2017

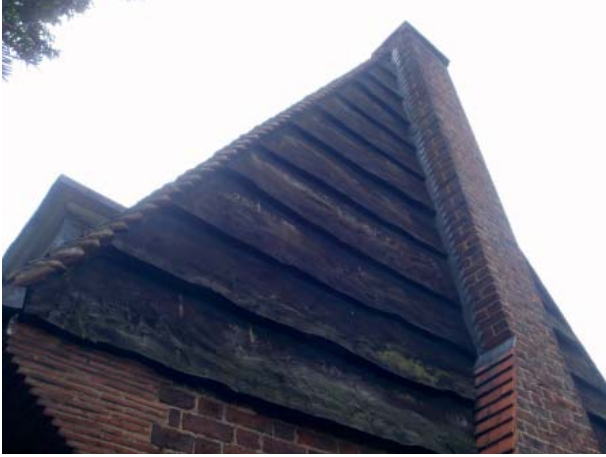
- 3.10 Timber weatherboarding is located on the northern and southern gable ends of the building. The boards are loosely fitted with gaps between them, creating potential crevices which may be utilised by roosting bats. Upon close inspection some of the gaps contained cobwebs with some were clear at the time of survey.

- 3.14 The exterior of the building provides a small number of potential roosting opportunities for individual bats, the majority of which are under weatherboarding on the gable ends of the building. Given that the roof is unlined, whilst lifted tiles provide access to the roof void which may be utilised as a feeding roost, it is unlikely that lifted tiles provide potential roosting opportunities for crevice dwelling bats. Given the light and drafty nature of the internal roof void this space offers very little roosting potential to bats.

Plate 1. Weatherboarding with gaps on south-east gable end.

- 4.1 The building on-site provides a small number of potential roost sites which may be used by individual bats opportunistically and therefore is categorised as having 'low' suitability for roosting bats. Given the potential for roosting bats to be present, as a precaution and in line with the BCT guidelines (2016), a single dusk emergence or dawn re-entry survey conducted between May and August is recommended to confirm presence or likely absence of bats and the requirement for a licence before demolition of the building. In the unlikely event that bats are noted to be present, further survey work in line with BCT guidelines (2016) would be required.

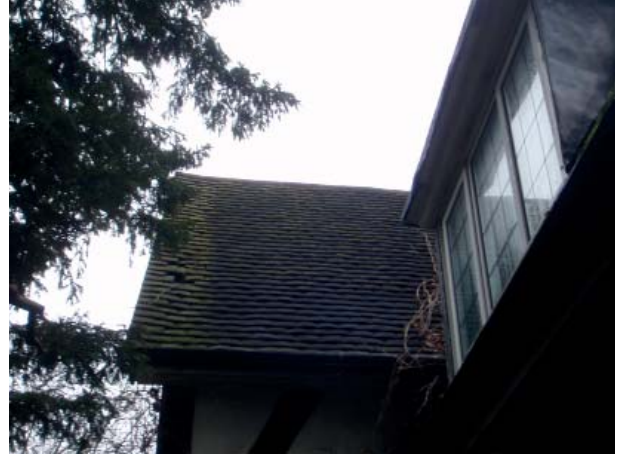
- 3.6 A single, unoccupied dwelling is located within the south-western half of the Site. The building is set over two storeys and is of brick construction with a partial mock-Tudor frame and a multi-pitched roof. Single storey, flat roofed sections are also present, comprising a single garage and porch area on the south-eastern and north-eastern aspects of the buildings.
- 3.7 The multi-pitched roof is covered by flat clay tiles. The roof tiles appear to be tightly fitted with some moss covering. However, a number of tiles are slipped or missing, presenting potential access points for bats into

the internal roof space. Lead flashing appears intact across the roof structure.

Plate 2. Section of roof with slipped/missing clay tiles.

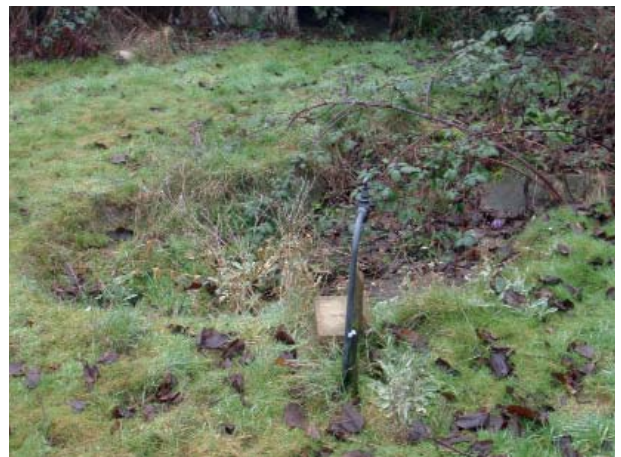
Plate 6. Dry pond lined with concrete slabs and encroaching vegetation.
