6.0 THE TREES AND SHRUBS

6.2 CONDITION APPRAISAL OF TREES AND SHRUBS

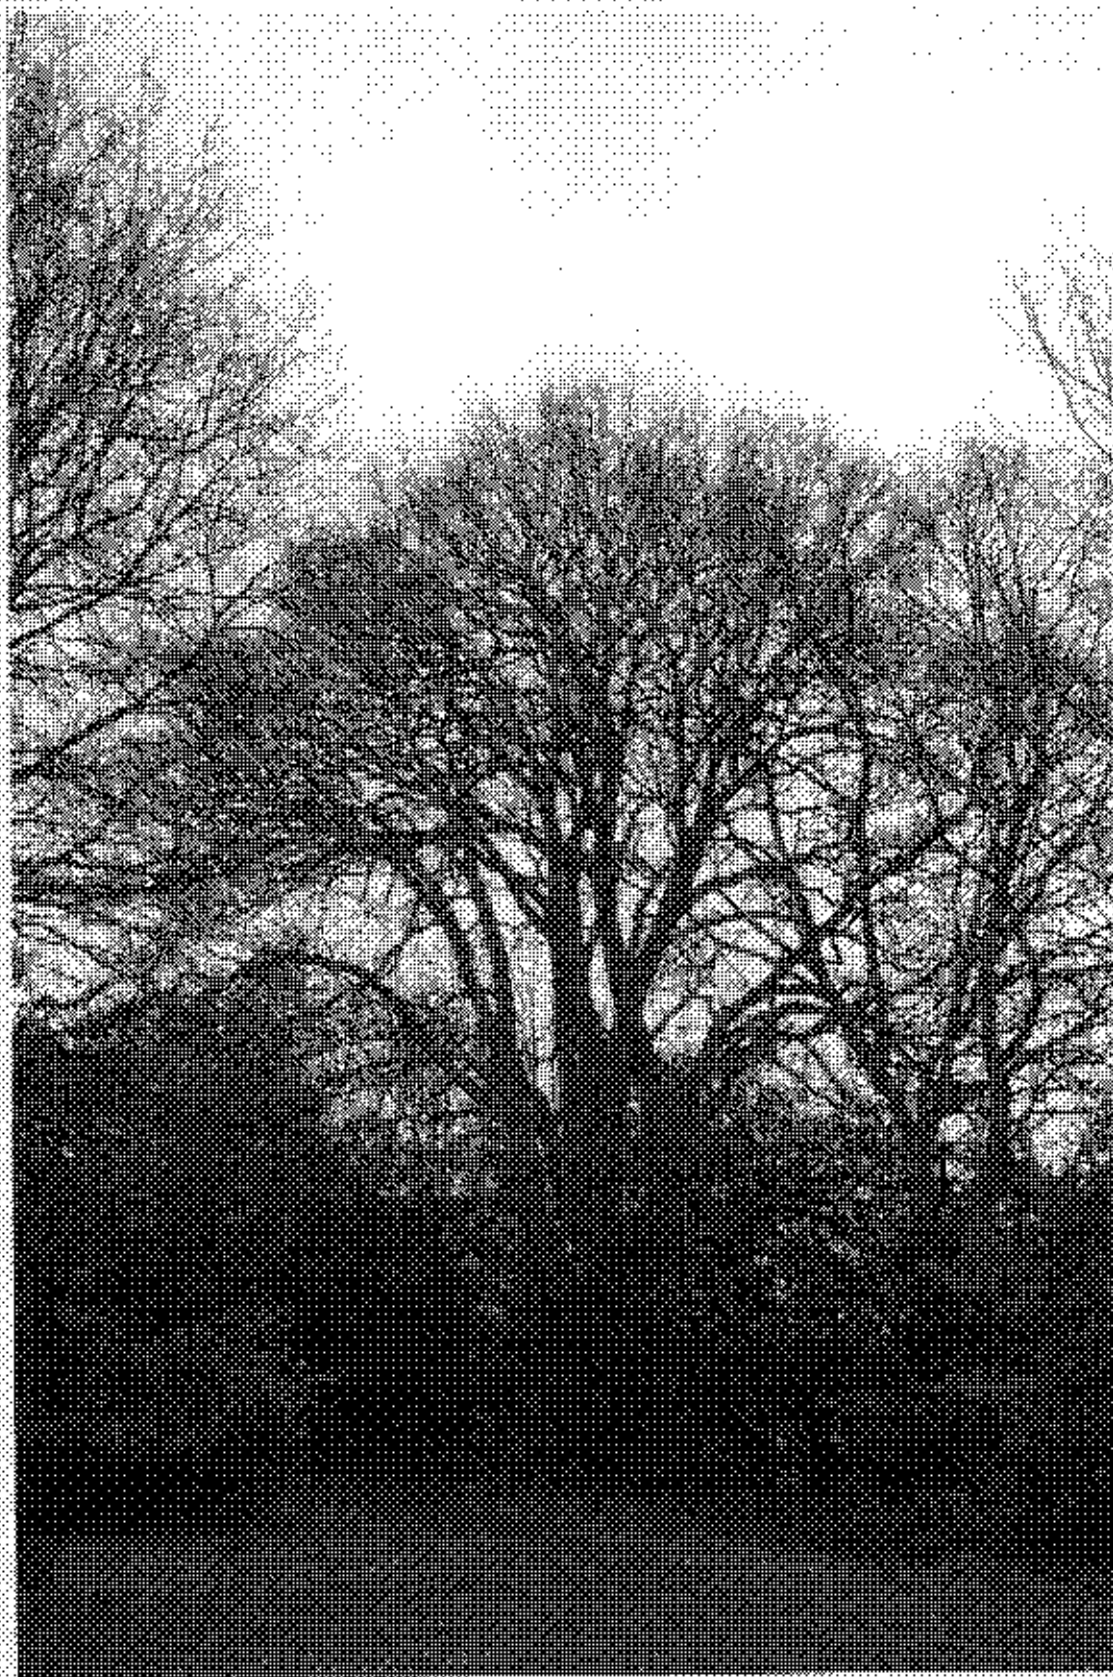
Despite the inevitable changes in land use over the last 250 years, there are still some notable trees on the site. One English Oak (T56) is probably the sole survivor from the mid-18th century plantings associated with the creation of the house from 1749 onward. This is a magnificent tree in its prime on the edge of the eastern screen behind a more recent 20th century group planting (see photo 1).

Photo 1 – The Fine Oak of Mid-18th Century Origin (T56)

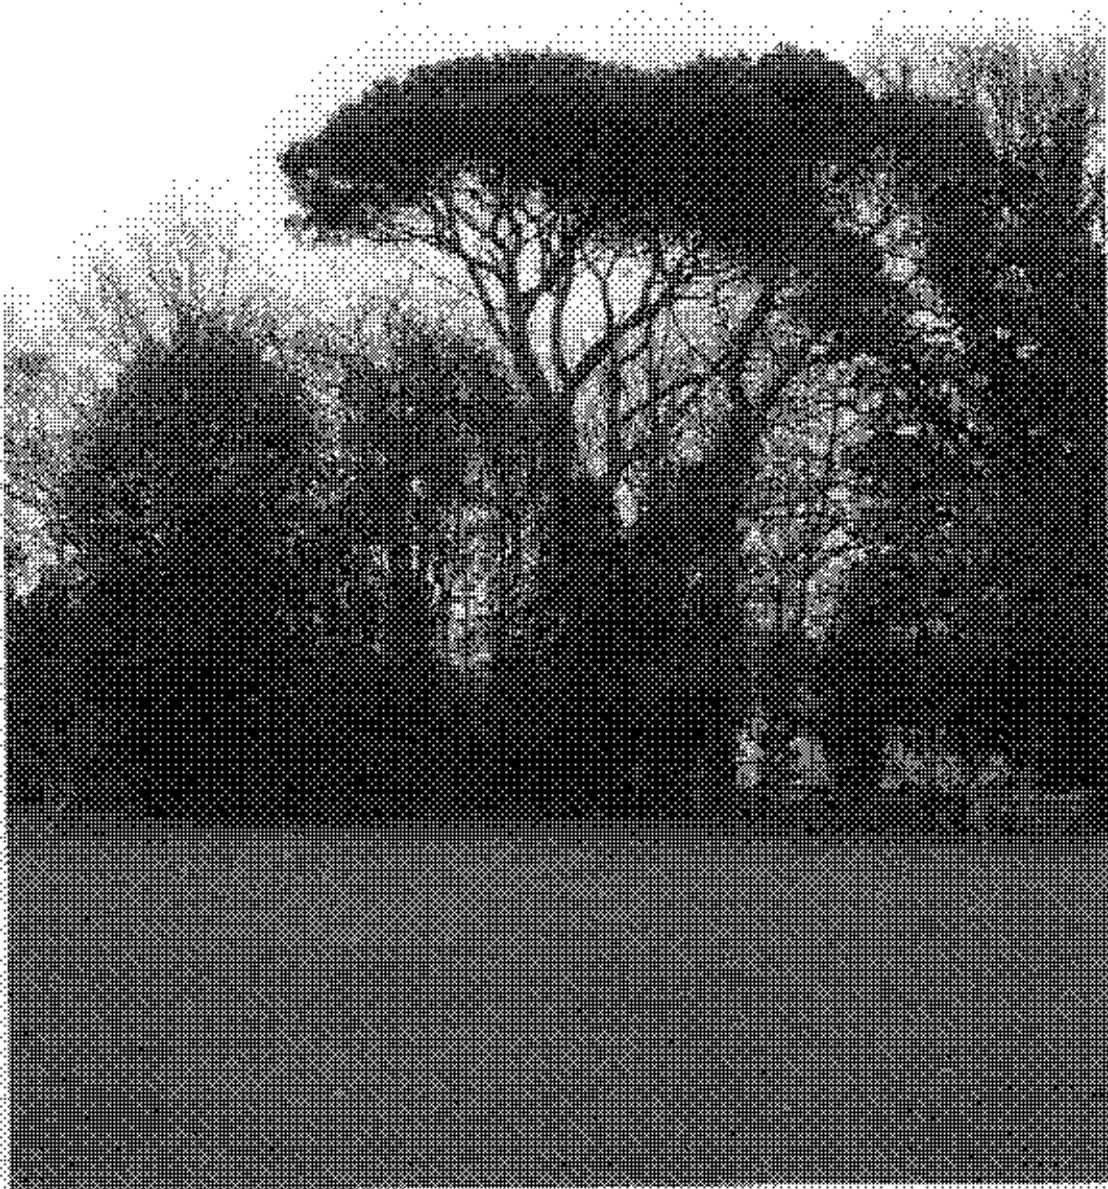
The current tree belts on the southern and eastern boundaries of the garden have their origins in the 18th century, being on the original footprint of the serpentine walk created by Walpole. There is still a walkway running through these belts, but the trees within them – with the exception of Oak T56 – are of Victorian origin. Oak T9 and T46 were probably planted between 1820 and 1850, while Sweet Chestnut T32 in the southern screen and a fine Stone Pine (T75 – see photo 2) in the eastern screen are other significant Victorian specimens.

It is interesting that Stone Pine is mentioned in correspondence by Walpole, and may have been planted by him at Strawberry Hill. However, the ring count on the existing tree dates it to around 1860, a legacy of the Lady Waldegrave era. It is possible that mature Stone Pine were already present in 1860 and like-for-like replacement planting was carried out.

Photo 2 – The Stone Pine Planted Around 1860 (T75)

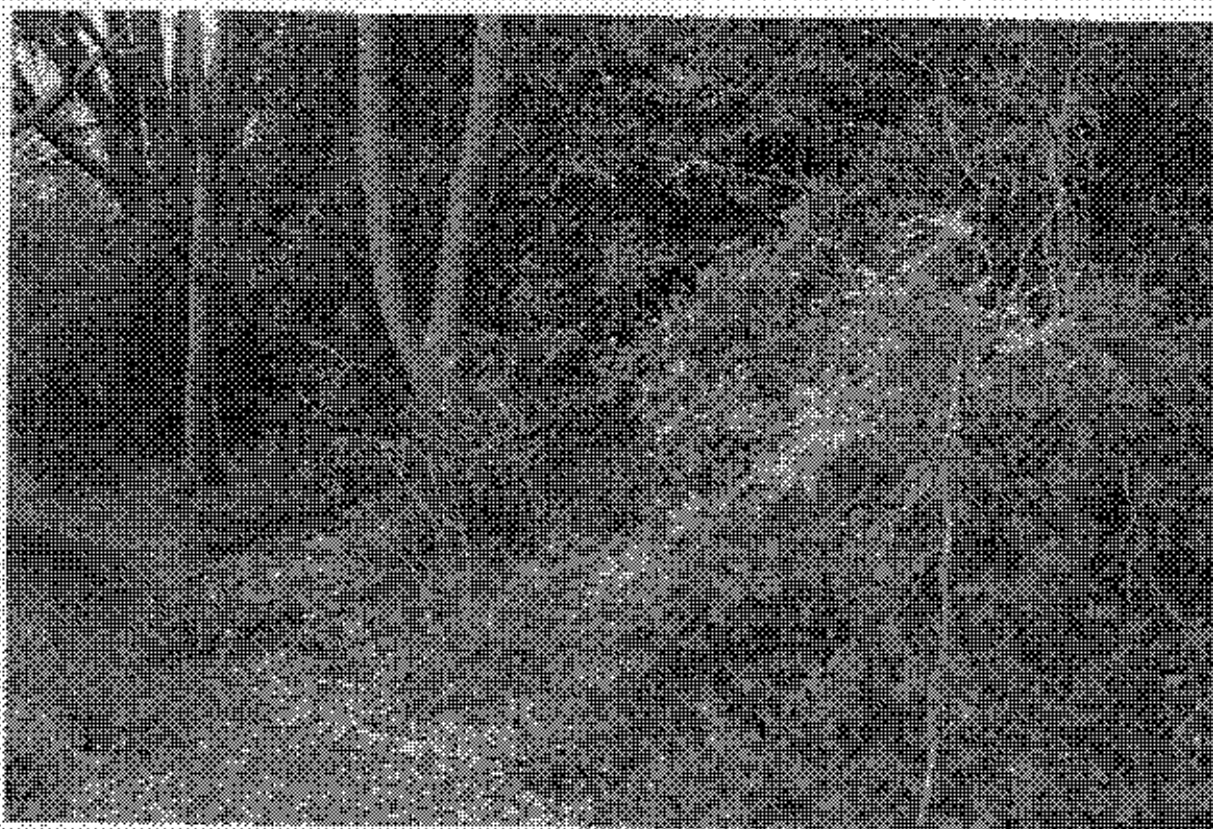
The understorey layer in both belts still has a good network of evergreen plants, particularly Holly with some Yew, Common Laurel and Rhododendron (see photo 3): these provide good screening from the athletics track and private houses in Michelham Gardens. The north end of the east belt is a little sparse; 4 Leyland Cypress (T87) have been planted to give short-term screening, but those are inappropriate as a long-term component of the species mix. Ongoing management to preserve and replace the existing Holly and Yew in the understorey – and to plant new clumps where necessary – is essential.

Photo 3 – Holly / Yew / Rhododendron Understorey

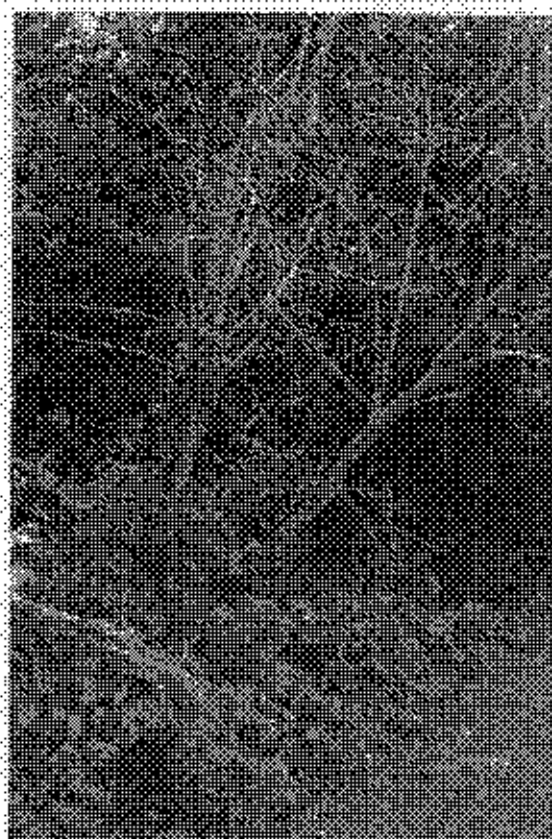
There has clearly been a lack of maintenance in these belts, and hence the condition of the remaining understorey is poor. Bramble is extensive, and there are several patches of dead or dying Elm and of Elder encroachment (see photo 4). In the eastern belt, a lot of young Sycamore has self-seeded, and there are fallen trees or parts of trees lying on the ground.

Photo 4 – Sycamore / Elm / Elder / Bramble Encroachment

Overall, ground work is urgently required to remove unwanted species (Bramble, Elm, Sycamore, Elder) and to replant historically-appropriate trees and shrub species. This restoration work needs to address the issues of providing the next generation of overstorey trees, as well as diversifying and enriching the understorey and midstorey layers. Remedial tree surgery will also benefit the existing young and mature trees which are desirable to retain.

Sycamore, Elder, Elm and Bramble will have to be removed and appropriate understorey and overstorey tree and shrub species replanted if the historic integrity and landscape quality of the Serpentine Walk is to be preserved.
