The Firs, Church Grove, Hampton Wick, Kingston-Upon-Thames

Ecological Briefing Note

June 2017

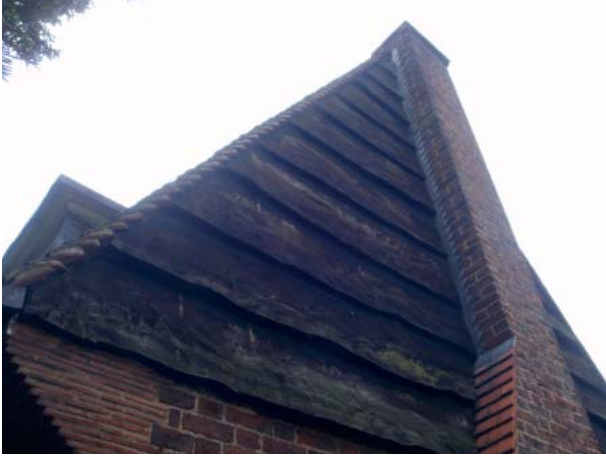
- 3.10 Timber weatherboarding is located on the northern and southern gable ends of the building. The boards are loosely fitted with gaps between them, creating potential crevices which may be utilised by roosting bats.

Upon close inspection some of the gaps contained cobwebs with some were clear at the time of survey.

Plate 1. Weatherboarding with gaps on south-east gable end.

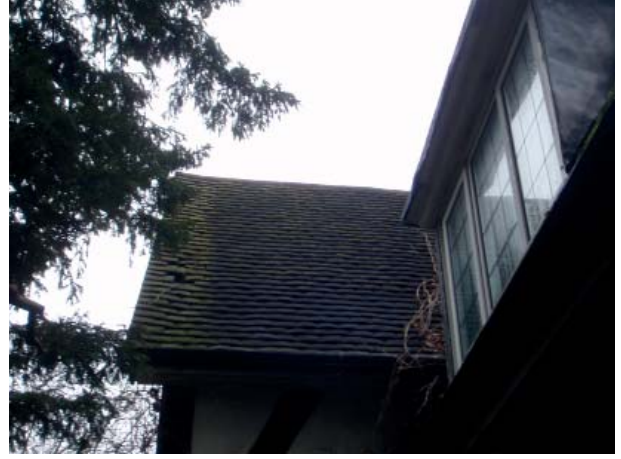
- 3.7 The multi-pitched roof is covered by flat clay tiles. The roof tiles appear to be tightly fitted with some moss covering. However, a number of tiles are slipped or missing, presenting potential access points for bats into the internal roof space. Lead flashing appears intact across the roof structure.

Plate 2. Section of roof with slipped/missing clay tiles.

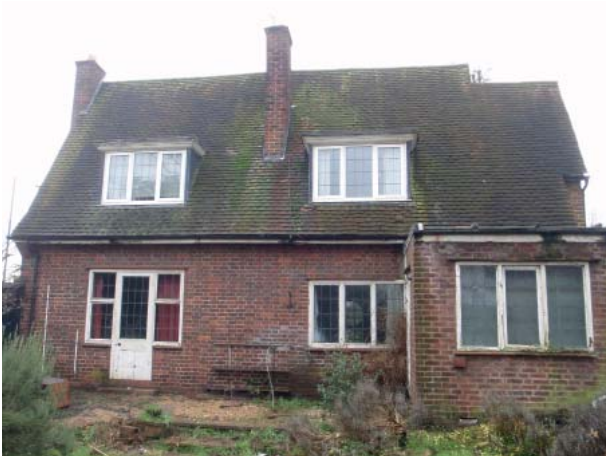
Plate 3. Rear of unoccupied residential property.

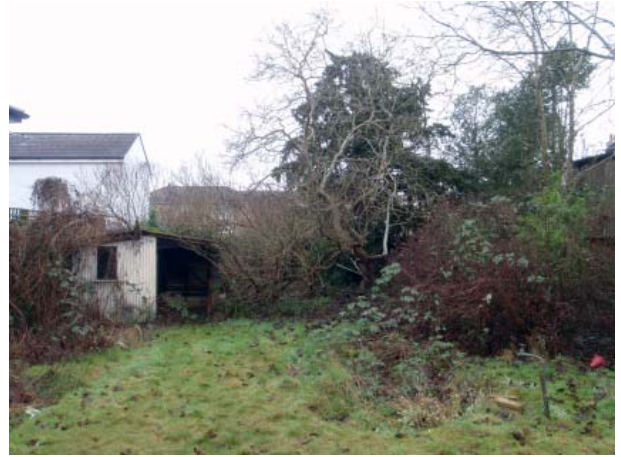
Plate 4. Rear garden with shed and dry pond.

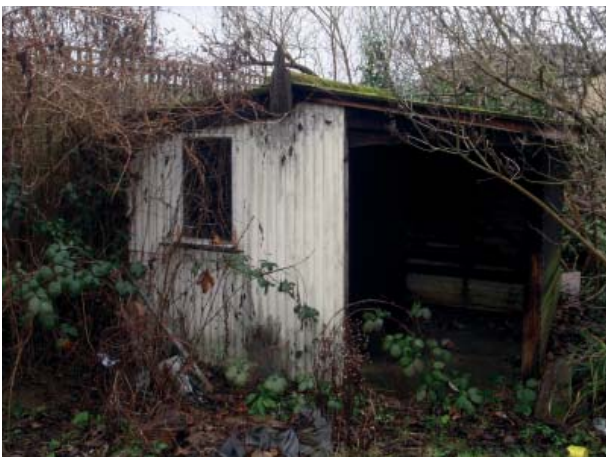
- 3.15 A small open sided garden shed is located in the north-east of the rear garden. The shed is constructed of timber and corrugated cement bonded sheet with a concrete floor.

Plate 5. Timber and corrugated asbestos sheet shed with concrete floor.
