ARBORICULTURAL DEVELOPMENT STATEMENT

Site:
Marble Hill House and Park

Client:	English Heritage
Site:	Marble Hill House and Park
Arboricultural Consultant:	Stefan Rose <i>BSc (Hons), TechCert (Arbor.A), TechArborA</i>
Date:	September 2018

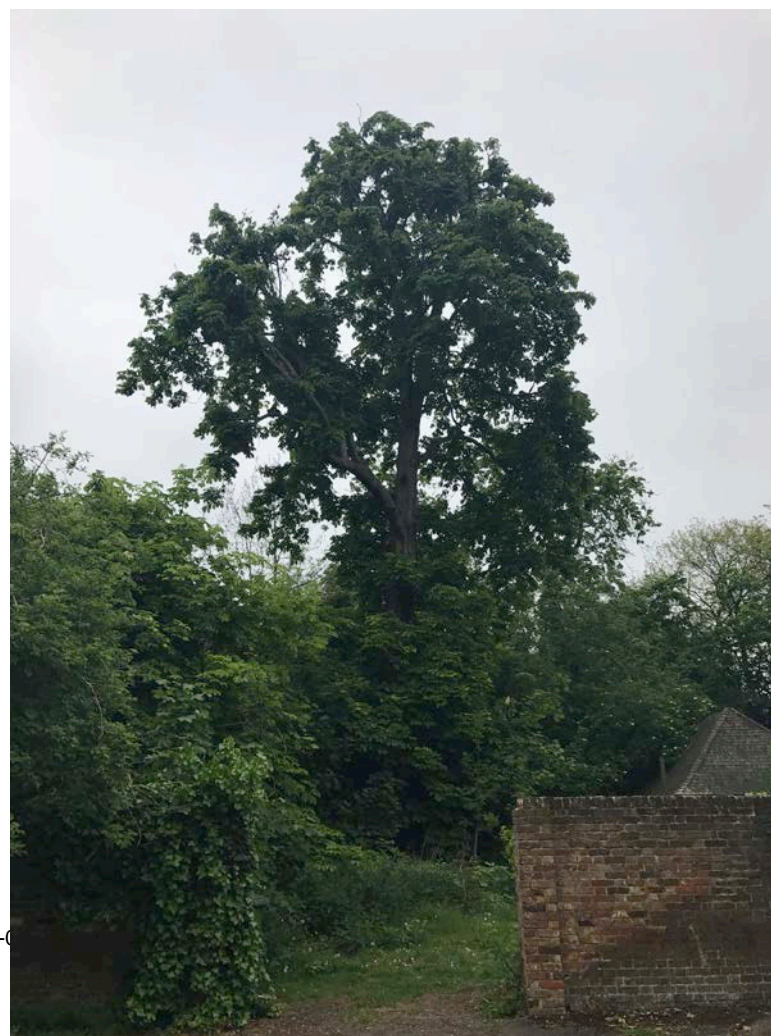
Photograph 1: Showing T12 from the existing stable car park

7.2 Originally the Horse Chestnut was surveyed in the winter; a further visit to site gave the opportunity of taking the above photograph that shows the tree to be in a state of apparent stress and not having the appearance typically associated with this species; that is of a full crown and unable to see through for the density of leaves.

7.3 There are signs of dieback in the crown and reduced vitality, all indicating that the tree has a limited life expectancy and would not cope with further stress of damage and loss of roots or changes to its immediate rooting environment. By losing this tree and providing more development space for the service yard to the northern side of the stable block it has allowed for café and court yard to be positioned for the better retention of the healthier trees to the southern side – Trees 53, 54, 55,56, 57 and 59.
