2.8 SOIL RESOURCE SURVEY

2.9 SPORTS PITCH AGRONOMY SURVEY

The following is a summary of the Sports Pitch Agronomy Survey Report, December 2016, by TOHA.

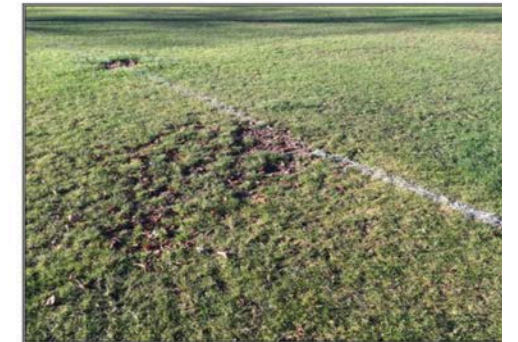
- The overall quality of the turf is moderately high in relation to use for the sports catered for
- Evidence of wear was observed in play 'hotspots', such as football goal mouths and centre circles.
- Significant surface undulations were recorded within these hotspots and as such, localised infilling and regrading may be necessary here
- The existing maintenance schedule is fairly comprehensive and includes important operations such as aeration, overseeding, localised topdressing and a fertiliser regime.
- A more intensive maintenance programme may be considered to further improve the resilience of the sward and complement any new drainage infrastructure
- The overall condition and quality of the existing sports pitches was good, with satisfactory overall ground cover, soil depths, root development and grass species.

Plate 13: Slight wear in goal mouth – Pitch 4

- Selective regrading of football pitches to include stone reduction.
- Drainage to south west pitches and ongoing maintenance of connections to primary drainage.
- Overseed with shade tolerant seed mixes.
- Manage tree canopy to avoid shade issues.
- Fertilize soils.
- Intensify maintenance regime to supplement existing good practice.

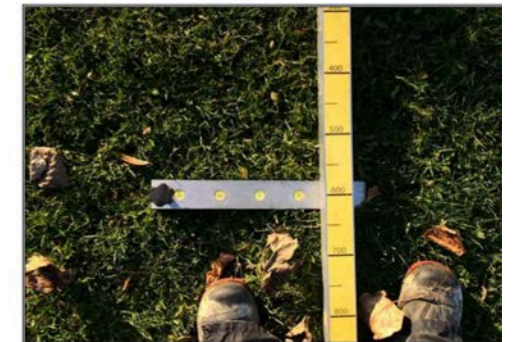
Plate 15: Minor undulation <5 mm

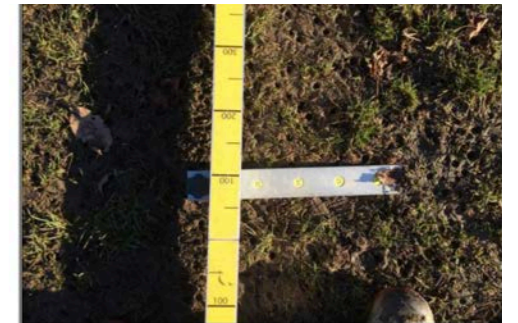
Plate 14: Undulation > 25mm depth – centre circle

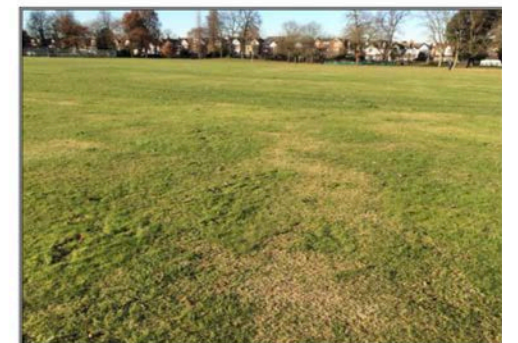
- The chemical composition of the soils is generally acceptable for sports pitch grass cultivars, provided the nutrient levels are supplemented by an appropriate annual fertiliser regime
- The soil pH in the cricket outfield area was found to be strongly acid (pH 5.0) and as such, application of agricultural grade lime could be beneficial. Perennial ryegrass typically prefers a slightly acid to slightly alkaline pH range (pH 5.5 – 7.5).

Plate 16: Patchy grass colour – cricket outfield
