Royal Richmond BS5837 Arboricultural Impact Assessment

1. Executive Summary

- 1.1 Tamla Trees Ltd has been appointed by Spacehub to provide advice on the arboricultural issues relating to the proposed development which can be summarised as *'demolition of the existing buildings and construction of new residential development'*. We surveyed the site in September 2018. The survey accorded with BS5837:2012 "Trees in relation to design, demolition and construction – Recommendations".

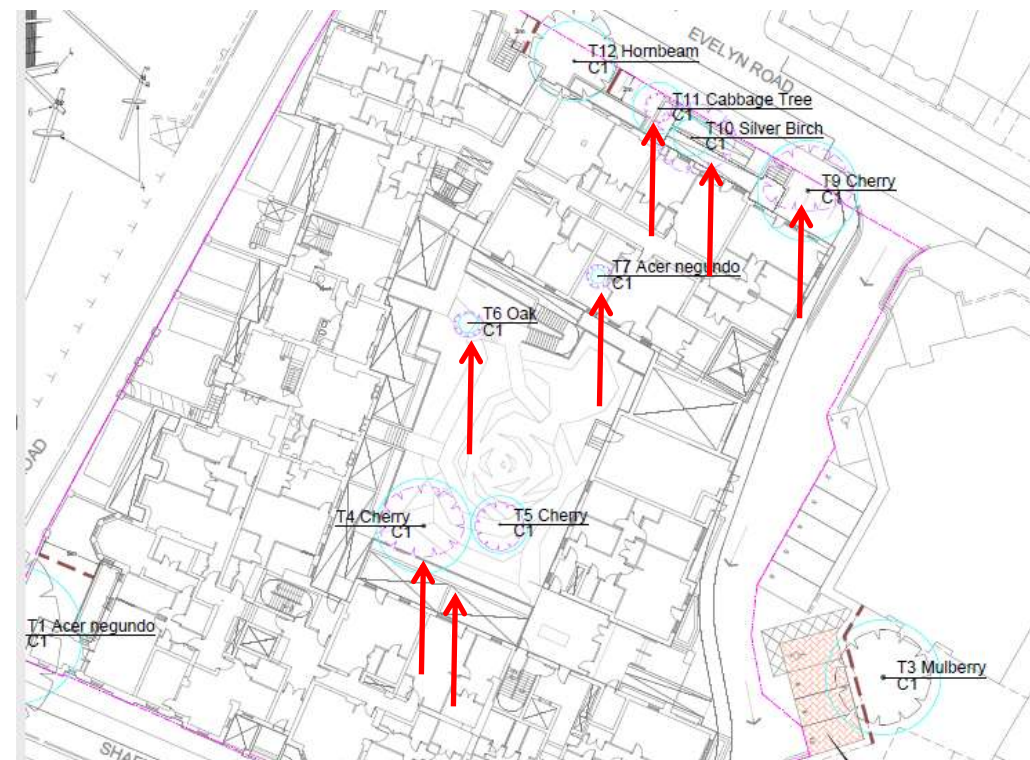
5.3.1 T4 (Cherry), T5 (Cherry) T6 (Oak), T7 (Acer) will all be removed from the internal courtyard of the site. These are small trees of minimal amenity although T4 is noted as a ‘memorial tree’ and we recommend that the family are advised prior to its removal. Any new planting could carry a replacement dedication. T9 (Cherry), T10 (Silver Birch) and T11 (Cabbage) tree will also be removed. These trees are visible to Evelyn Road but are all low quality Cat C trees based on their size and form and vigour.

Fig 1 – TPP extract indicating the relative locations of those trees to be removed. T4 is the memorial tree.

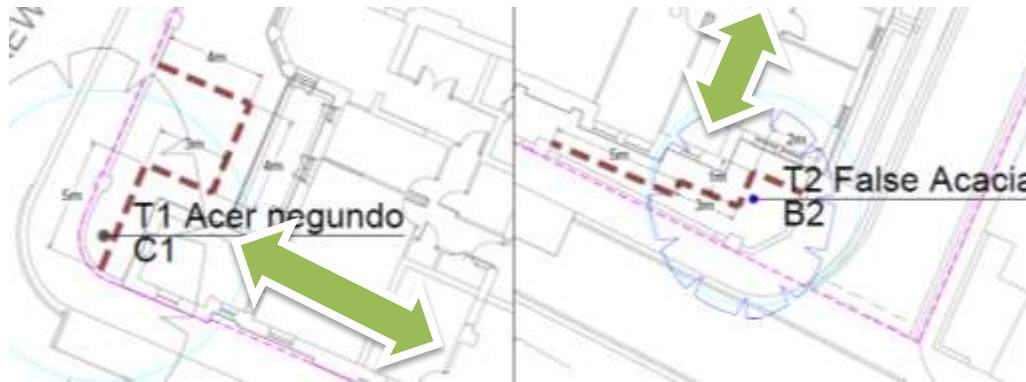
Fig 2 – Demolition of existing building. Space limits the exact position of tree protection measures.

HIGH

- *Building removed*
- *All movements from building direction as indicate in examples left.*
- *Top down and pull back manner*
- *Tree protection will be installed prior to any on site demolition works.*
- *Existing footing within RPA of T1 & T2 to be retained.*

- All tree protection installed.
- Tool Box Talk with operatives involved in demolition of building.

- Working in a pullback only manner and from existing access areas building demolished.
- Foundation section through RPA of T1 & T2 marked and retained for root assessment.
- Remaining foundations of existing building broken out in pull back manner.

- Root assessment (using airspade or similar) for T1 & T2 roots and existing footing.
- Protective fencing and ground protection remains in place for duration of all construction works.

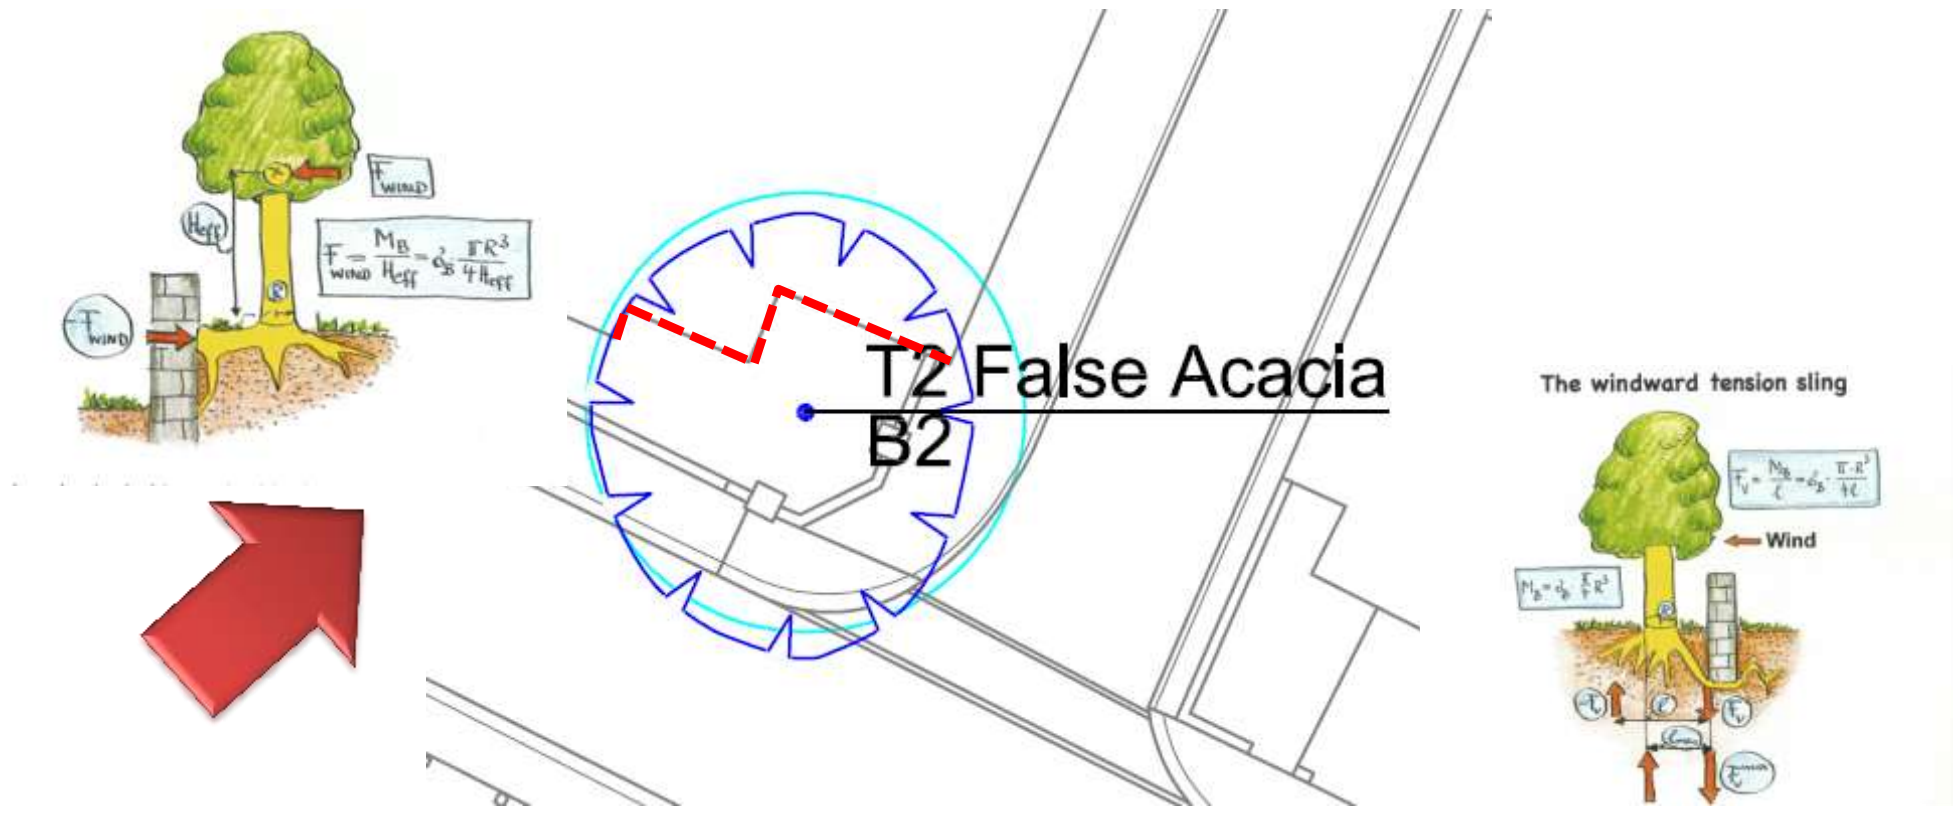
5.4.3 Initially footing of existing building retained. This is to reflect the real risk of roots being in tension against the face of the footing given the close proximity and minimal rooting area T1 & T2 have currently. The prevailing wind direction may have limited such root development but careful excavation is needed in these areas with a detailed on site assessment to ensure that both T1 and T2 do not become unstable from the works.

Fig 3 – To reflect the fact roots from T1 & T2 may be tensioned against the existing footing it should initially be retained at demolition stage for an on-site assessment as shown in the example for T2 (but repeated for T1). Arrow indicates prevailing wind direction.

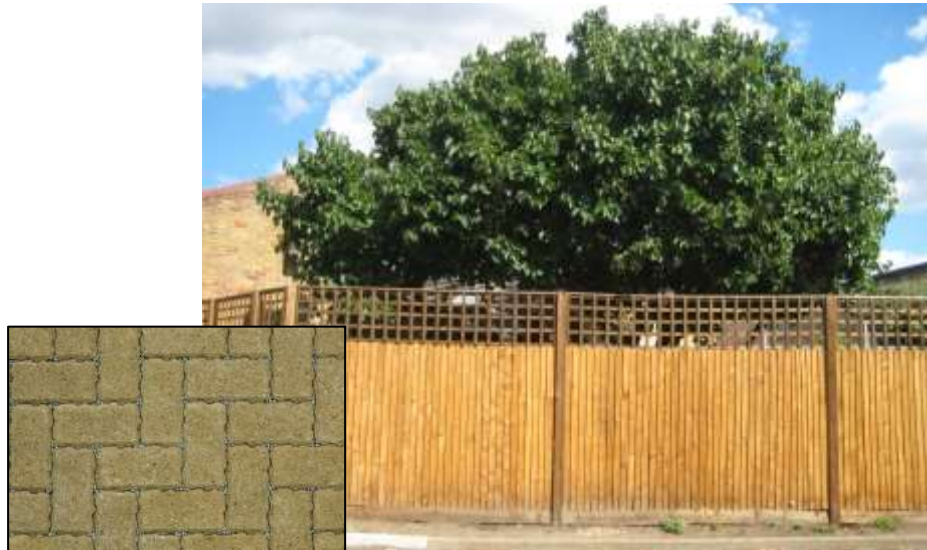
LOW/ MODERATE

- *In the event of resurfacing close to T3 (Mulberry) shown left the new surface will be permeable (such as marshalls top pave – inset)*
- *Purpose to be briefed to site operatives.*
- *To be laid on existing sub base following any surface removal being undertaken by hand.*

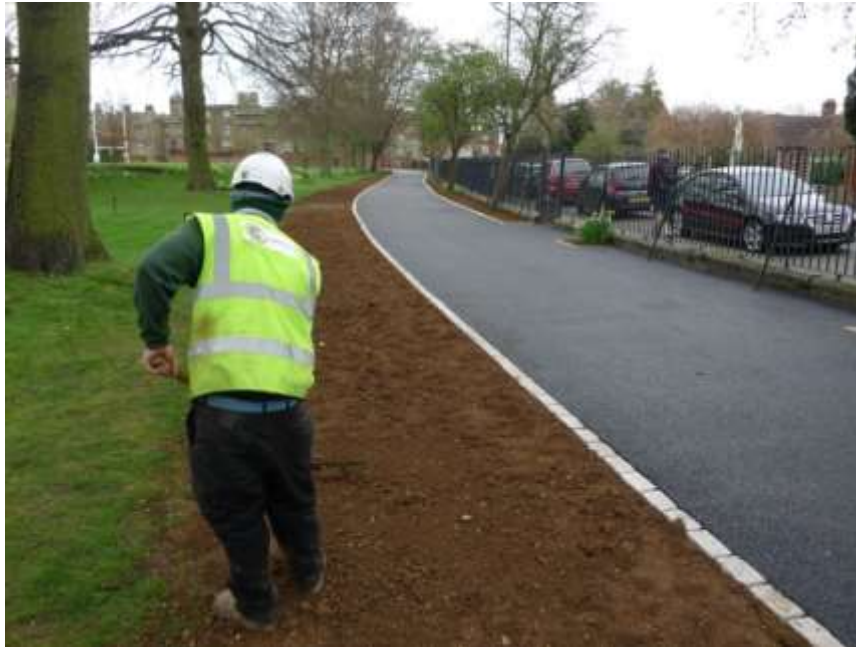
LOW

- BS3882 compliant top soil raked out by hand (left)
- Completed following removal of all site machinery and materials.
- Seeded or turfed as appropriate.
- No new soil within RPA to depths greater than 100mm.
