# FAIRHURST

Homebase Ltd, 84, Manor Road, RICHMOND, TW9 1YB

**APPENDIX C**

# Detailed Unexploded Ordnance (UXO) Threat & Risk Assessment

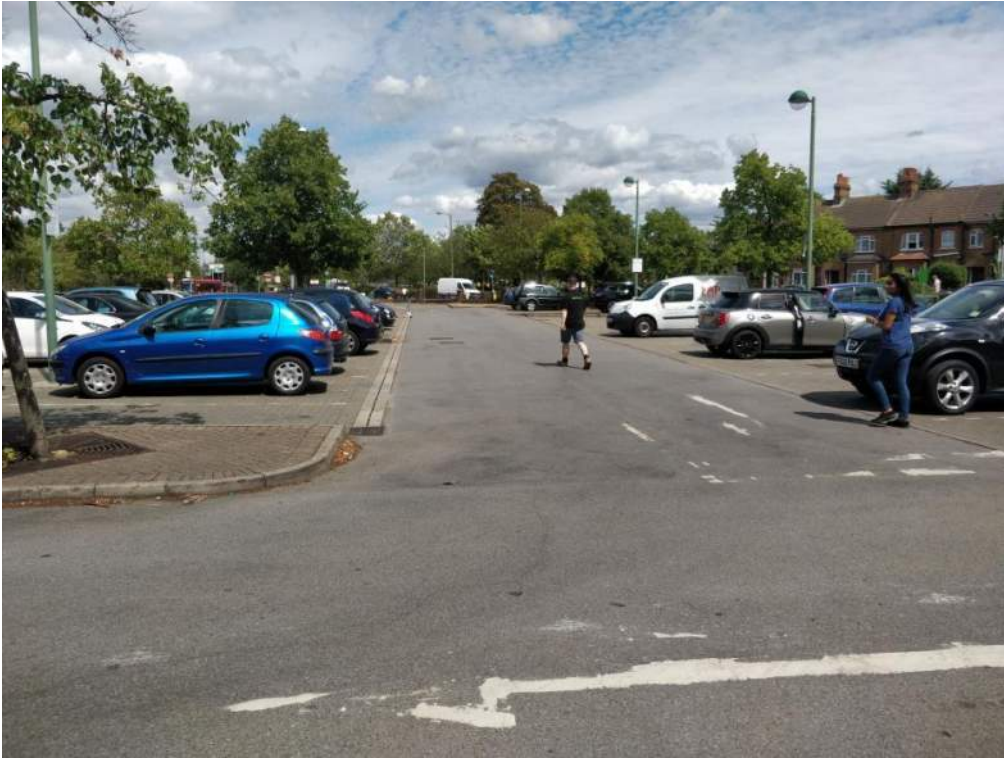
Photo 1: Car parking in the northern portion of the site

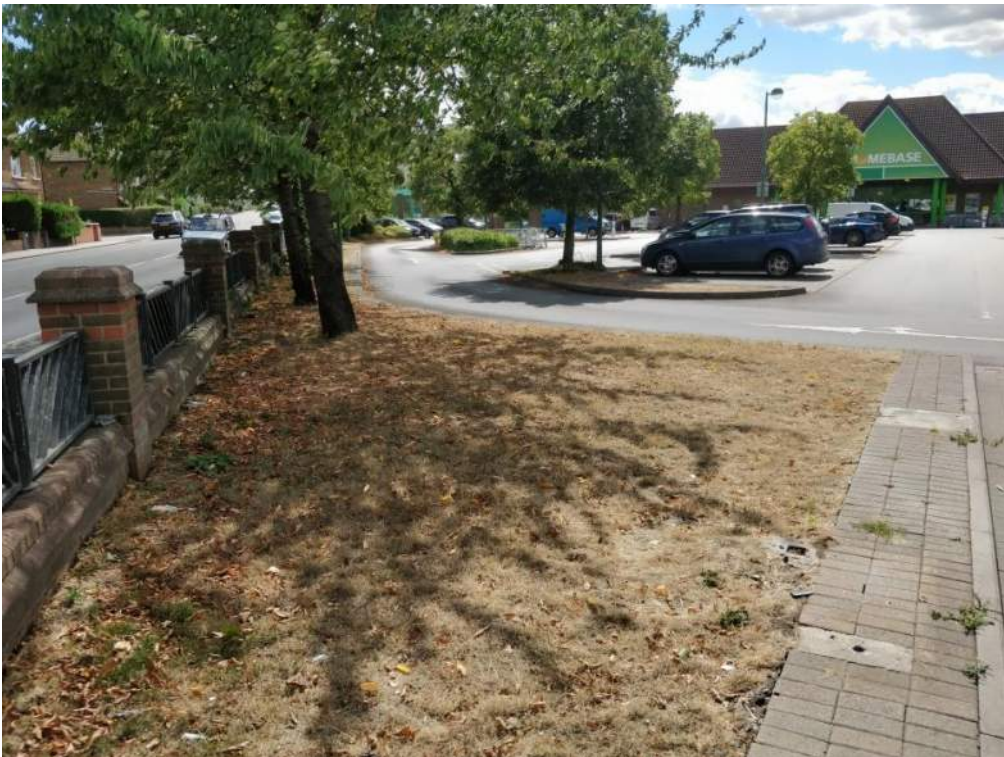
Photo 2: Soft landscaping along site's eastern boundary

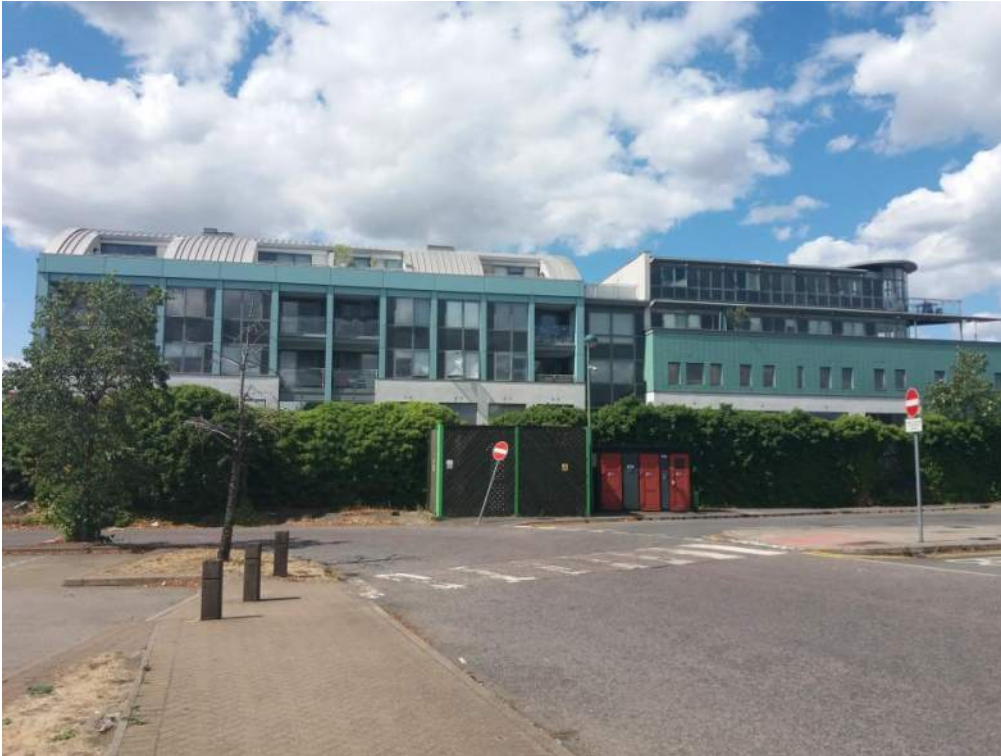
Photo 3: Looking west from site access towards electrical substation

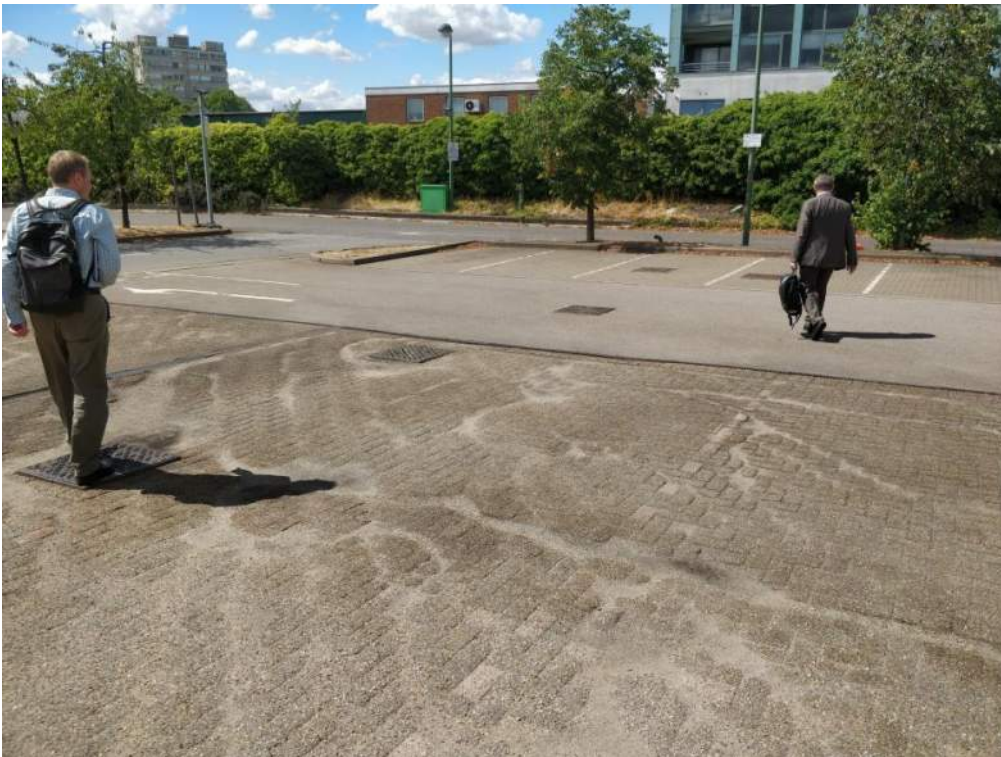
Photo 4: Area of paving and possible interceptors at assumed location of former car park

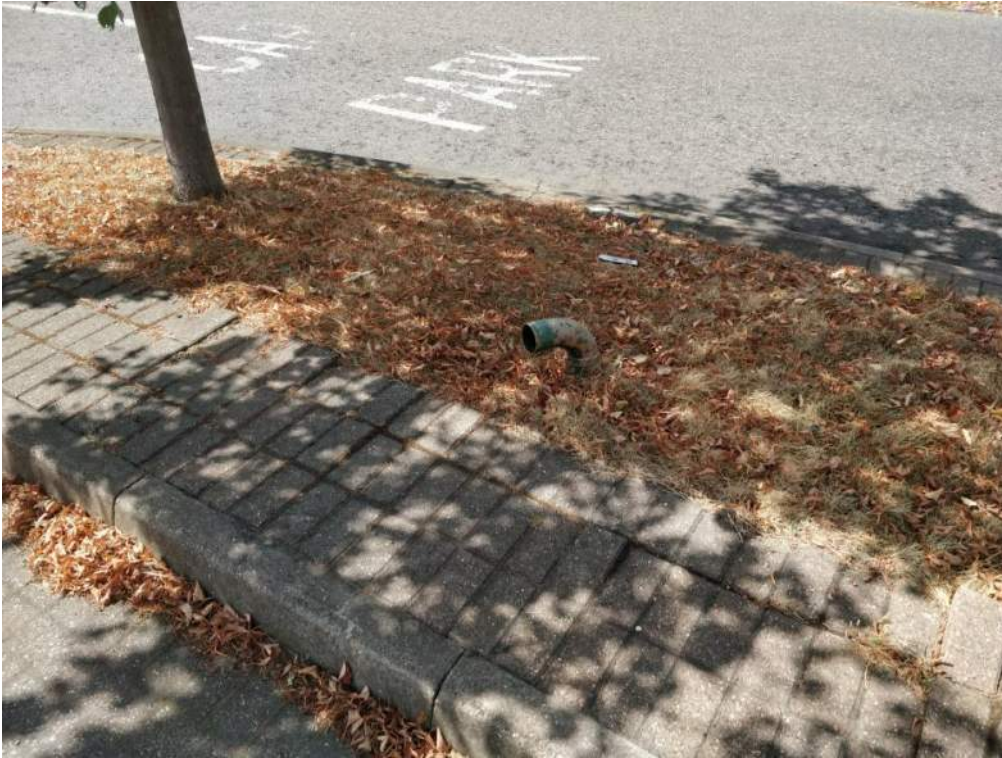
Photo 5: Vent pipe assumed to be associated with possibly identified interceptors

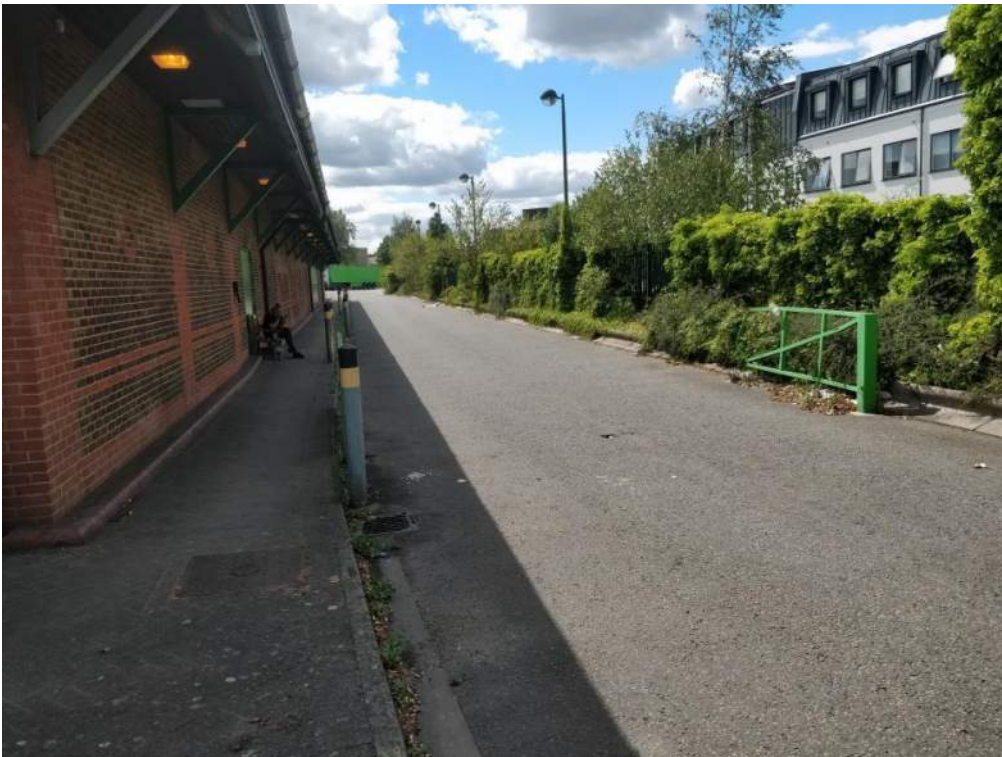
Photo 6: Access road along the western boundary of the site

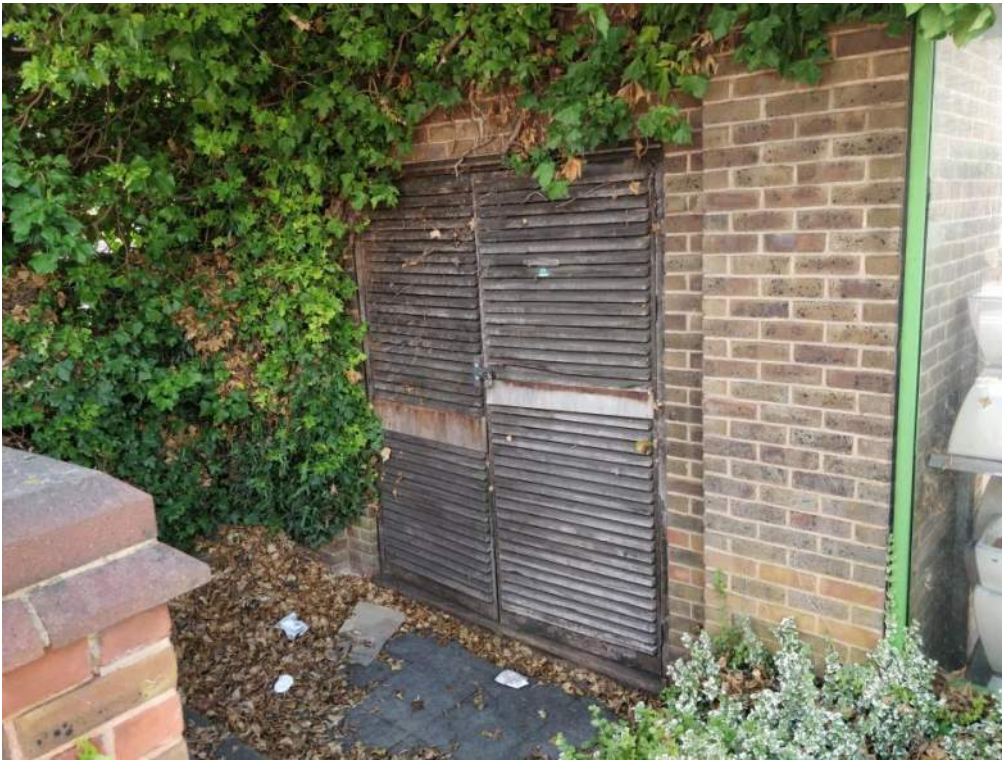
Photo 7: Brick structure assumed to be occupied by Southern Gas Network

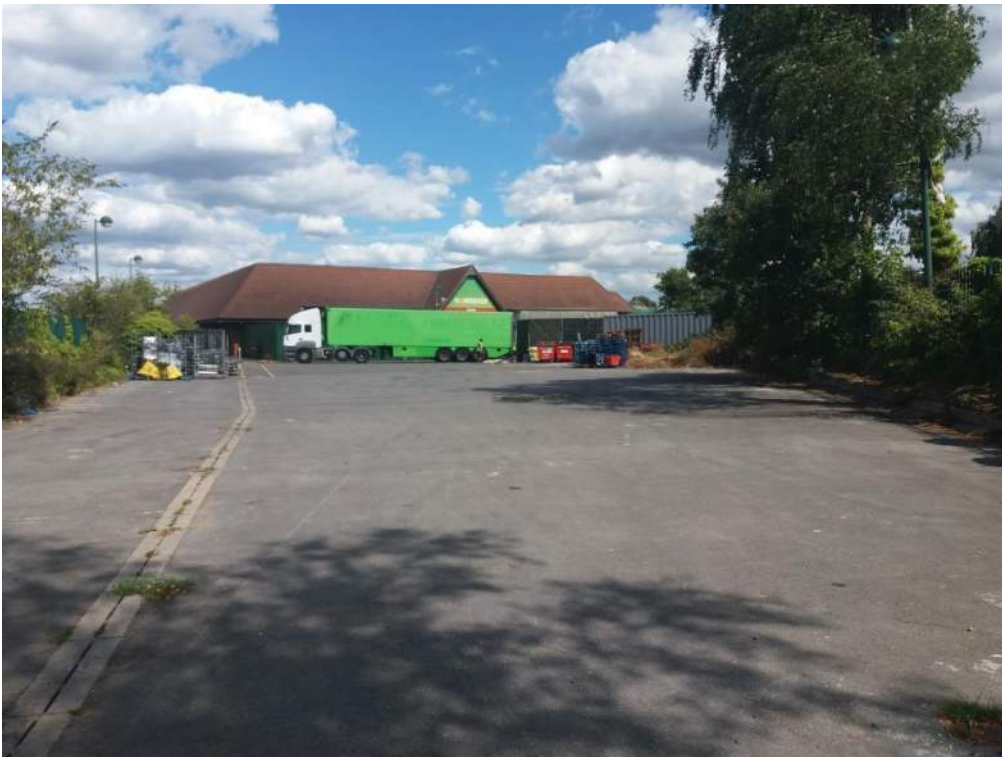
Photo 8: Delivery yard in the south-western portion of the site

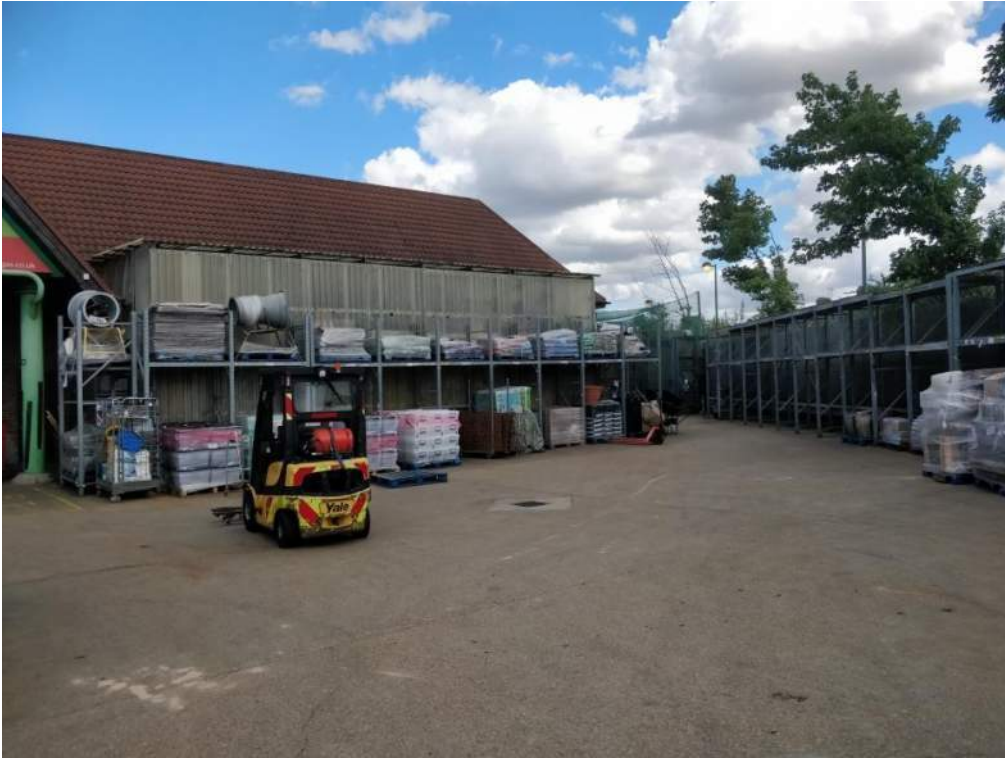
Photo 9: Homebase delivery yard

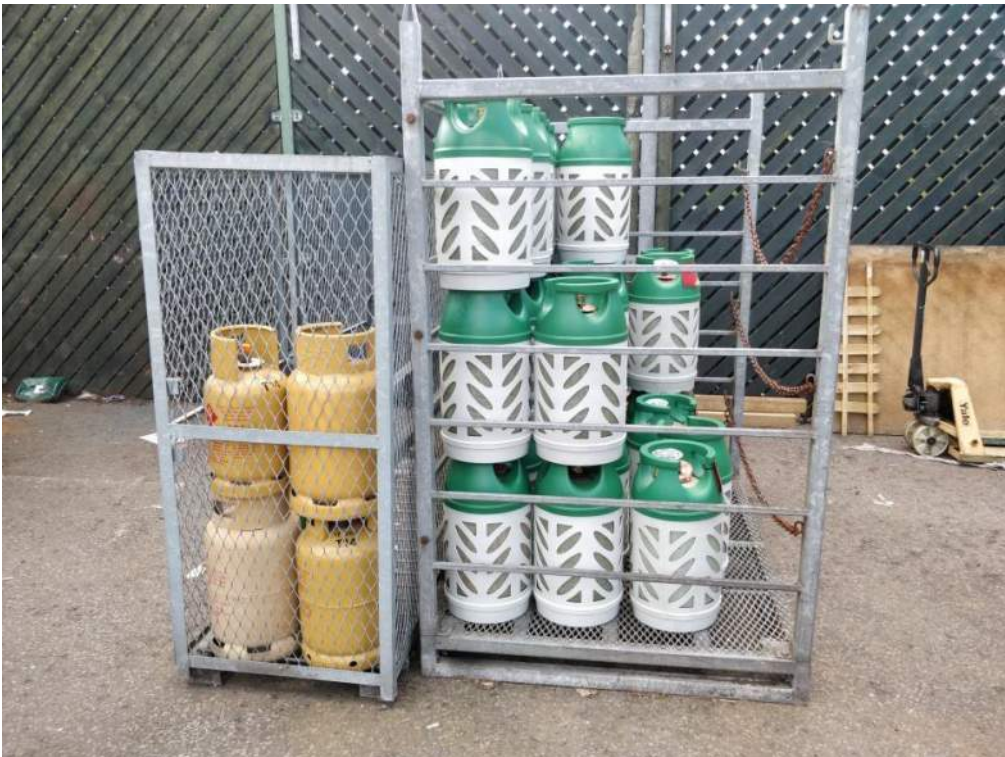
Photo 10: Gas canister storage in Homebase delivery yard

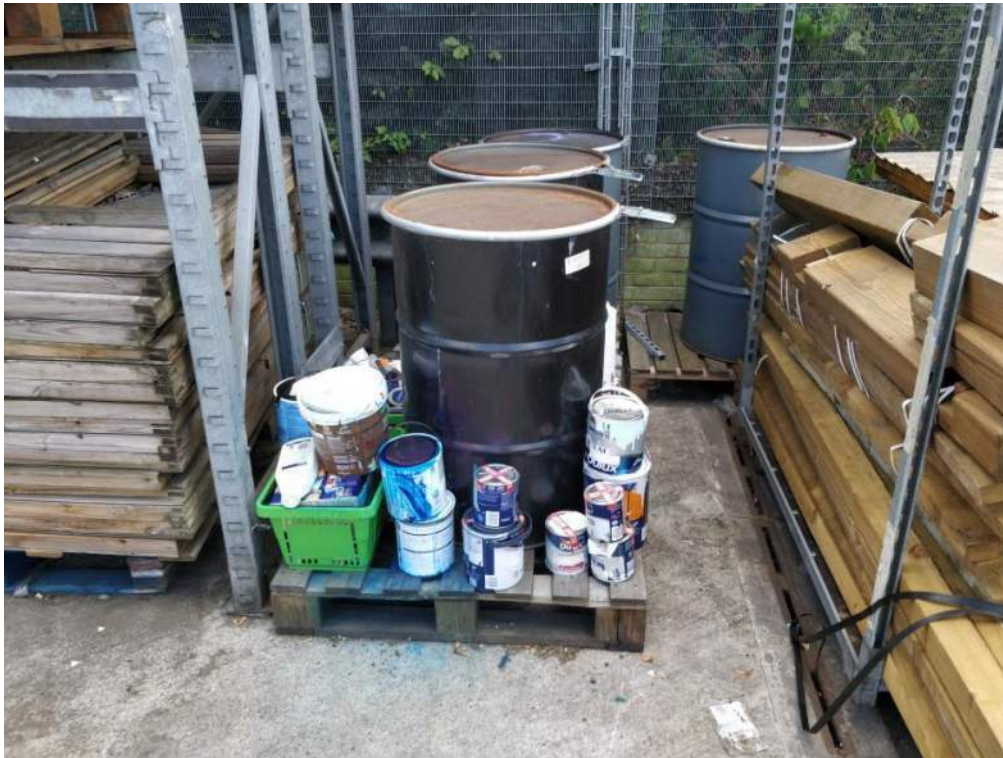
Photo 11: Waste paint storage within Homebase delivery yard

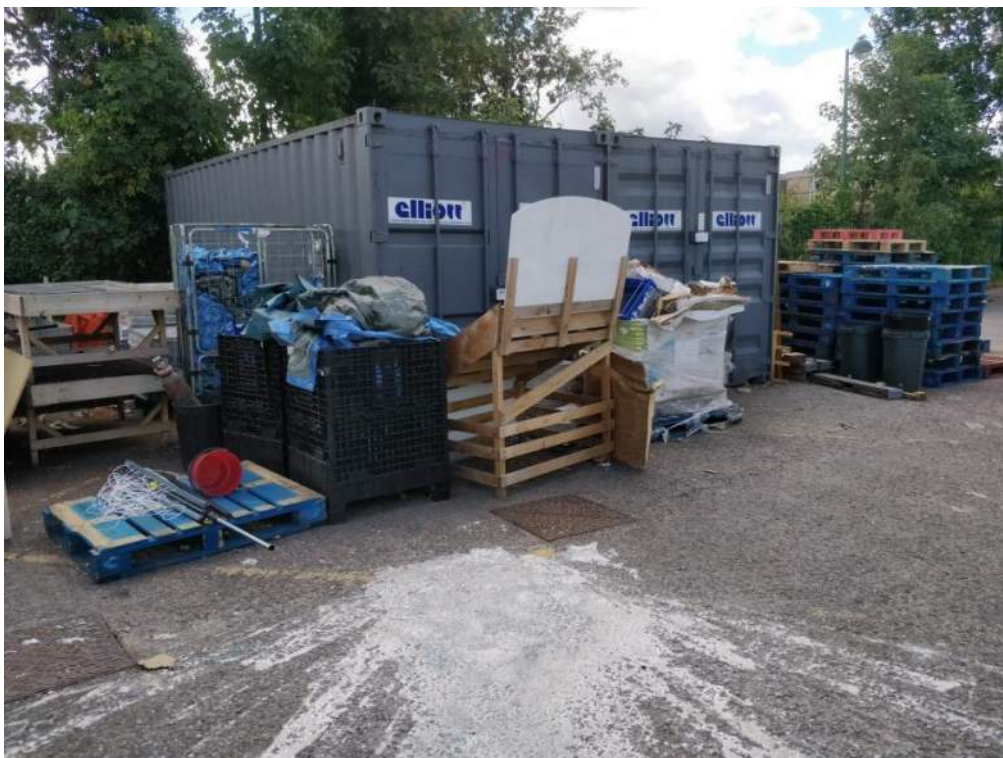
Photo 12: Homebase bin and container storage

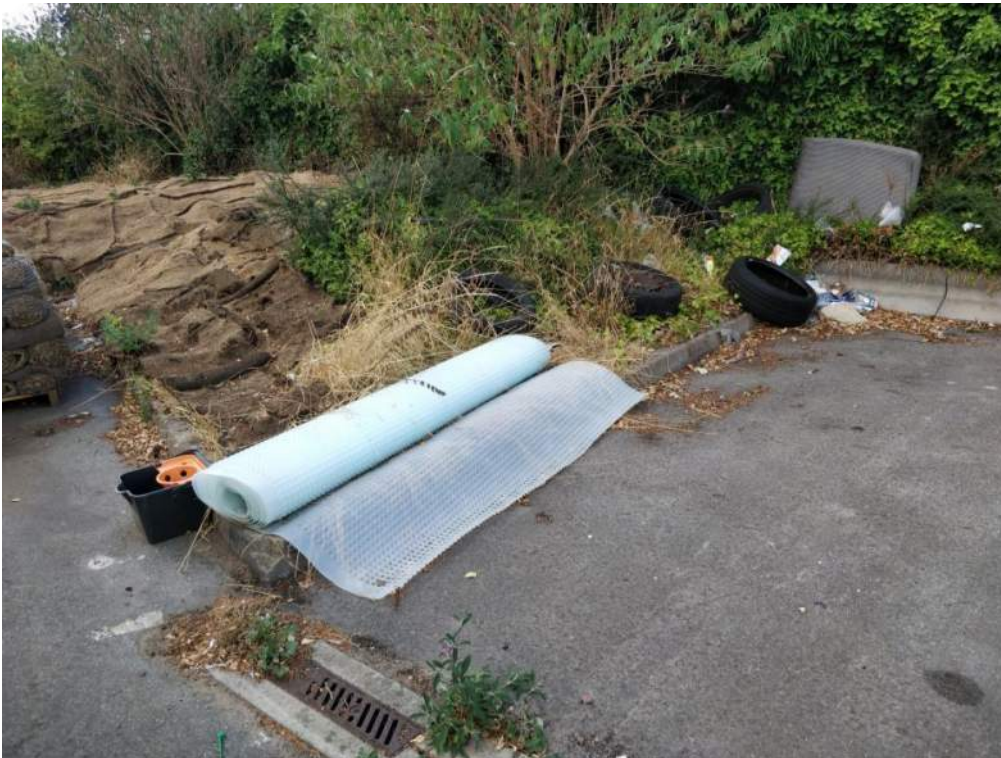
Photo 13: Fly tipping in the south-western portion of the site

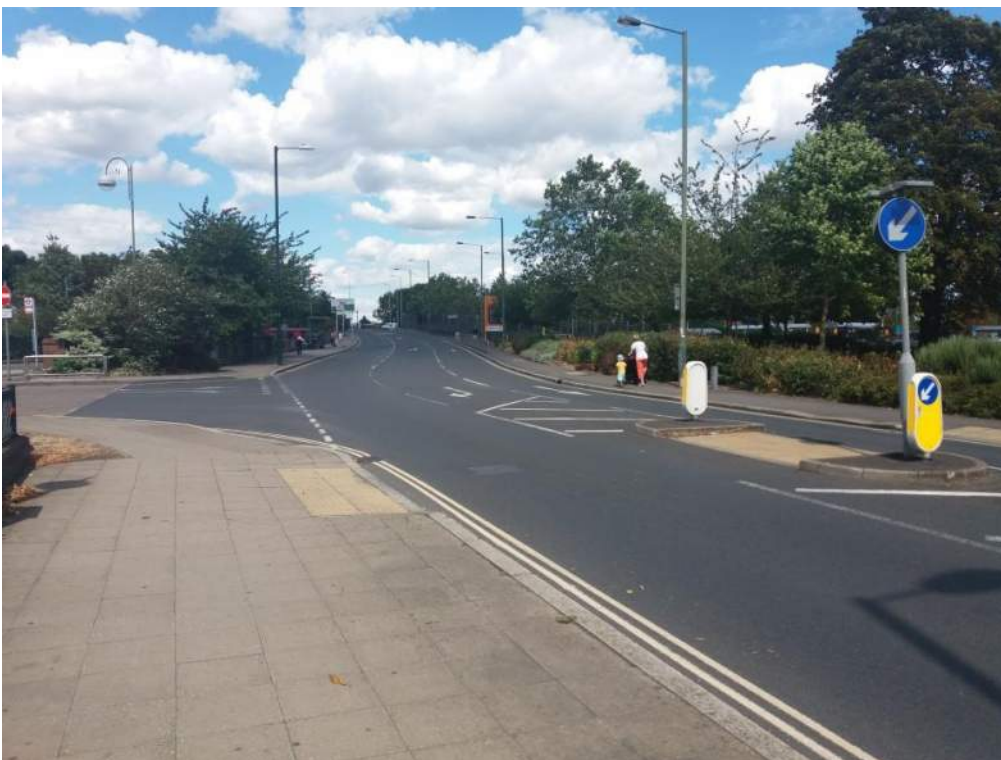
Photo 14: Manor Road ramping up towards the roundabout to the north of the site

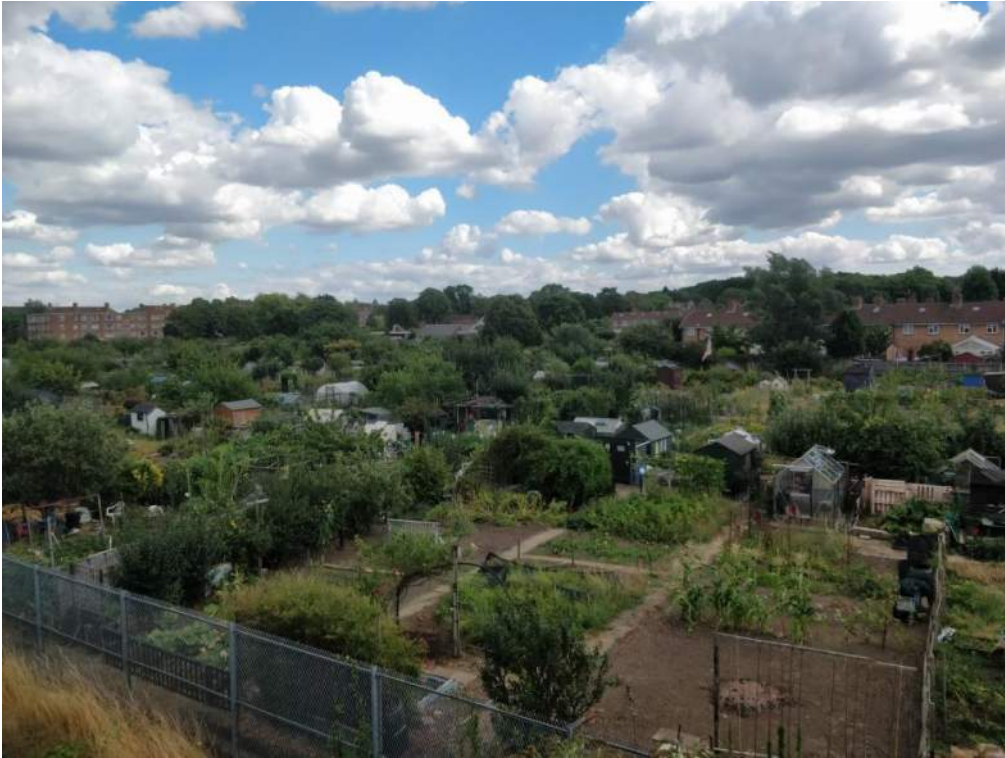
Photo 15: Allotment gardens

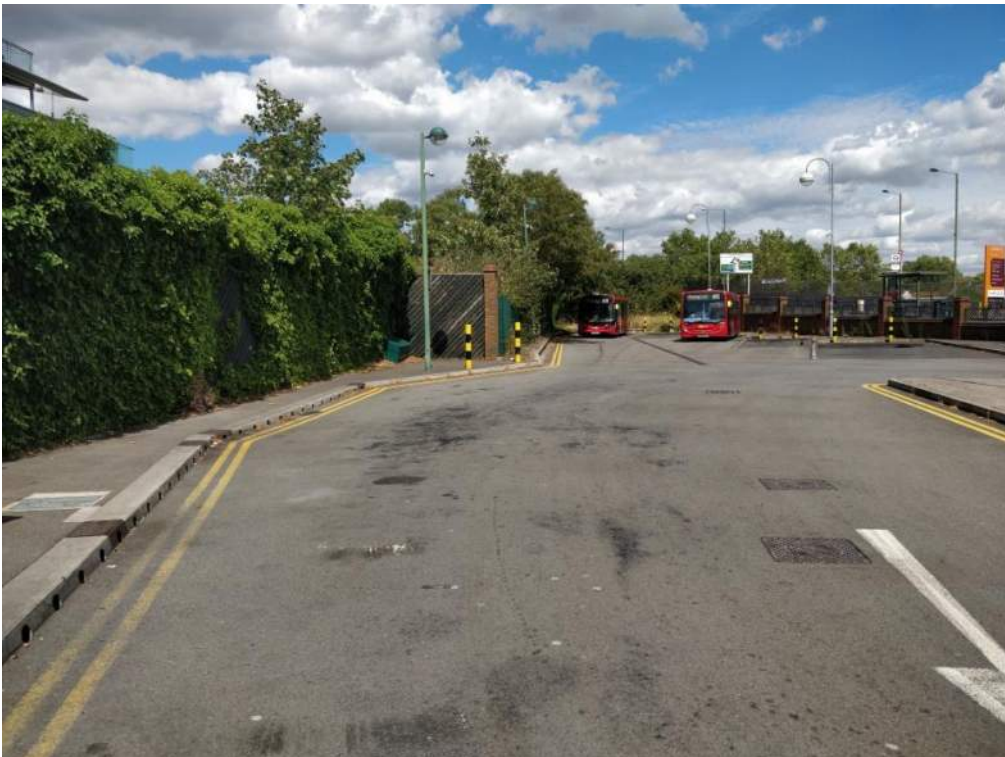
Photo 16: Bus terminal to the north of the site

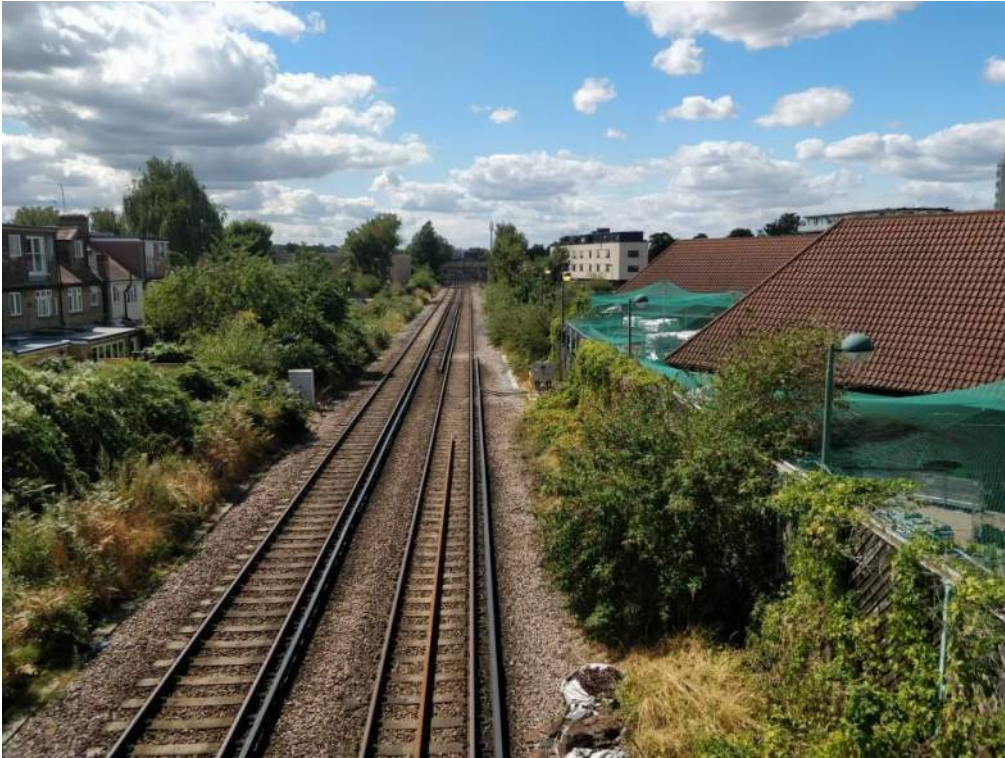
Photo 17: Railway line bounding the site to the south

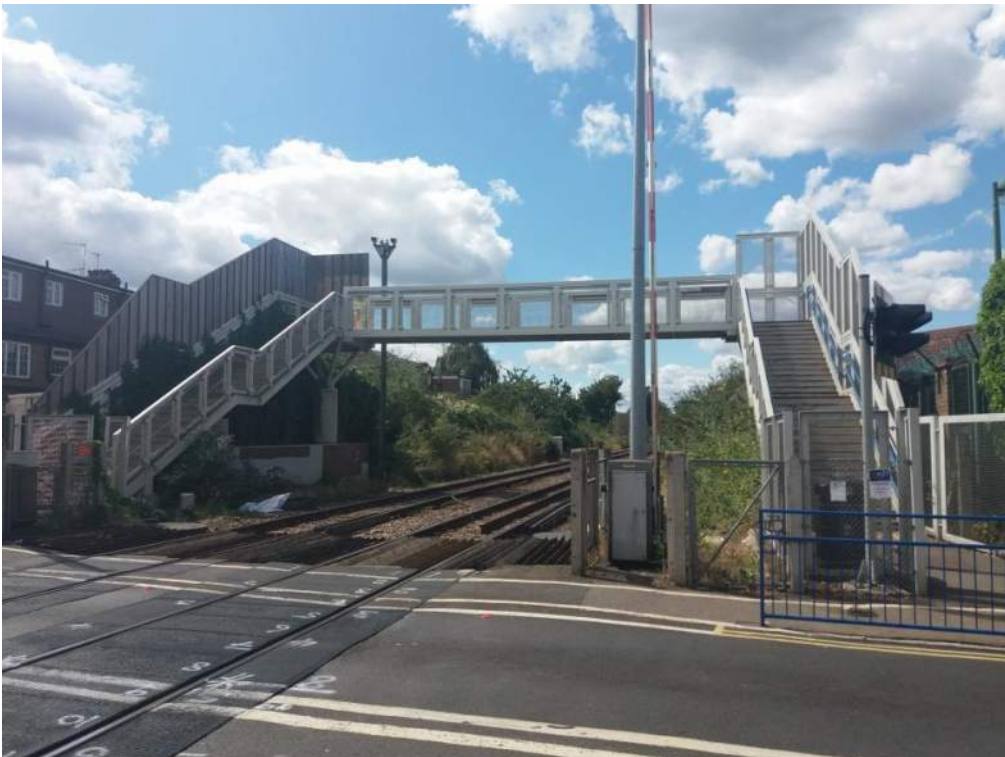
Photo 18: Footbridge adjacent to the south-east of the site

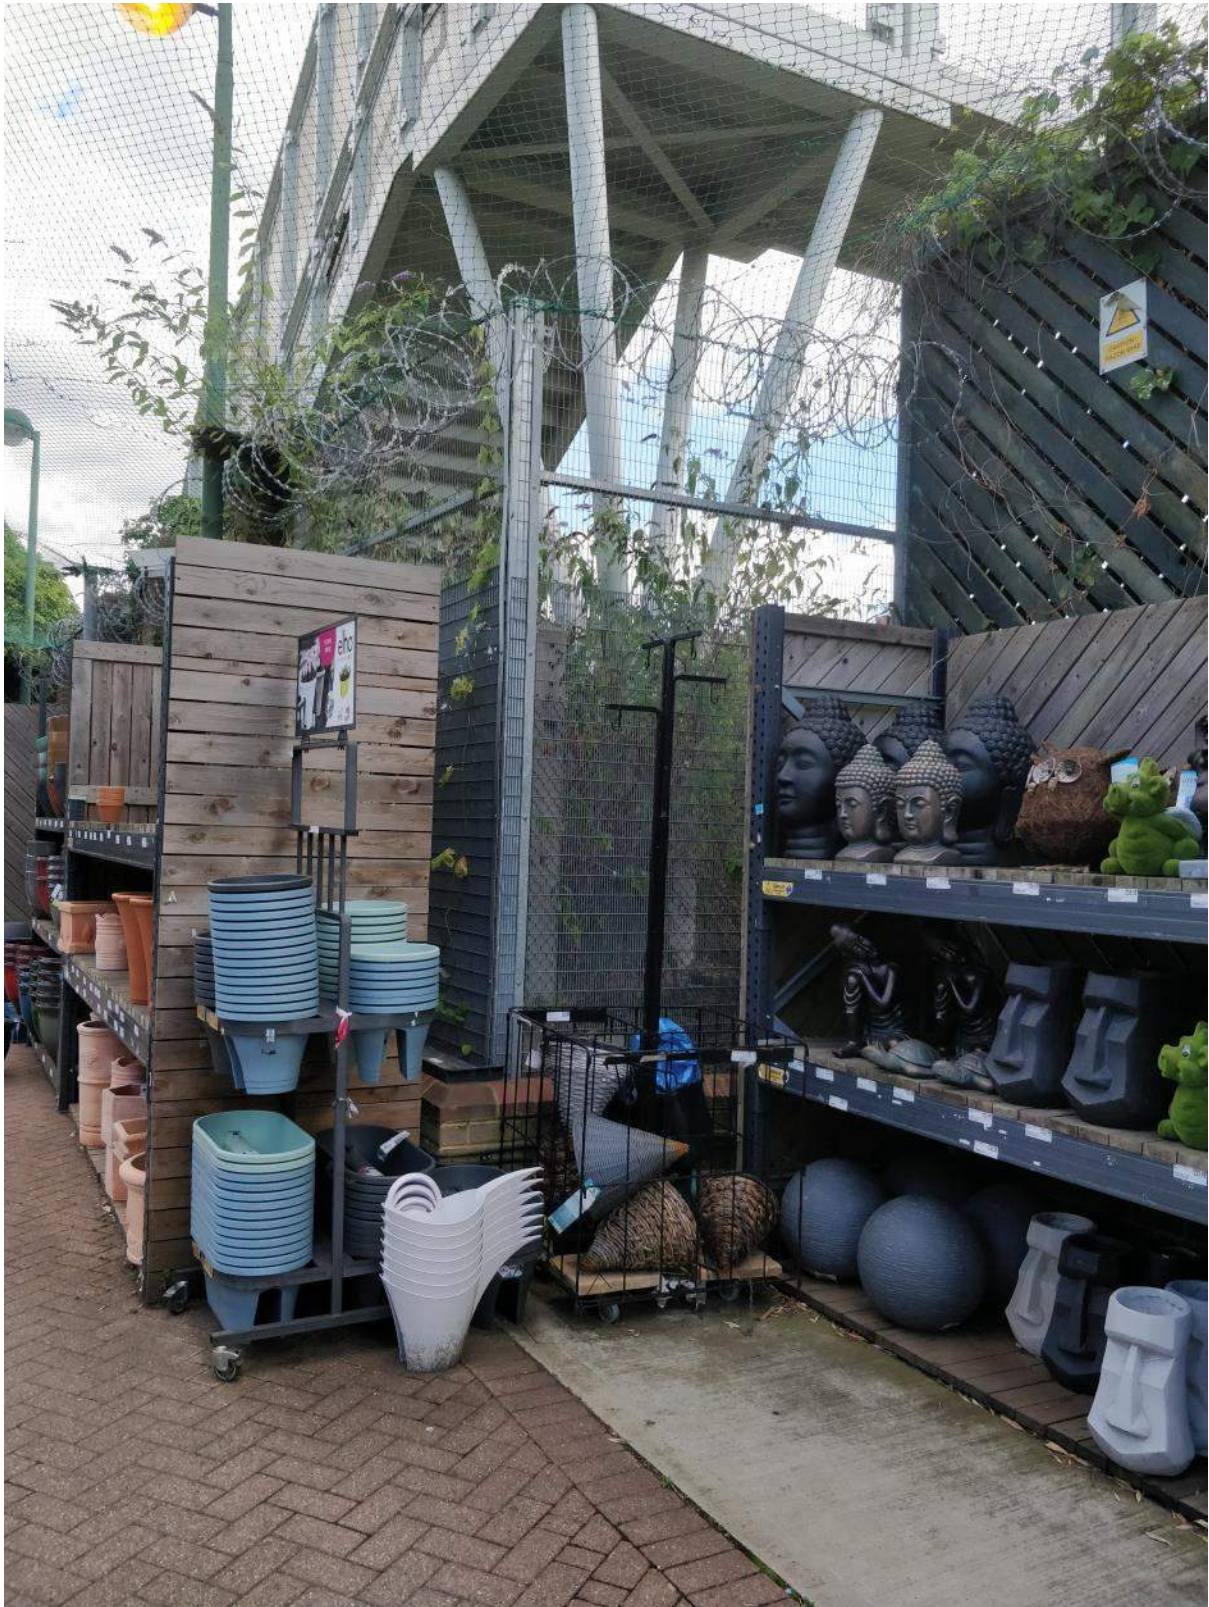
Photo 19: Railway footbridge cutting into Homebase garden centre

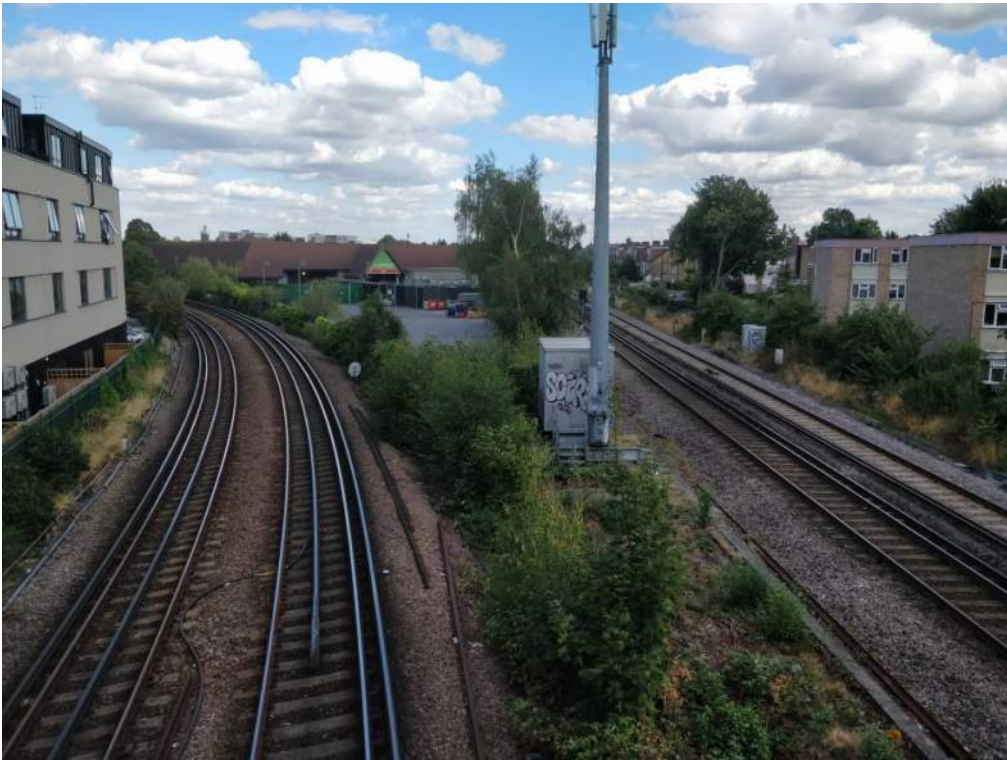
Photo 20: National Rail infrastructure
