# West Elevation - Existing Eastbank Road

## Existing Condition

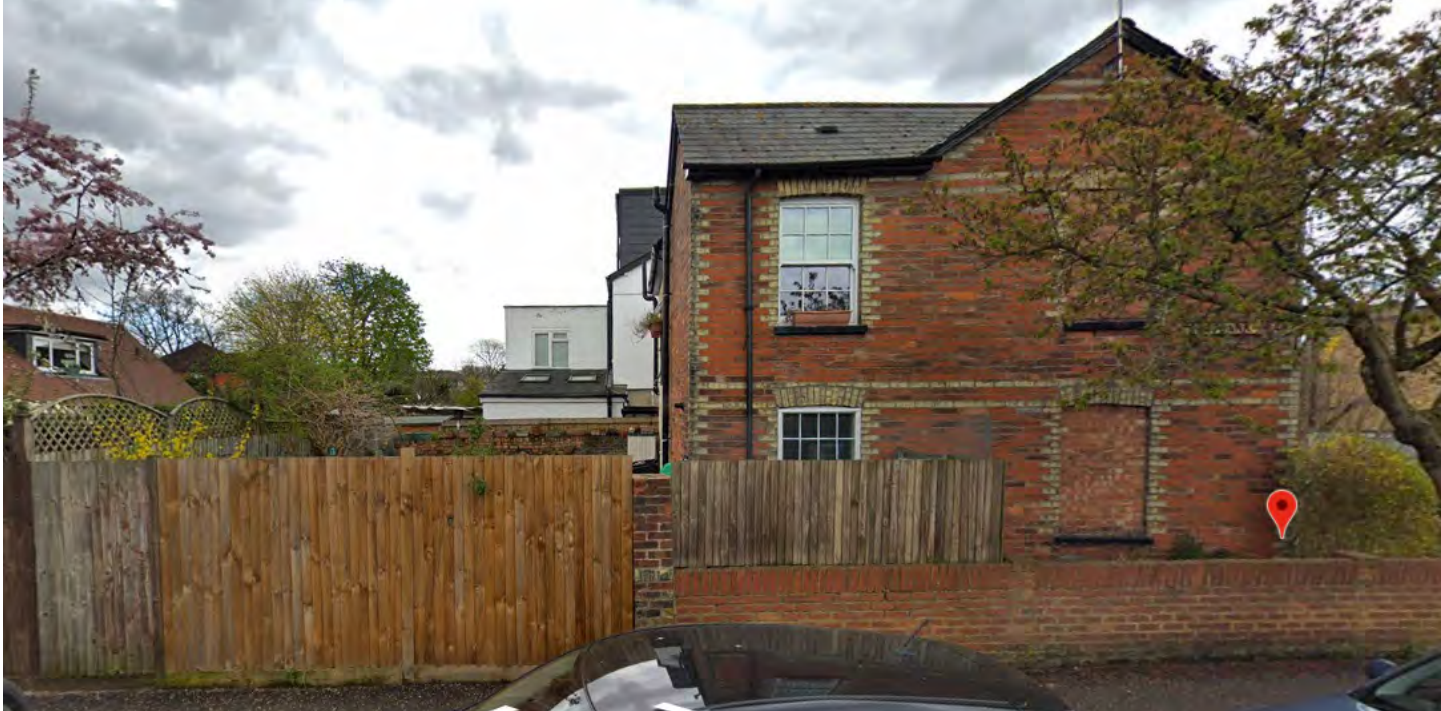
In general, the house is currently in need of restoration.

Wooden fence to be replaced by a brick wall of matching height. Original bricks to be re used as much as possible.

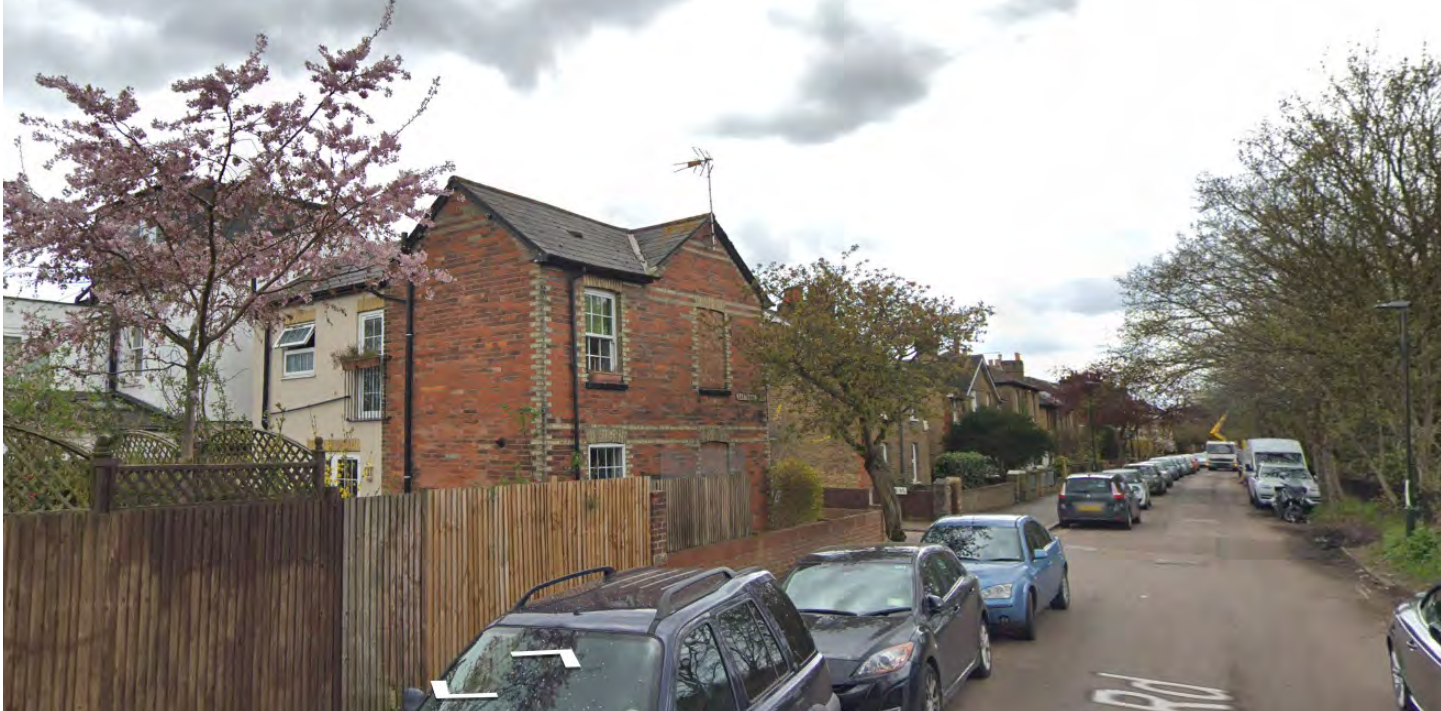
In general, the house is currently in need of restoration.

Wooden fence to be replaced by a brick wall of matching height. Roof dormer to sit back on rear elevation by at least 500mm.

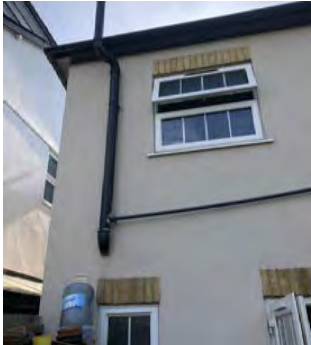
UPVC windows, downpipes and soil pipes

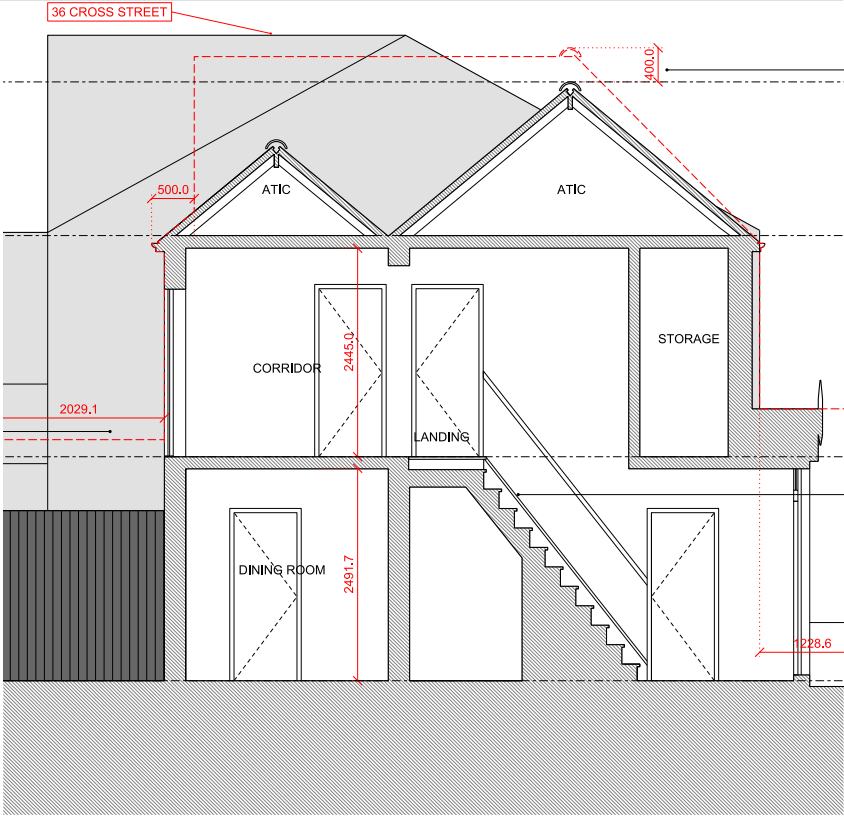
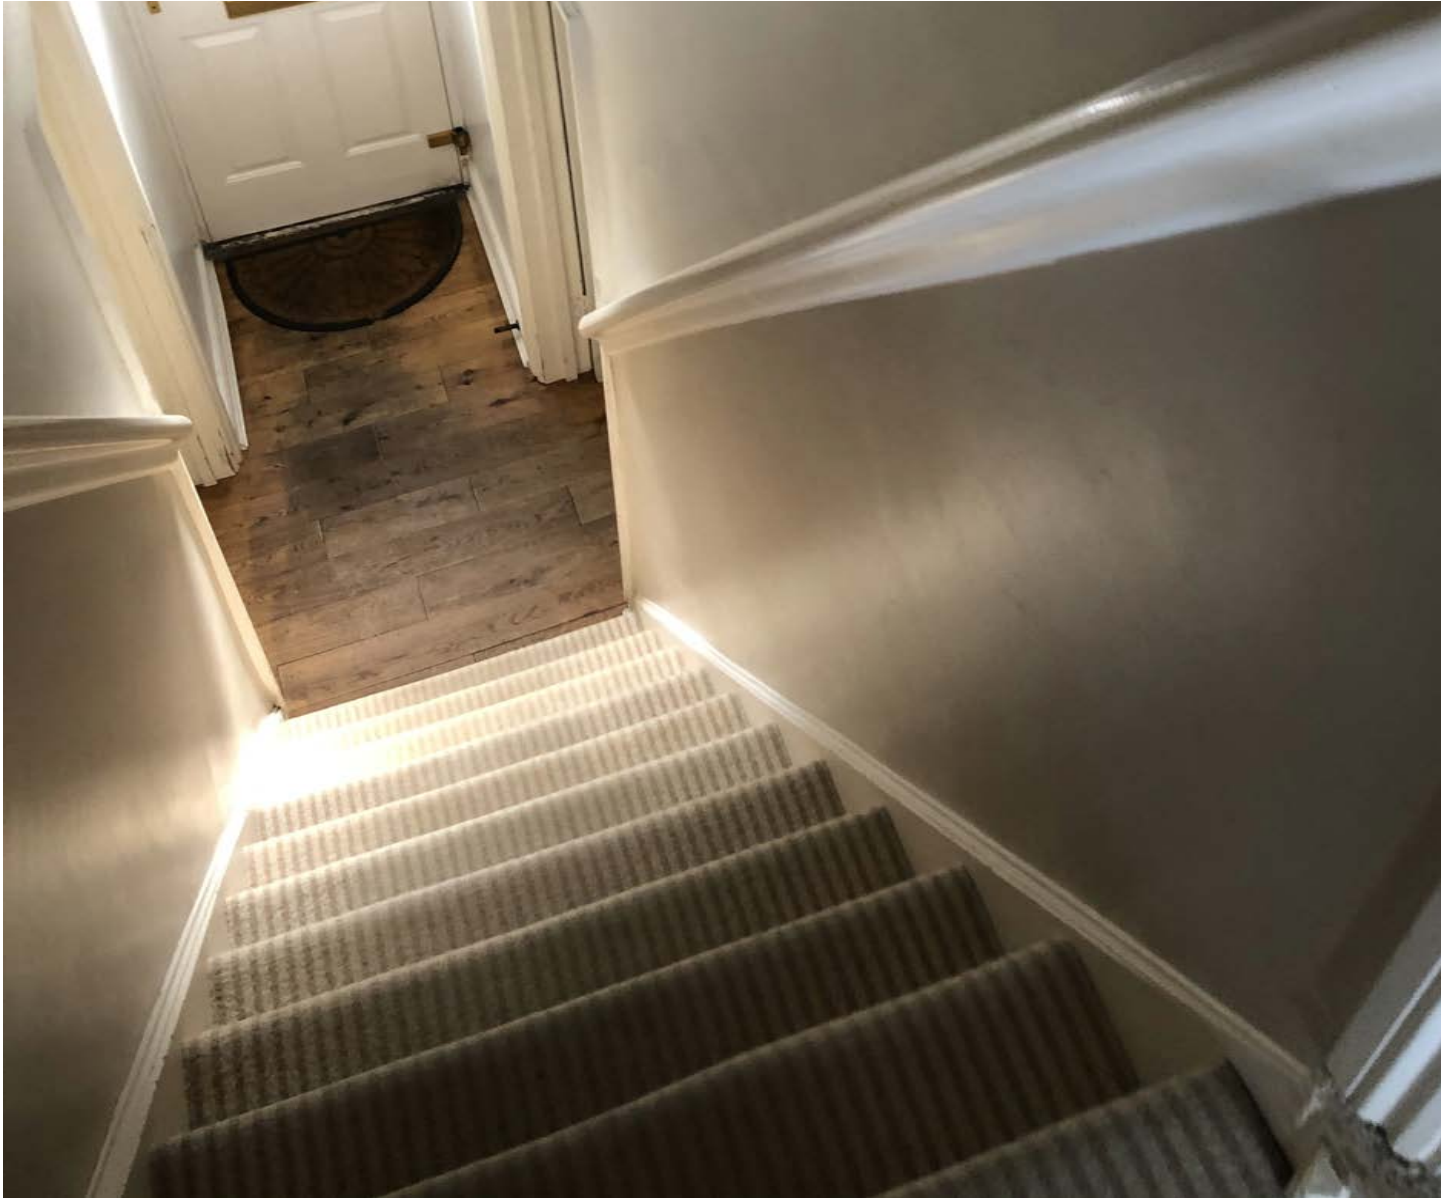
The current stairs' pitch is over 50 degrees and does not meet current building regulations.

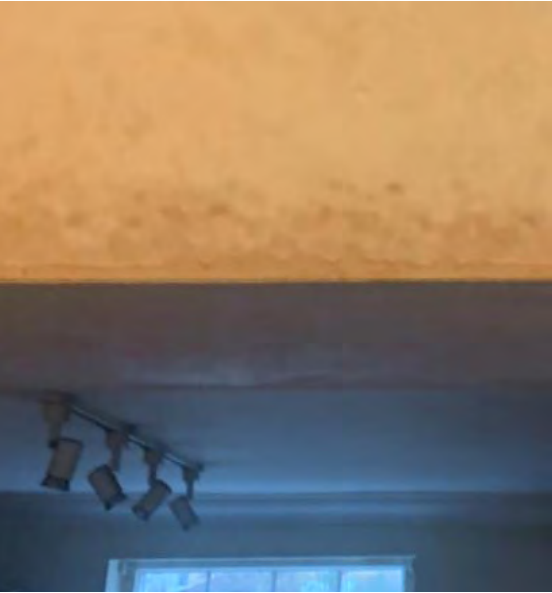
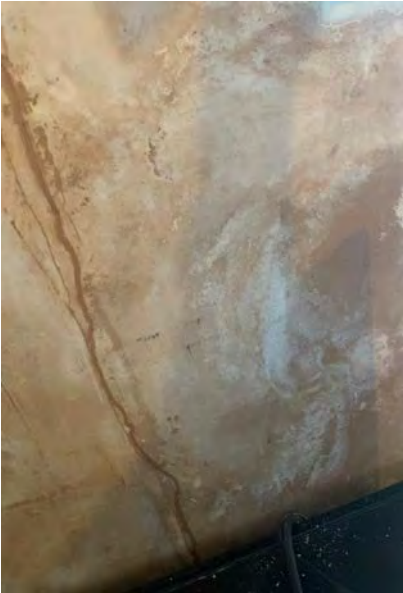
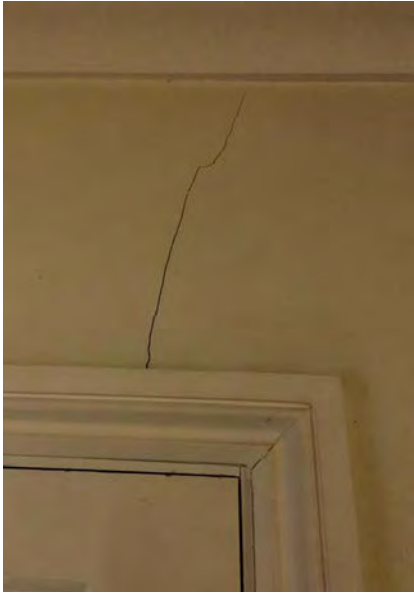
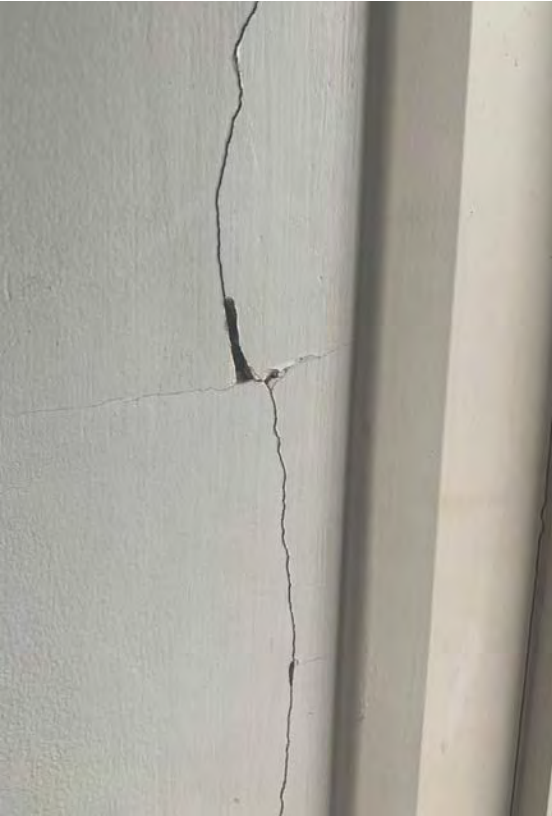
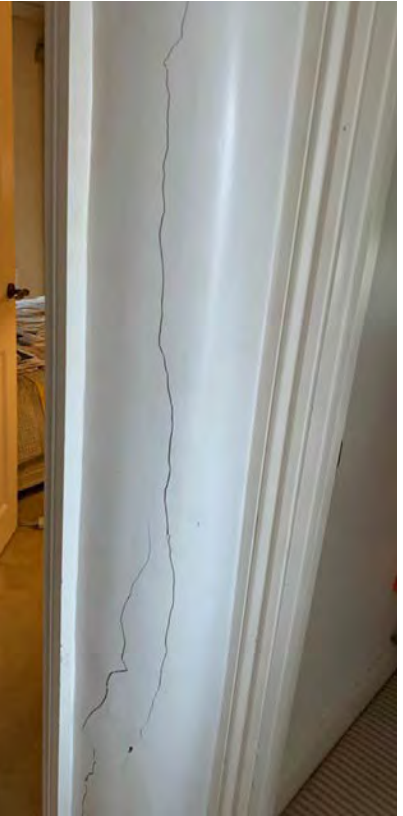
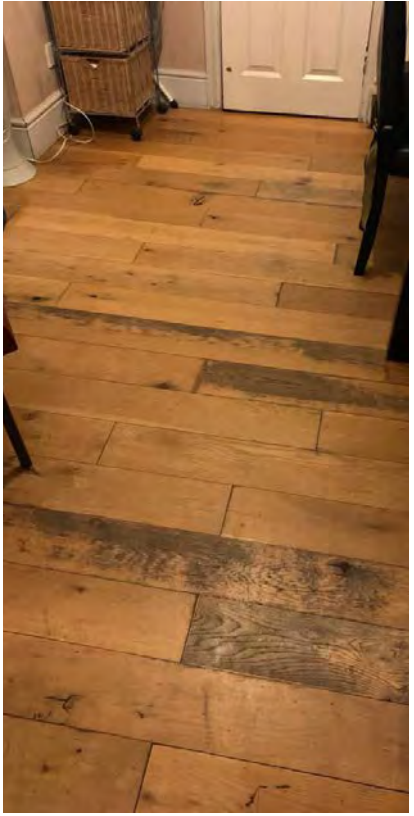
Water ingress and structural damage noticed in different areas of the house, on ground and first floor, as well as attic space.
