**38 CROSS STREET**

### South Elevation - Existing Cross Street

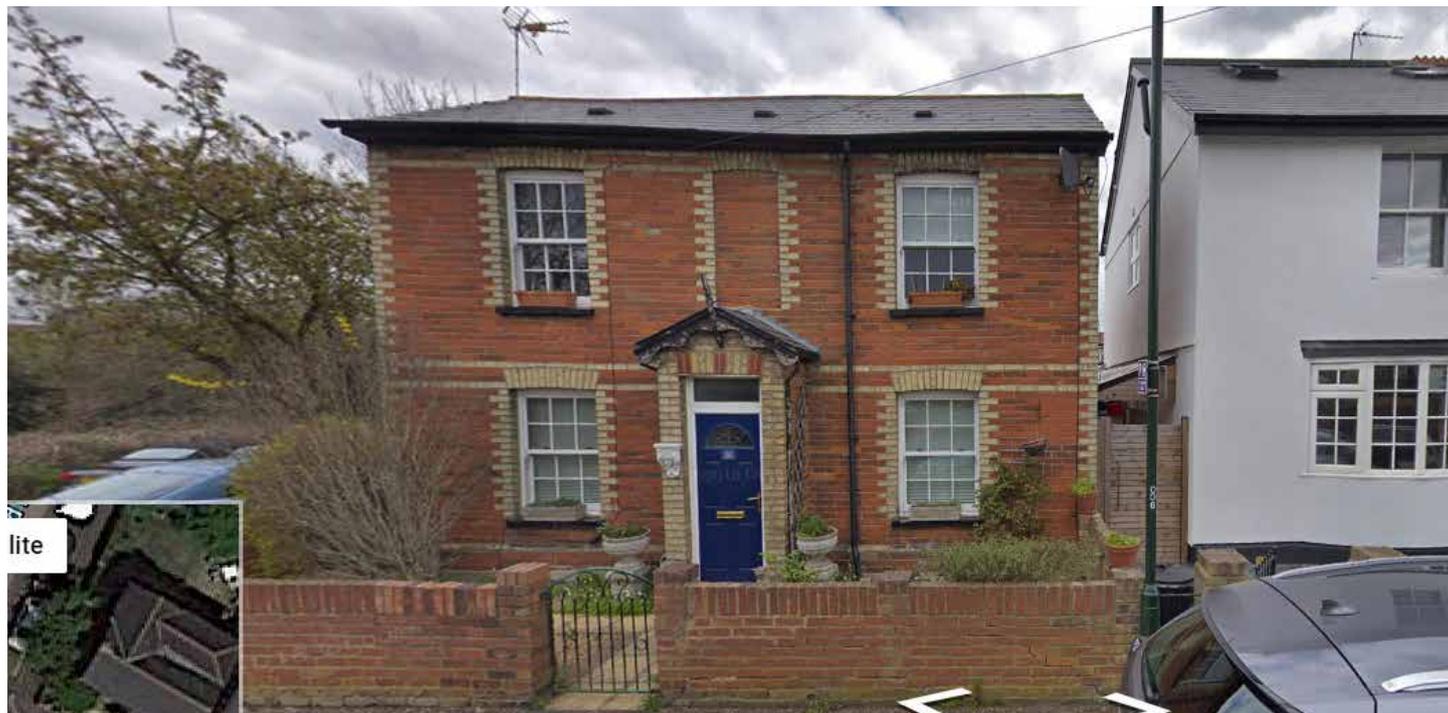
In general, the house is currently in need of restoration.

Proposed enlargement of front porch to provide adequate accessibility. All original details to be restored.

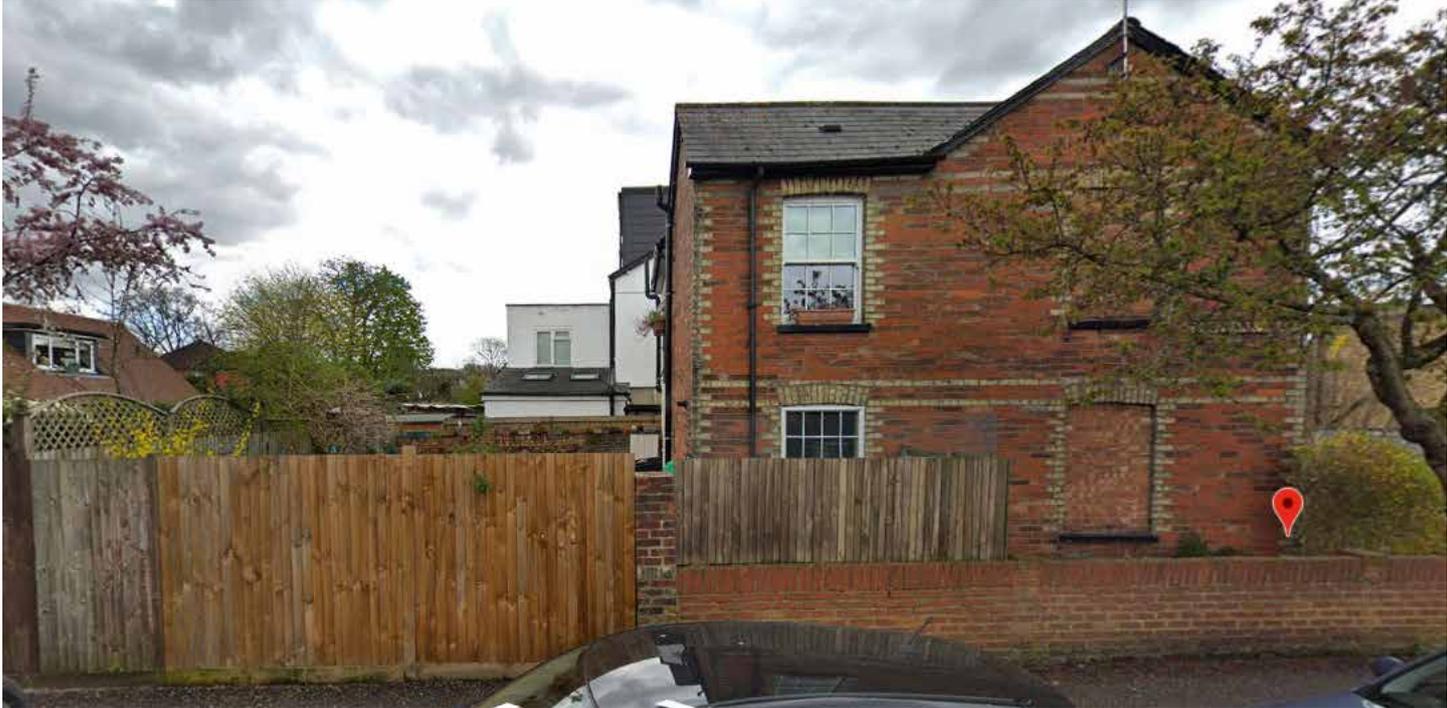
In general, the house is currently in need of restoration.

Wooden fence to be replaced by a brick wall of matching height. Original bricks to be re used as much as possible.

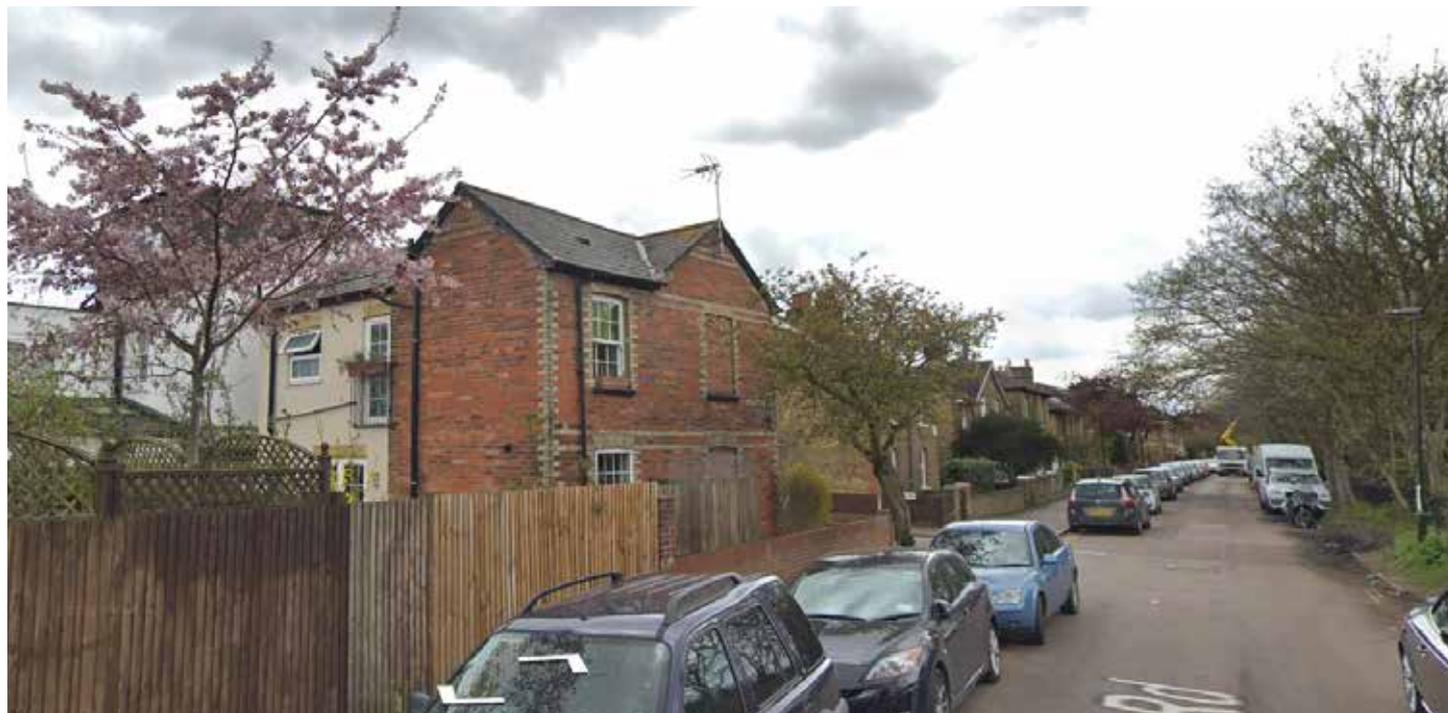
In general, the house is currently in need of restoration.

Wooden fence to be replaced by a brick wall of matching height. Roof dormer to sit back on rear elevation by at least 500mm.

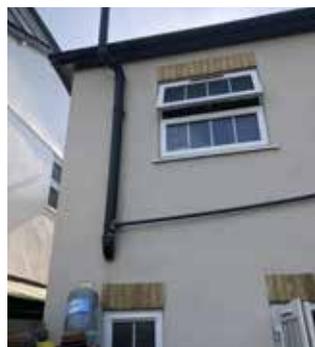
UPVC windows, downpipes and soil pipes

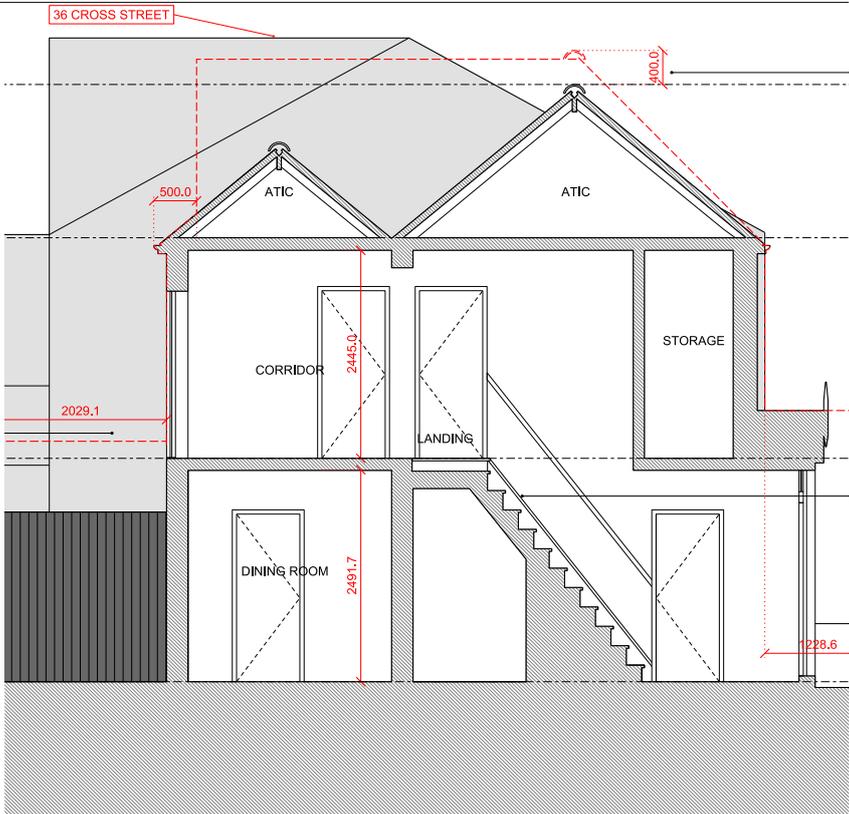
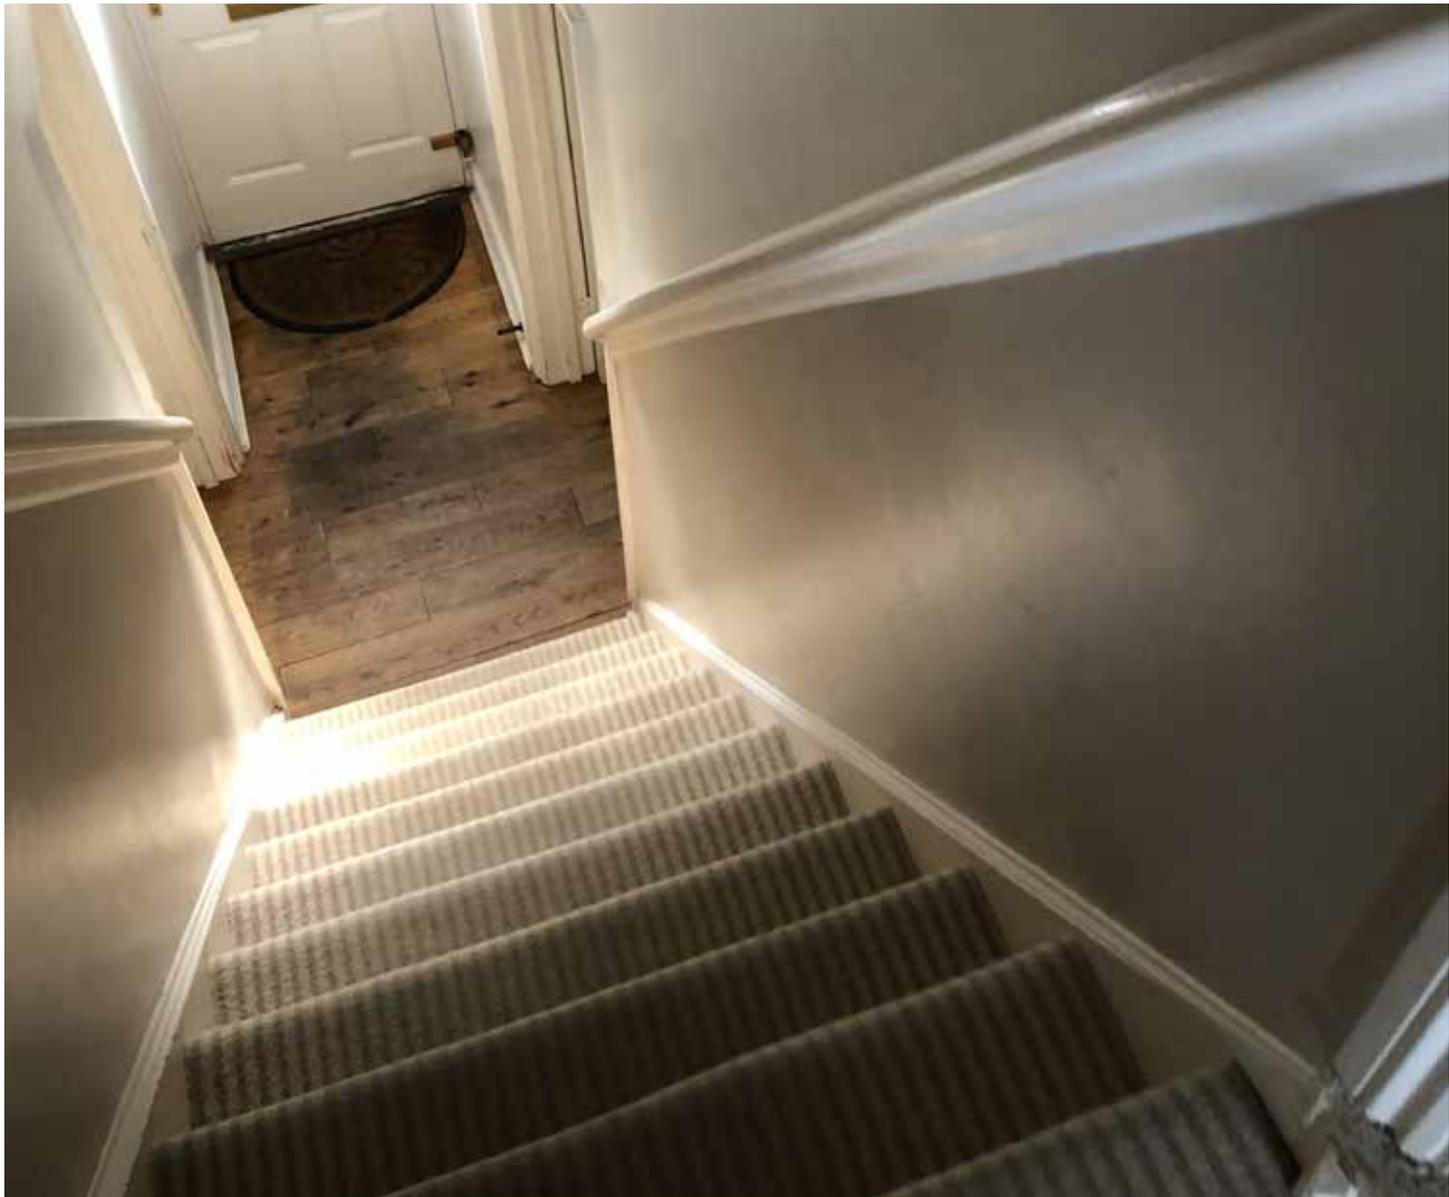
The current stairs' pitch is over 50 degrees and does not meet current building regulations.

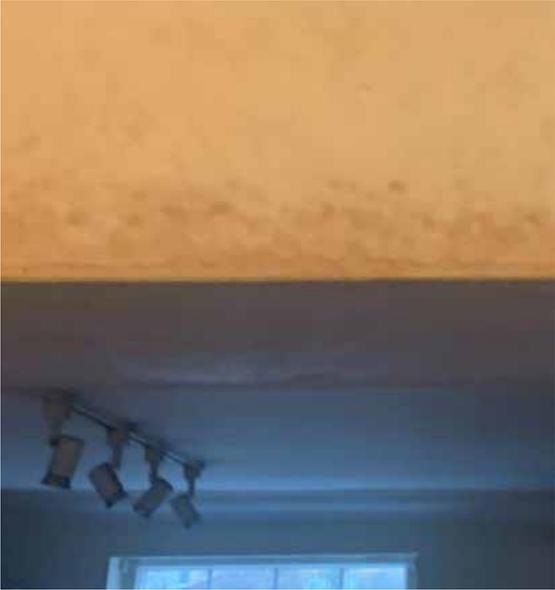
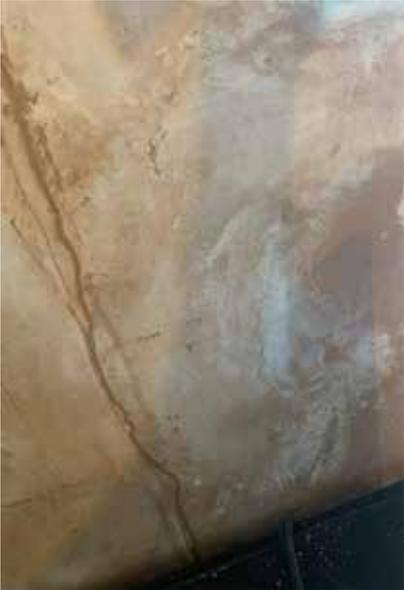
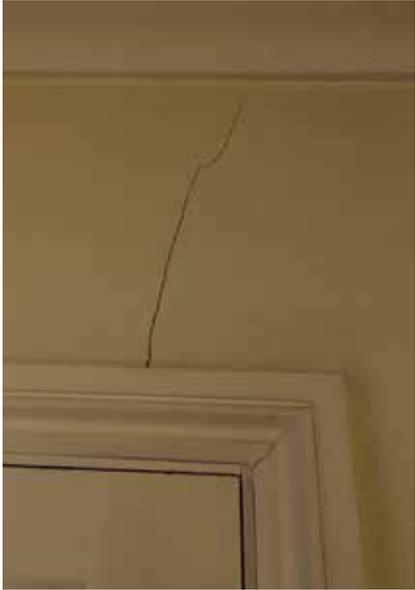
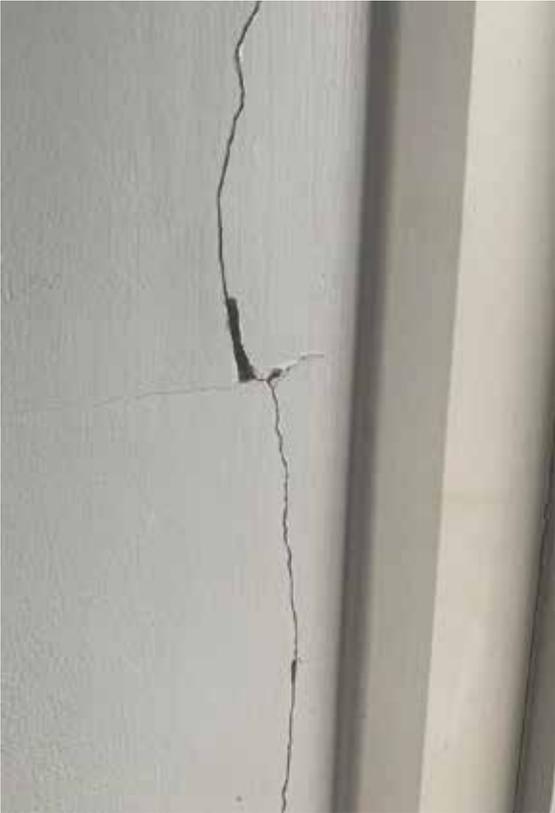
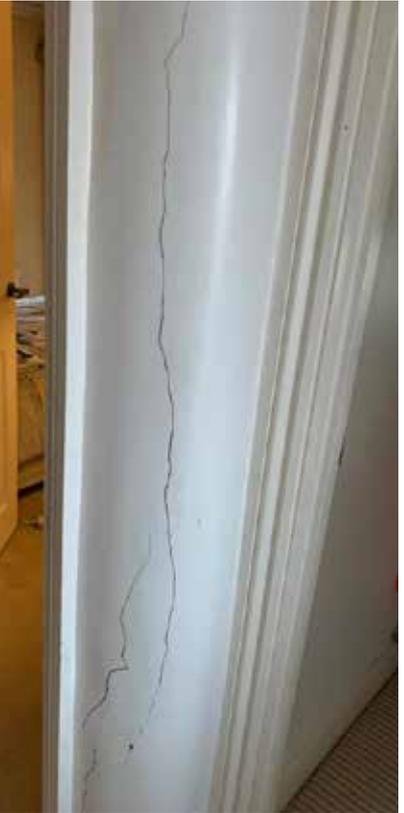
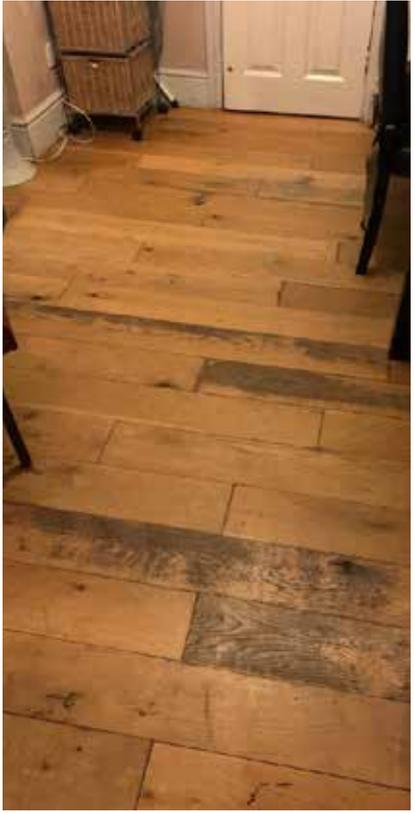
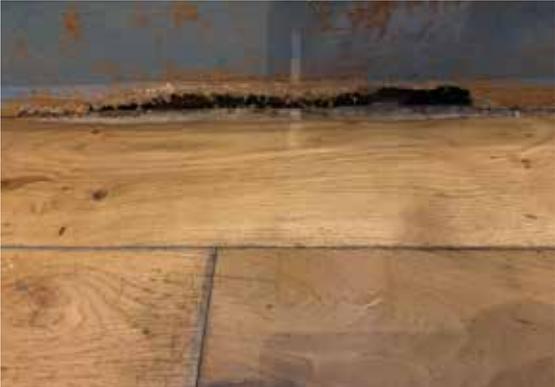
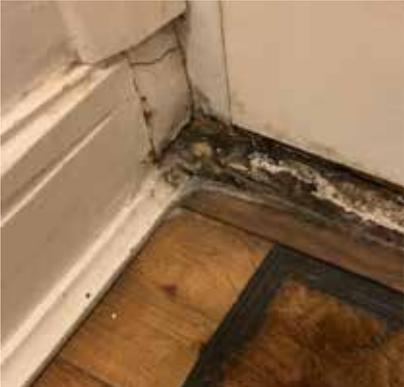
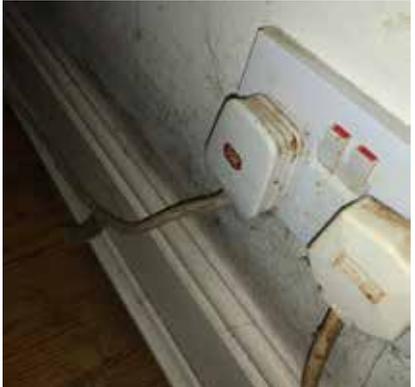
Water ingress and structural damage noticed in different areas of the house, on ground and first floor, as well as attic space.
