Connick Tree Consultants

TREE DEVELOPMENT REPORT

(BS5837:2012 ARBORICULTURAL IMPACT ASSESSMENT)

OUR REFERENCE	181716
CLIENT	Ms. Kulbinder Dosanjih
PLANNING AUTHORITY	London Borough of Richmond Upon Thames
SITE	2a Cole Park Road, Twickenham. TW1 1HW
SURVEY & REPORT BY	Mr Richard Tilling
DATE	6 th April 2021

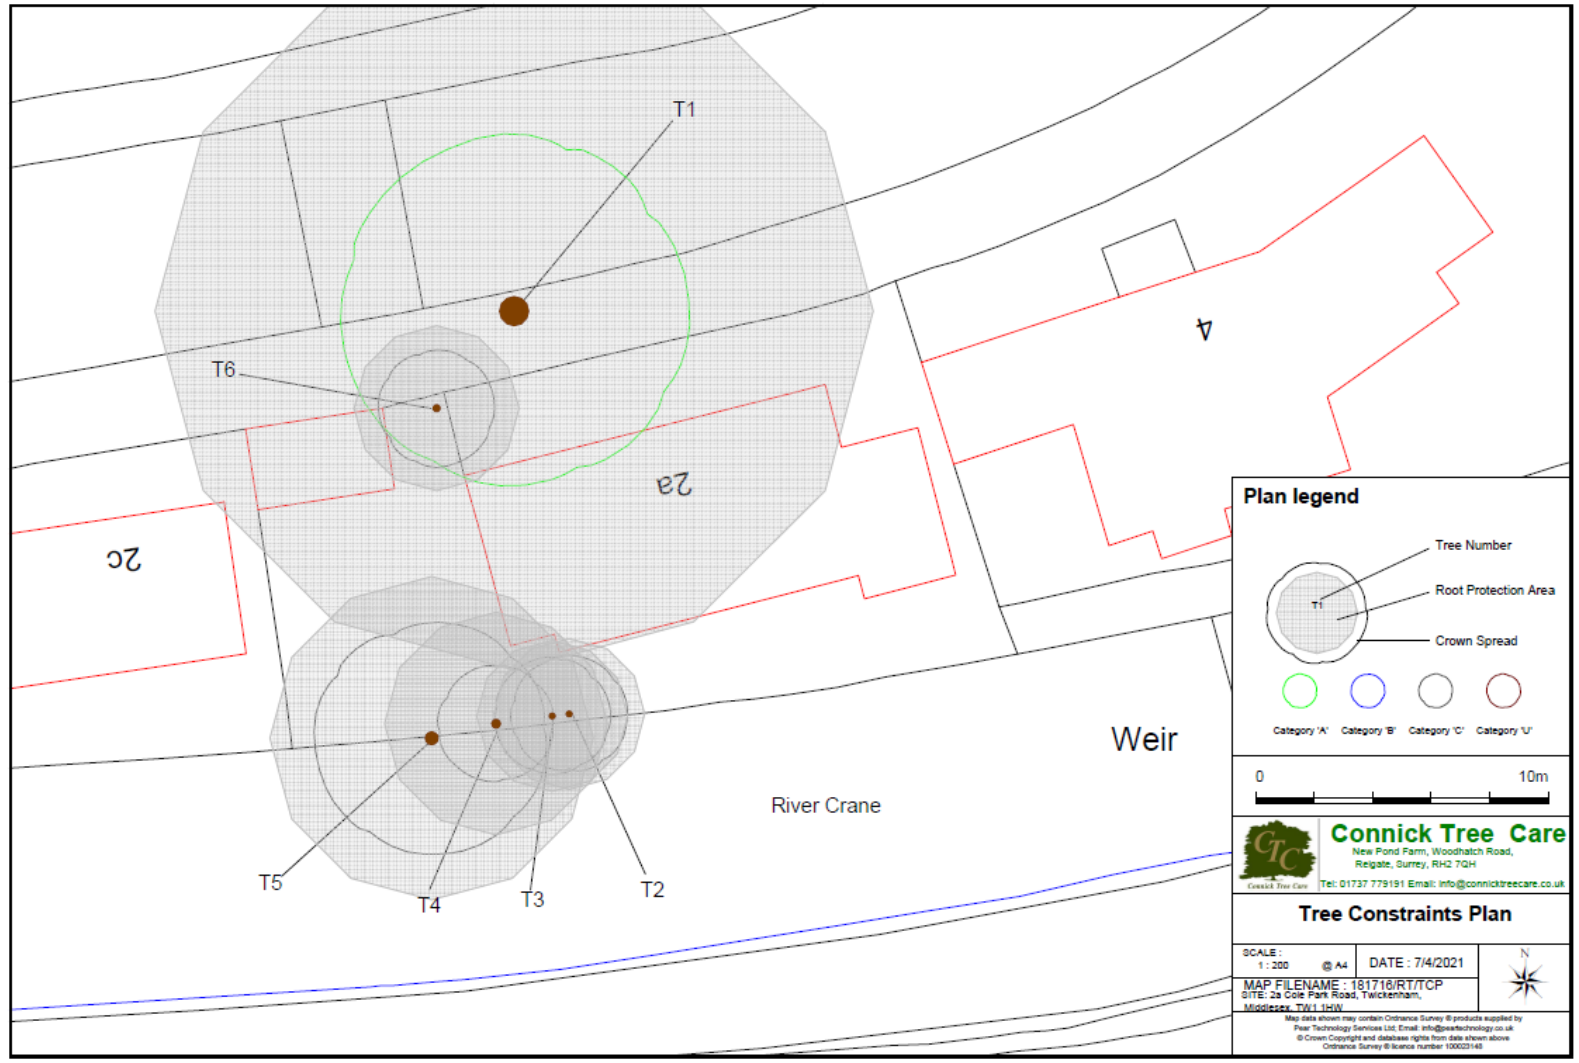
APPENDIX II TREE CONSTRAINTS PLAN

The root protection area's (RPA's) of the trees recorded within the survey are shown in the Tree Constraints Plan (Appendix II).

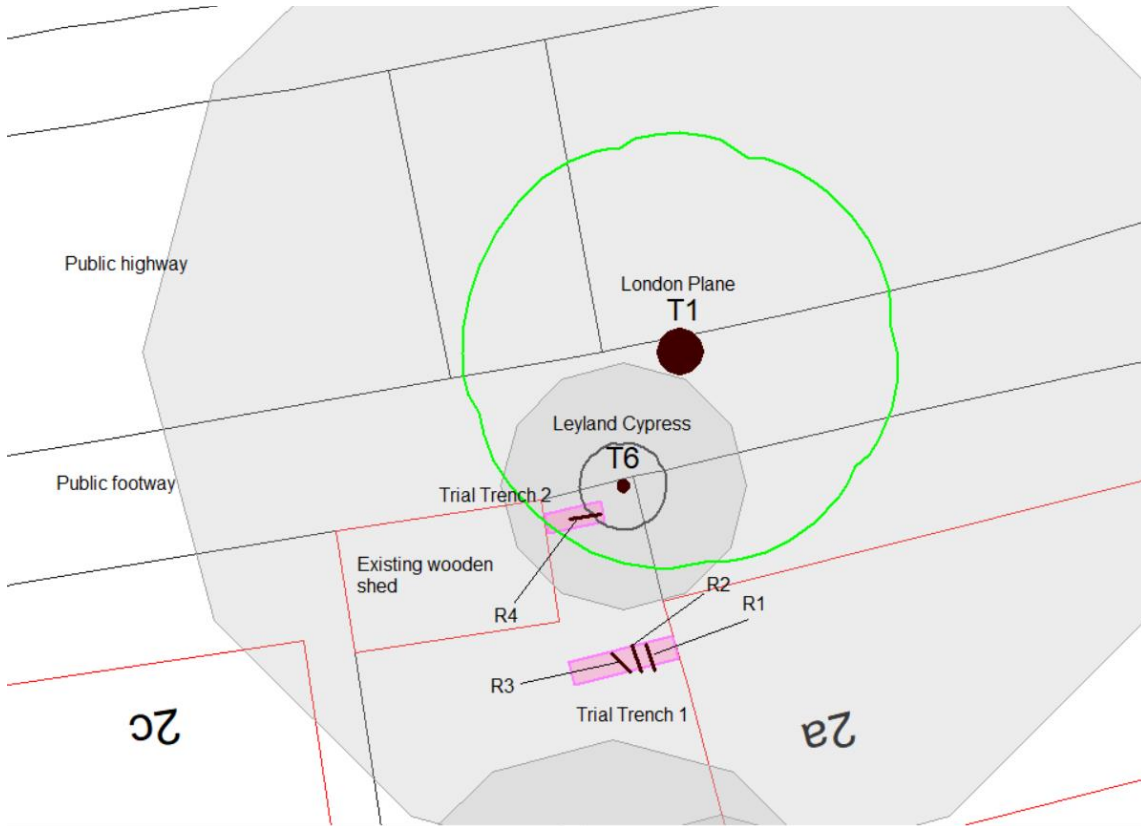
Figure 1: Showing location of trail trenches and roots found

In total two trial trenches were excavated. These excavations confirmed the presence of roots within the rear garden. The roots originate from tree T6. The location of the trial trenches is indicated in the root investigations plan, along with photographs of the findings attached as Appendix III.

In total four roots were identified within Trial trench 1, these consist of:

- R1 - 30mm in diameter, found at depth of 200mm and growing across the pit north to south
- R2 - 15mm in diameter root bundle, found at a depth of 180mm and growing across the pit north to south.
- R3 - 10mm in diameter, found at a depth of 400mm, which grows north to south rising to 280mm.

The second trench was excavated, closer to the front boundary wall, this was located 500mm from the base of tree T6. Within this trial trench roots were identified and consisted of:

- R4 – 10mm in diameter, found at depths from 150 to 450mm in depth, and growing east to west with some roots descending vertically to a depth of 600mm

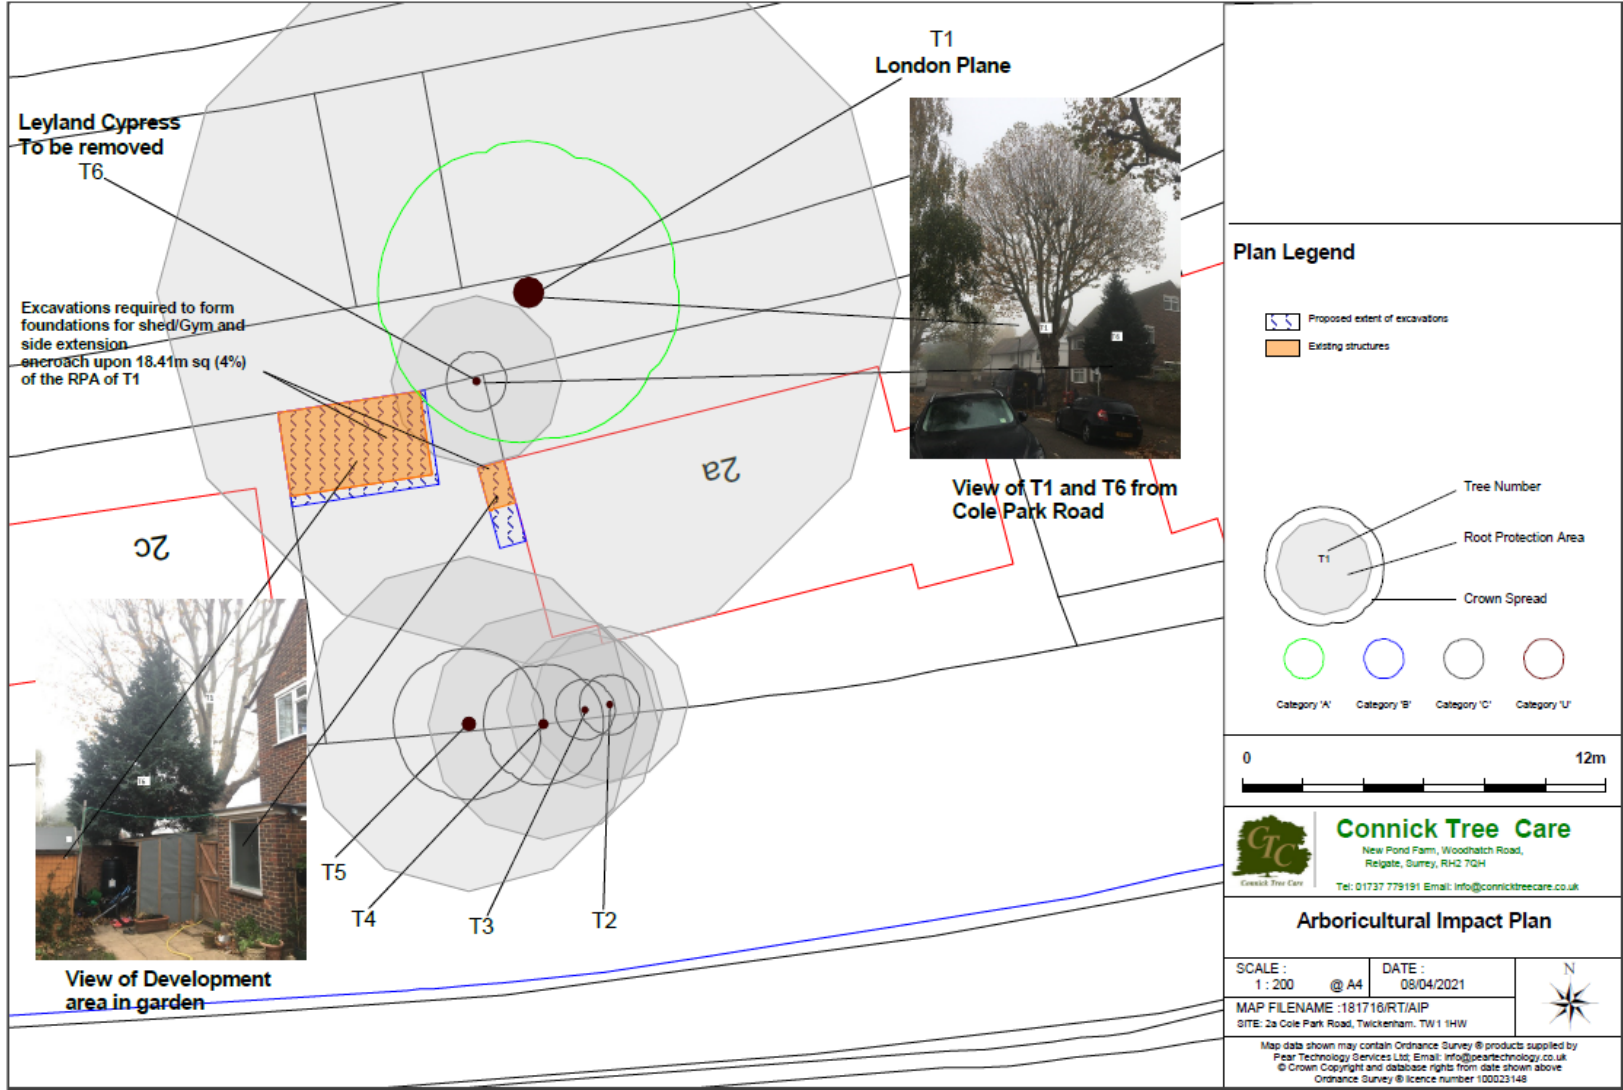
APPENDIX IV ARBORICULTURAL IMPACT PLAN

The survey process and the Arboricultural Impact Plan (Appendix IV) has indicated the extent of the theoretical Root Protection Areas (RPA) and crown spreads of the surveyed trees in relation to the development and identifies the potential impacts resulting from the proposed development. The details of the impacts caused by each construction stage is identified within Table 1 below:

Tree No.	Total RPA m ²	Development Section	Impact of proposed development.
T1	452.4	Excavations required to form side extension and Gym/shed foundations	The excavations required to form the side extension and Gym/ shed foundations will encroach upon 18.41 m ² of the total RPA, equating to approximately 4 %.
