Merewood
Arboricultural Consultancy Services

**Arboricultural survey to British
Standard B.S. 5837: 2012 'Trees in
relation to design, demolition and
construction - Recommendations'**

**The Bungalow
Willoughby Road
Twickenham
TW1 2QH
Rev. B**

**Client: Nomad Developments
126 New King's Road
Fulham
London
SW6 4LZ**

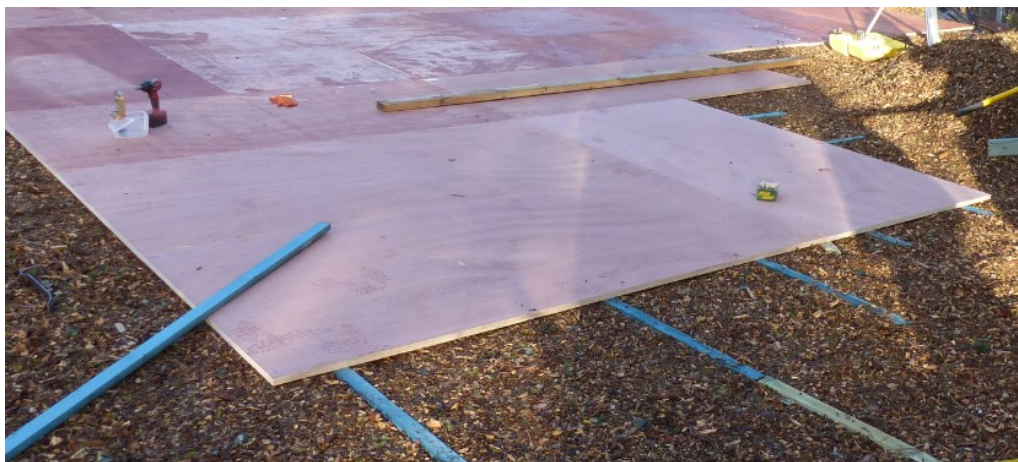
Fig.1 Ply-boards placed onto a layer of woodchips provides a good working surface for pedestrians or scaffolding

- 4.12 It is therefore proposed to protect the soil surface with the use of plyboards laid onto woodchips which will provide a suitable surface for pedestrians (see fig.1)

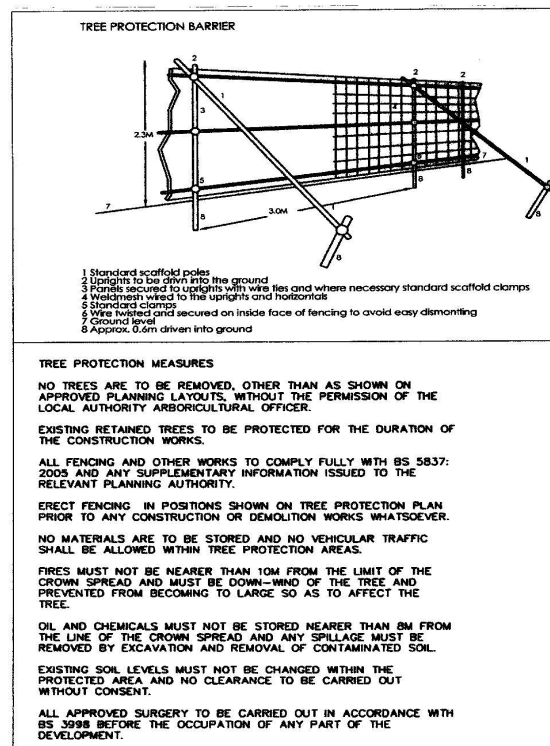
Fig.1 Protective fencing in accordance with B.S. 5837

- 4.15 Fencing for the root protection zones shall be constructed of scaffold tube uprights (set at 3m intervals with diagonal braces driven securely into the ground). Thereafter ‘Heras’ type fencing shall be attached to the scaffold framework using either steel strapping or scaffold clamps. The fencing shall comply with the requirements of the British Standard B.S. 5837:2012 ‘Trees in relation to design, demolition and construction - Recommendations’ (fig.2).
