OMC Associates

BS 5837 Arboricultural Impacts Assessment

SITE: 18 East Sheen Avenue, SW14 8AS

DATE OF REPORT: 14 July 2021

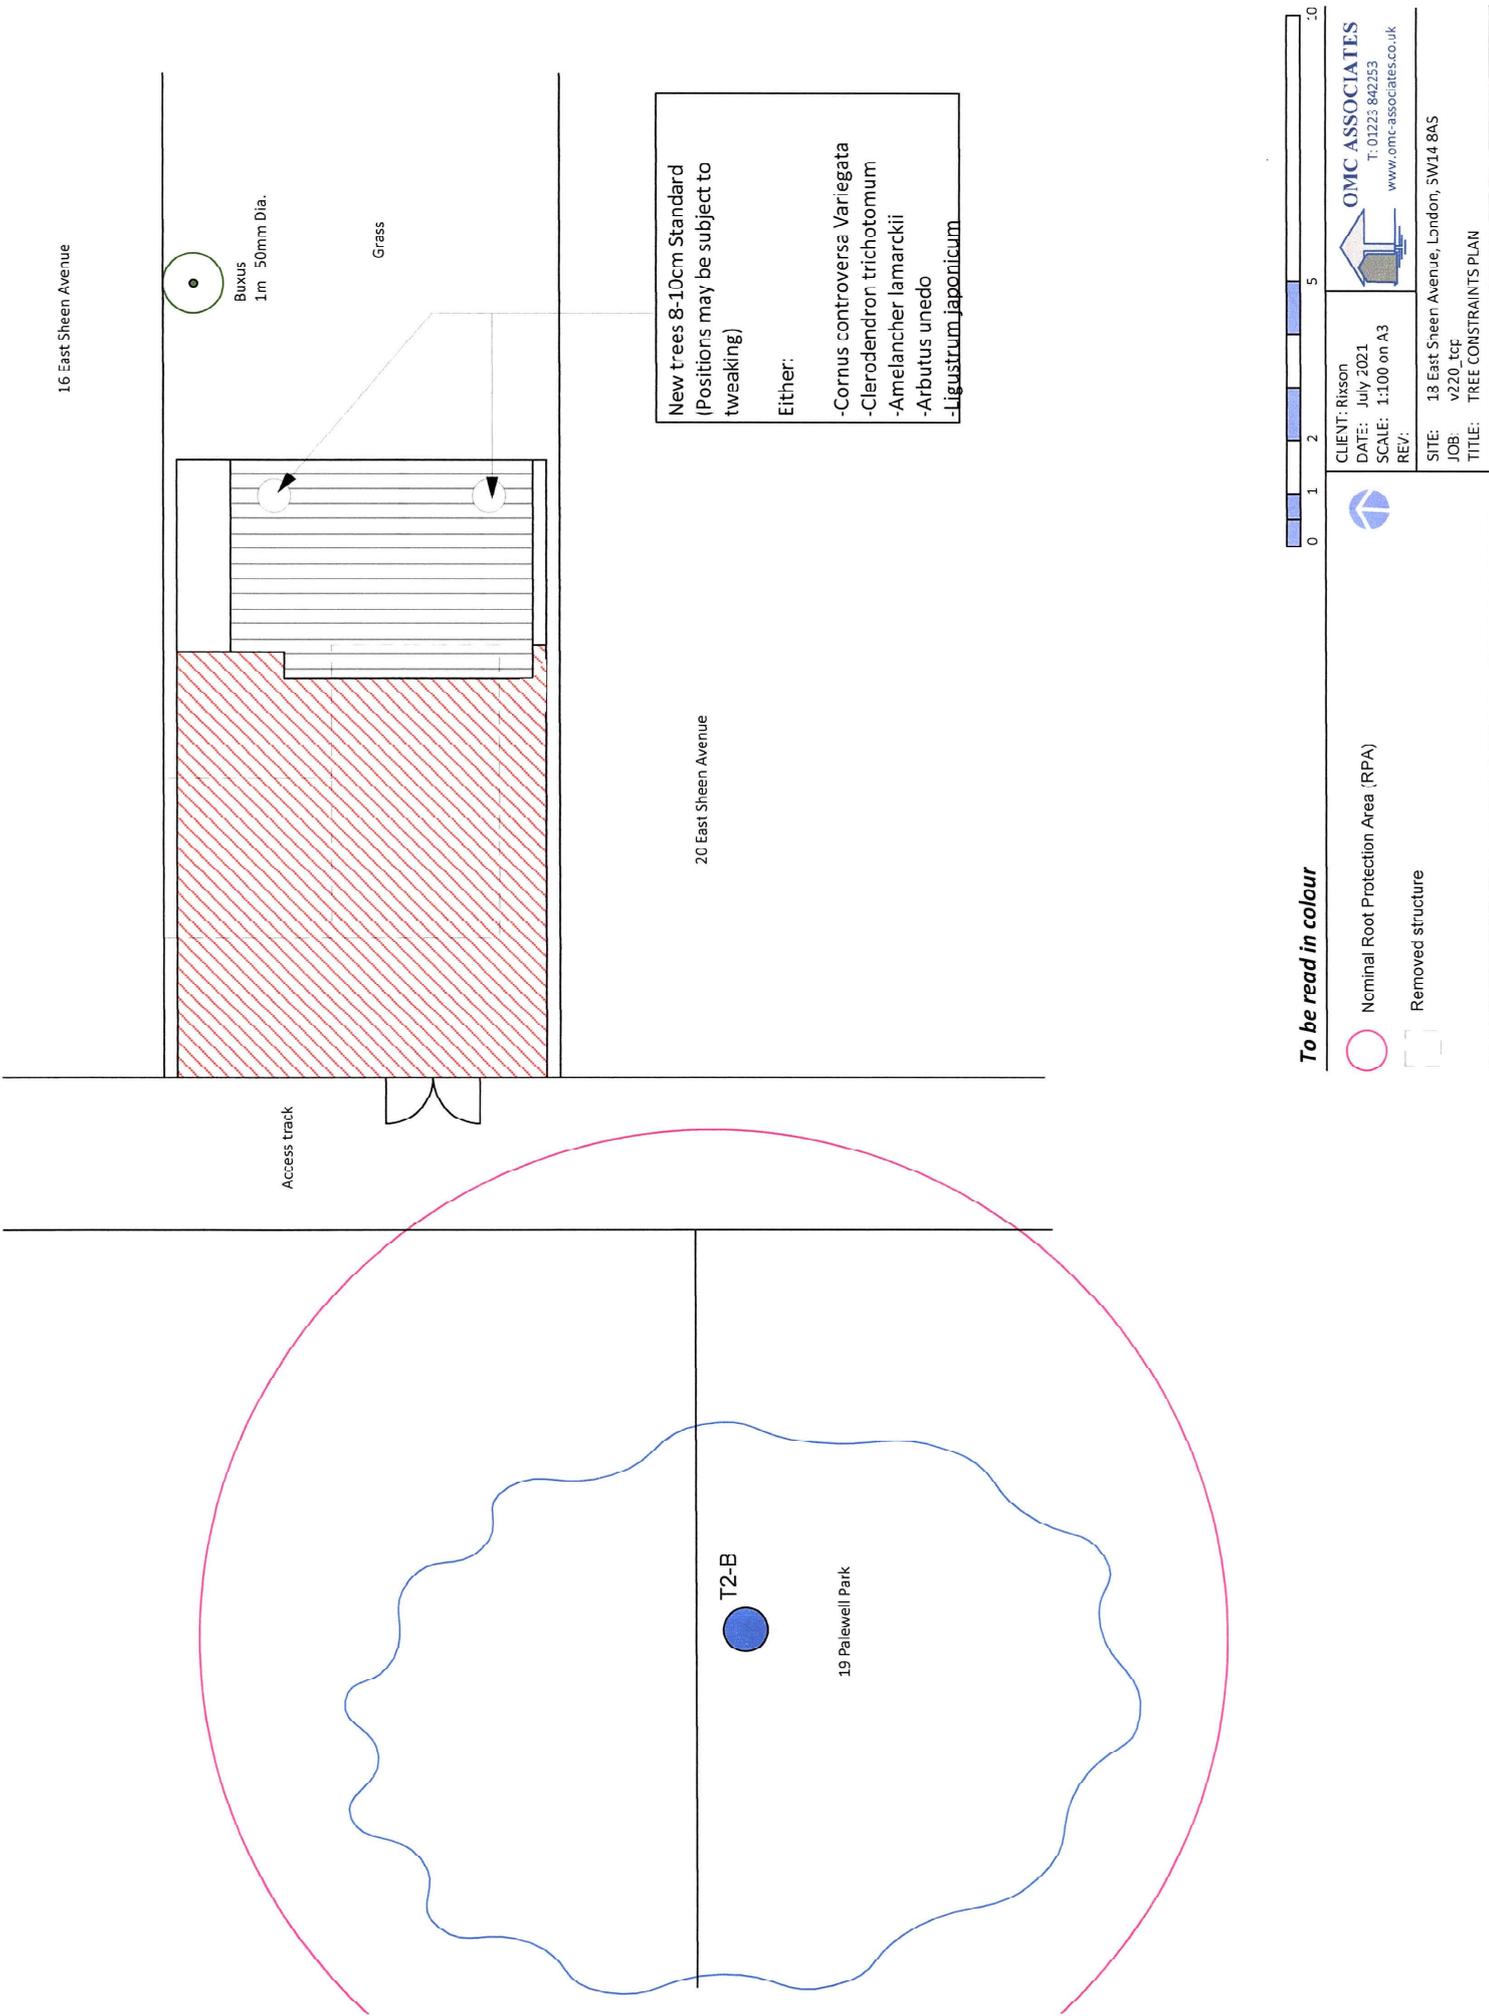
Appendix C - Tree Constraints Plan

The RPA of the large off-site ash T2 is shown on the tree implications plan which demonstrates that it does not encroach upon the site at all.

T2-B

The scheme involves, though does not necessitate, the removal of the C/B grade apple tree T1. This will have no impact on public amenity and only minimal impact on the prevailing landscape. Two new trees are proposed to replace T1 and these are shown on the tree constraints plan.

New trees 8-10cm Standard
(Positions may be subject to
tweaking)
Either:
-Cornus controversa Variegata
-Clorodendron trichotomum
-Amelanchier lamarckii
-Arbutus unedo
-Ligustrum japonicum

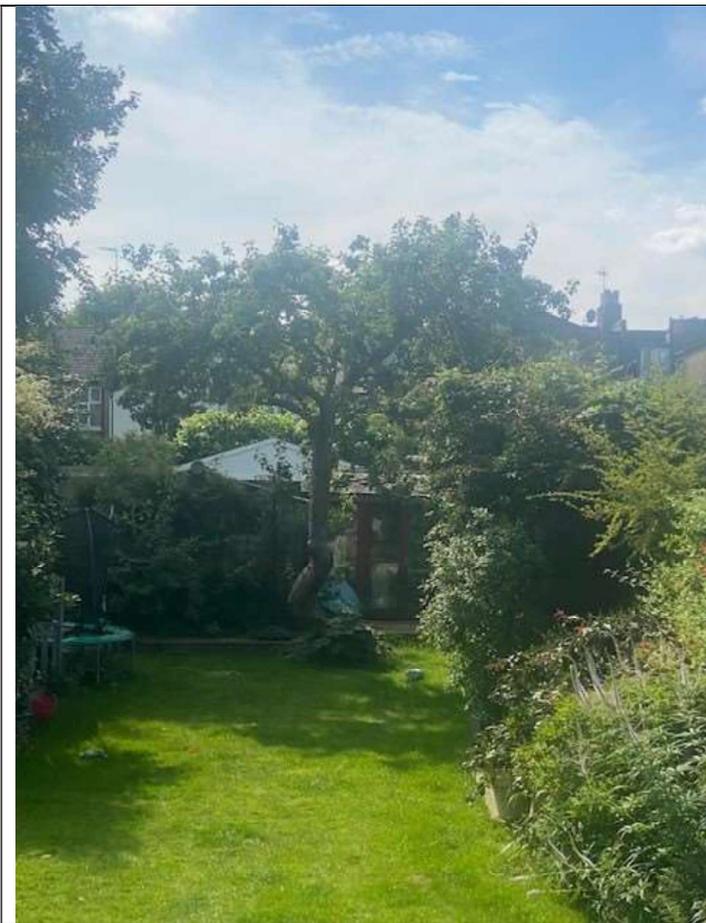
Photo 1

T1 is a mature apple that has been subject to rather unsympathetic pruning. It has no public amenity value and limited arboricultural value. It is regarded, therefore, as a C/B grade tree.

- T1 looking west
- Edge of canopy of T2 just visible far left

It is proposed that the C/B grade apple T1 is removed (it is understood that this will be subject of a CA Notice shortly).

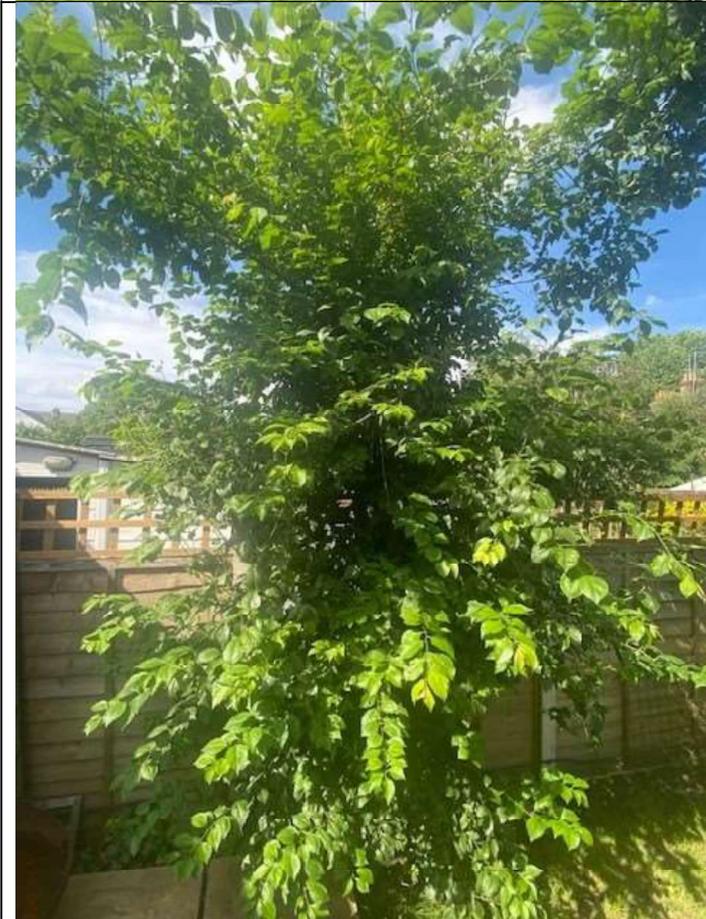
Photo 2

- Cherry sapling

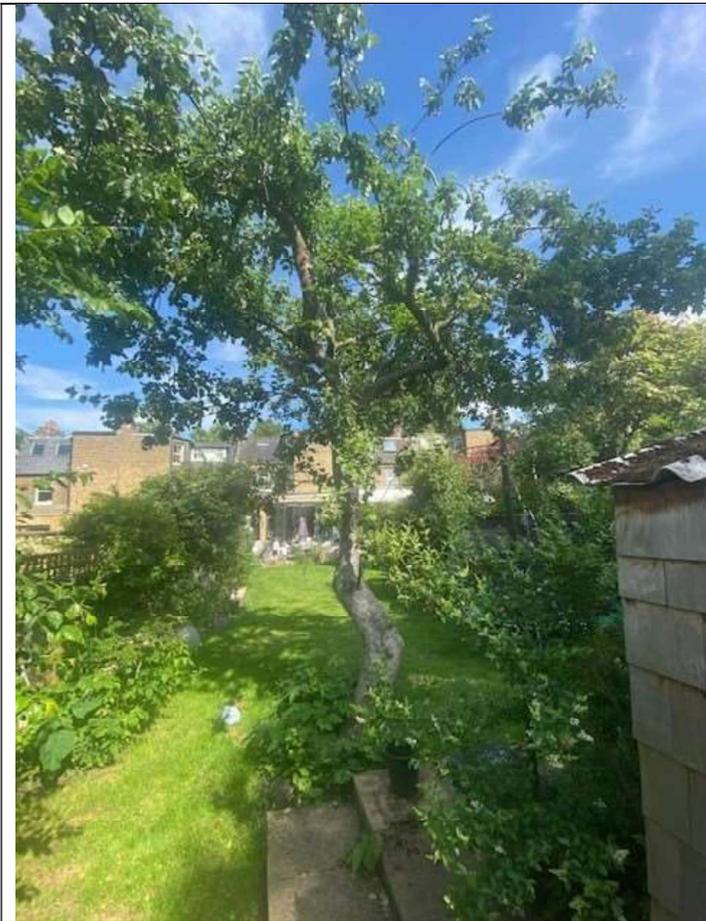
Photo 3

The apple has no public amenity value and has been subject to unsympathetic pruning and crown-lifting in the past. Its removal should not, therefore, be regarded as a material basis to object.

- T1 looking east

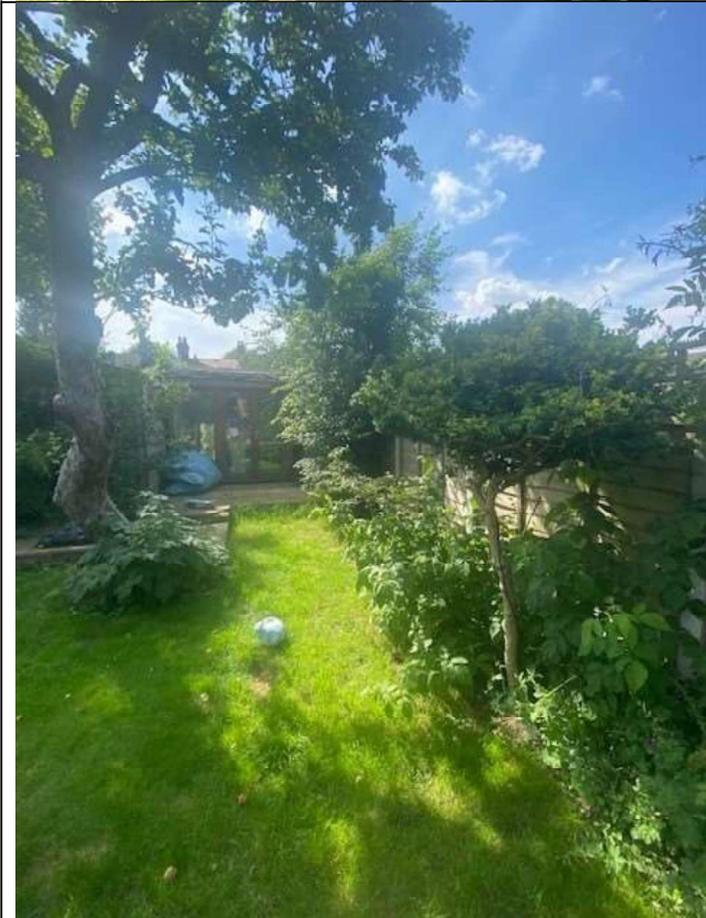
Photo 4

- T1 on left
- Small box tree in foreground
