ARBORICULTURAL IMPACT ASSESSMENT REPORT

BS 5837:2012 'Trees in relation to design, demolition and construction - Recommendations'

SITE
38-42 Vincam Close, Twickenham
CLIENT
NFC Homes Limited

DATE: 13th August 2021
OUR REF: RA802

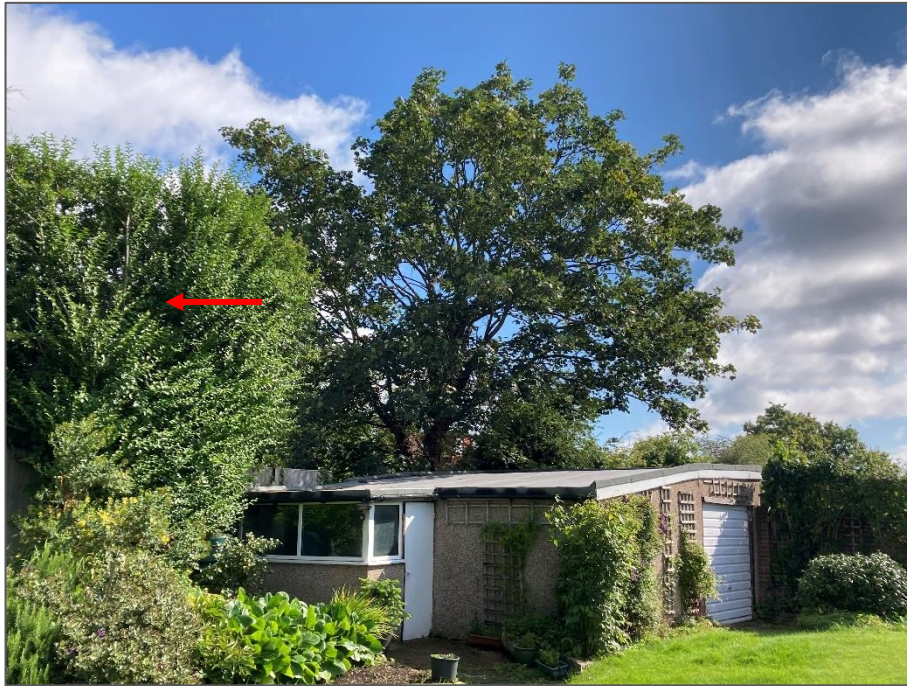
The sycamore is an offsite tree, which could only be viewed from a distance and over the garage/outbuilding. It appears to be in reasonable form and condition. The privet tree has been heavily pruned in the past and allowed to grow on in recent years. It has no major defects, but is rather unremarkable.

Photo 1 – T1 (centre) located behind outbuilding, T2 (left, arrow), looking north-east

Arboricultural impact assessment: The privet will be removed to facilitate landscaping works, the sycamore will be retained and protected during the development, particularly during the demolition phase.

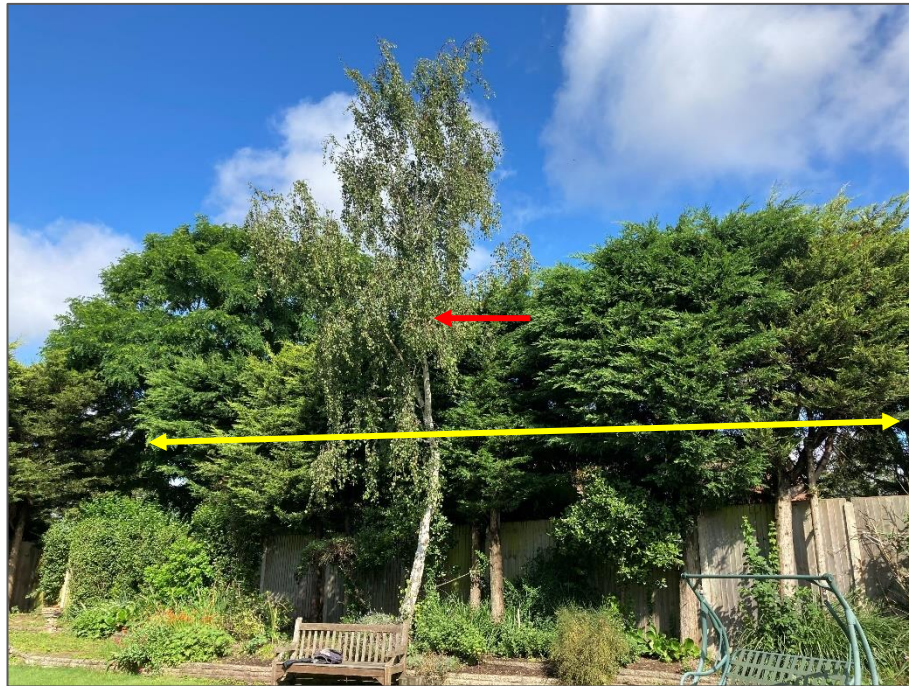
The cypress hedge and silver birch tree are located within a raised bed. The cypress have grown quite tall until the tops were taken out and a number of larger, lower branches has been removed on the south. The feature provides some screening value, but is rather tatty and of low aesthetic value. The silver birch is rather etiolated and of low value.

Photo 2 – H3 (yellow arrow), T4 (red arrow), looking north

Arboricultural impact assessment: The cypress hedge and birch tree are to be to facilitate landscaping works and likely level changes.

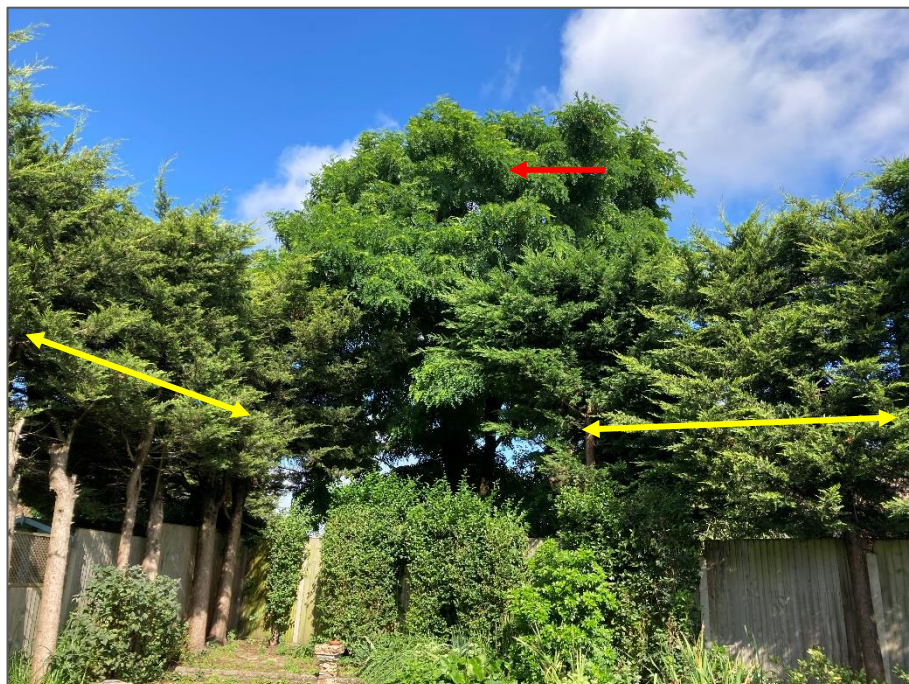
This is an offsite tree which was only viewed from a distance and over a tall closeboard fence. The tree appears to be in reasonable condition and is an attractive tree.

Photo 3 – T 5 (centre, red arrow), H3 (right, yellow arrow), H6 (left, yellow arrow)

Arboricultural impact assessment: There are no impacts to this tree

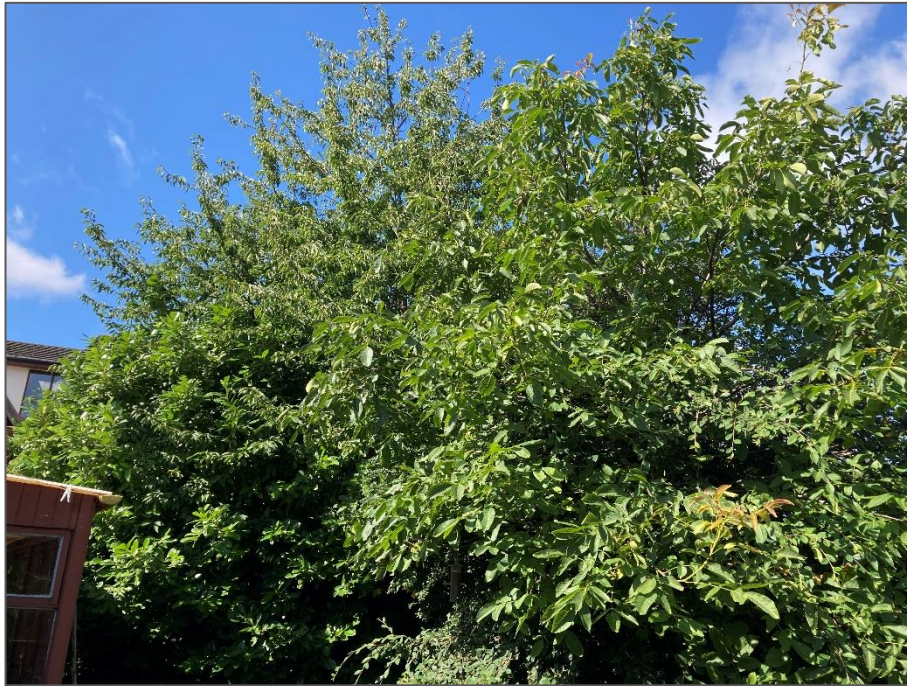
The cherry is the dominant tree within this area of the site, and has a typical broad spreading form. The hawthorn and walnut are suppressed by the cherry and surrounding vegetation. All three trees are unremarkable and of low value.

Photo 4 – T8 (right, red arrow), G9 (yellow arrow), looking south-west towards Vanquish Close

Arboricultural impact assessment: These trees are proposed for removal as they conflict with the replacement dwellings.
