Arboricultural Impact Assessment

29 Ham Farm Road

TW10 5NA

Shape

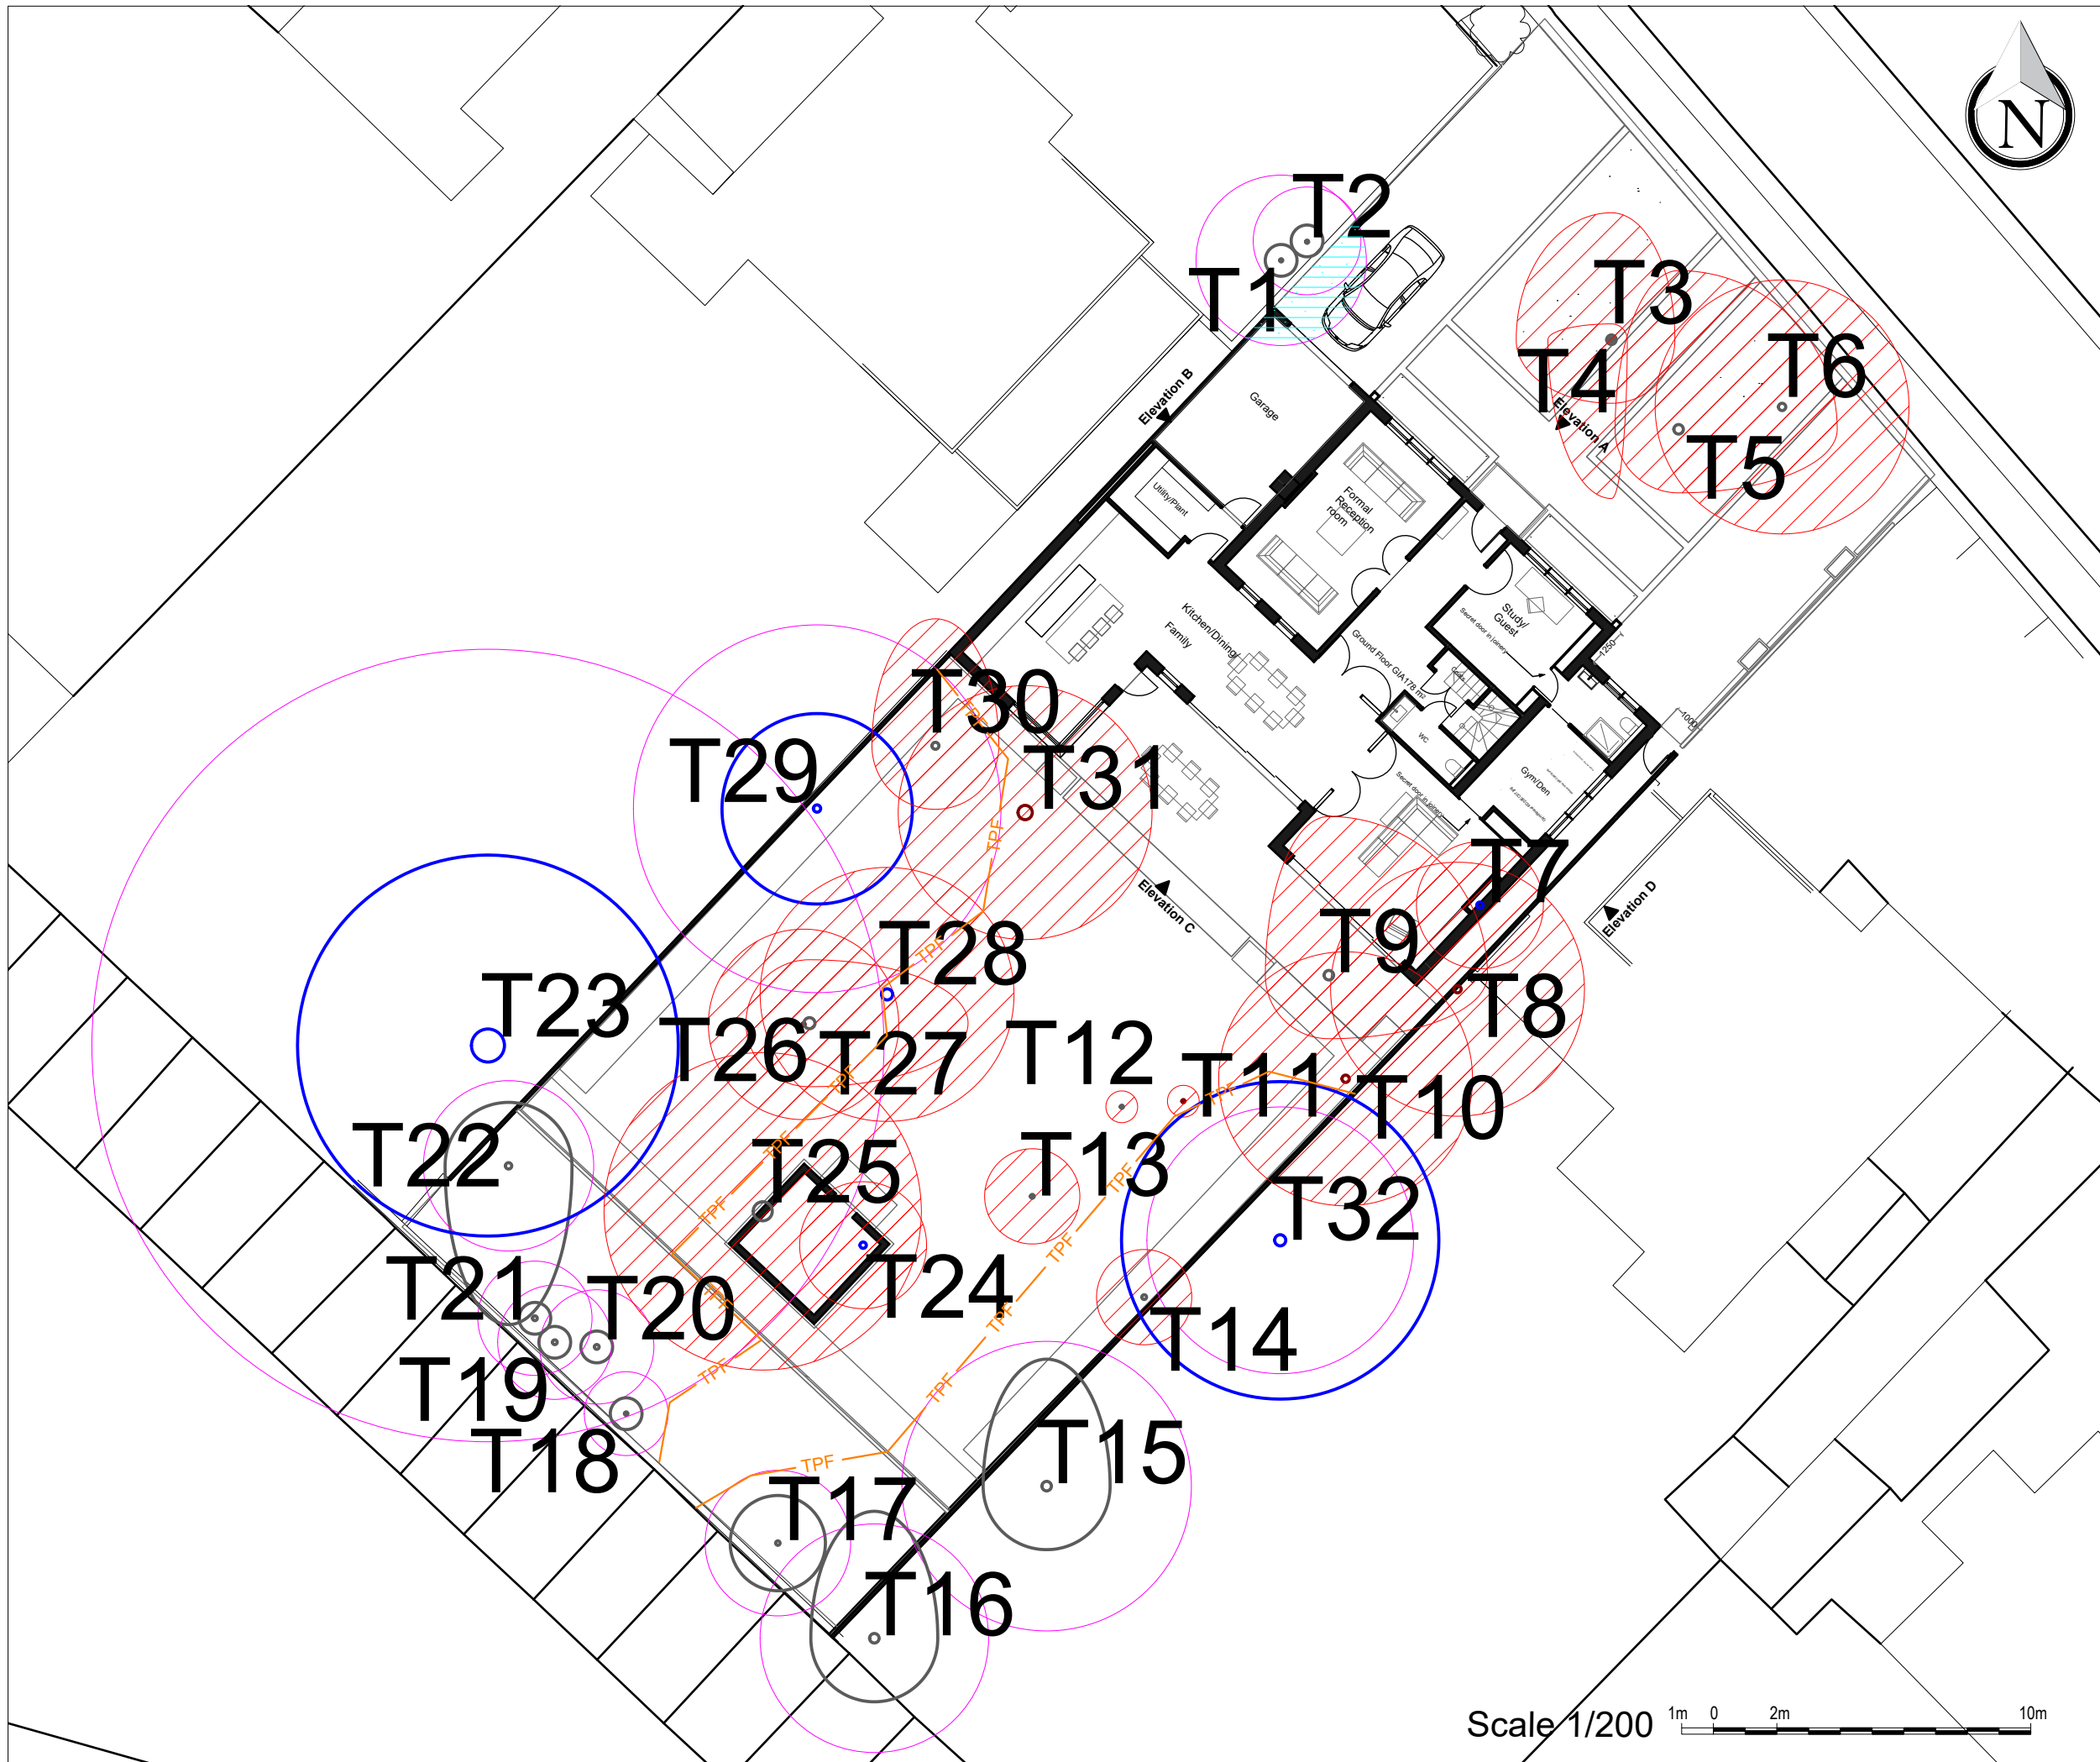
Drawing title	Tree Protection Plan
---------------	----------------------

Trees to be retained are coloured coded based on their tree category, whilst trees required for removal to facilitate the development have red hatch lines inside a red circle representing the tree crown spread. Tree protection is shown as barriers and/or ground protection defining the Construction Exclusion Zone (CEZ)², and any areas requiring non-standard methods of demolition or construction are shown.

No Root Protection Areas (RPAs) of any retained trees will be incurred into by the design layout. However, due to the presence of the stems of other trees directly within this area, it is unlikely that the roots of T23 would be encountered here.

Appendix 5 includes guidance for protective barriers based on BS 5837:2012. The approximate location of the barriers and the CEZs is shown on the TPP. The precise location of the barriers and other protective measures will be confirmed at the pre-commencement meeting before any demolition or construction activities (including site clearance) start.

The Tree Protective Fencing is represented on the Tree Protection Plan by a black linetype containing the letters 'TPF'.
