BS5837:2021 Arboricultural Tree Survey and Impact Assessment Report

Client: The Park Property Group

**Land Rear of:
24 Hampton Road
Twickenham
TW2 5QB**

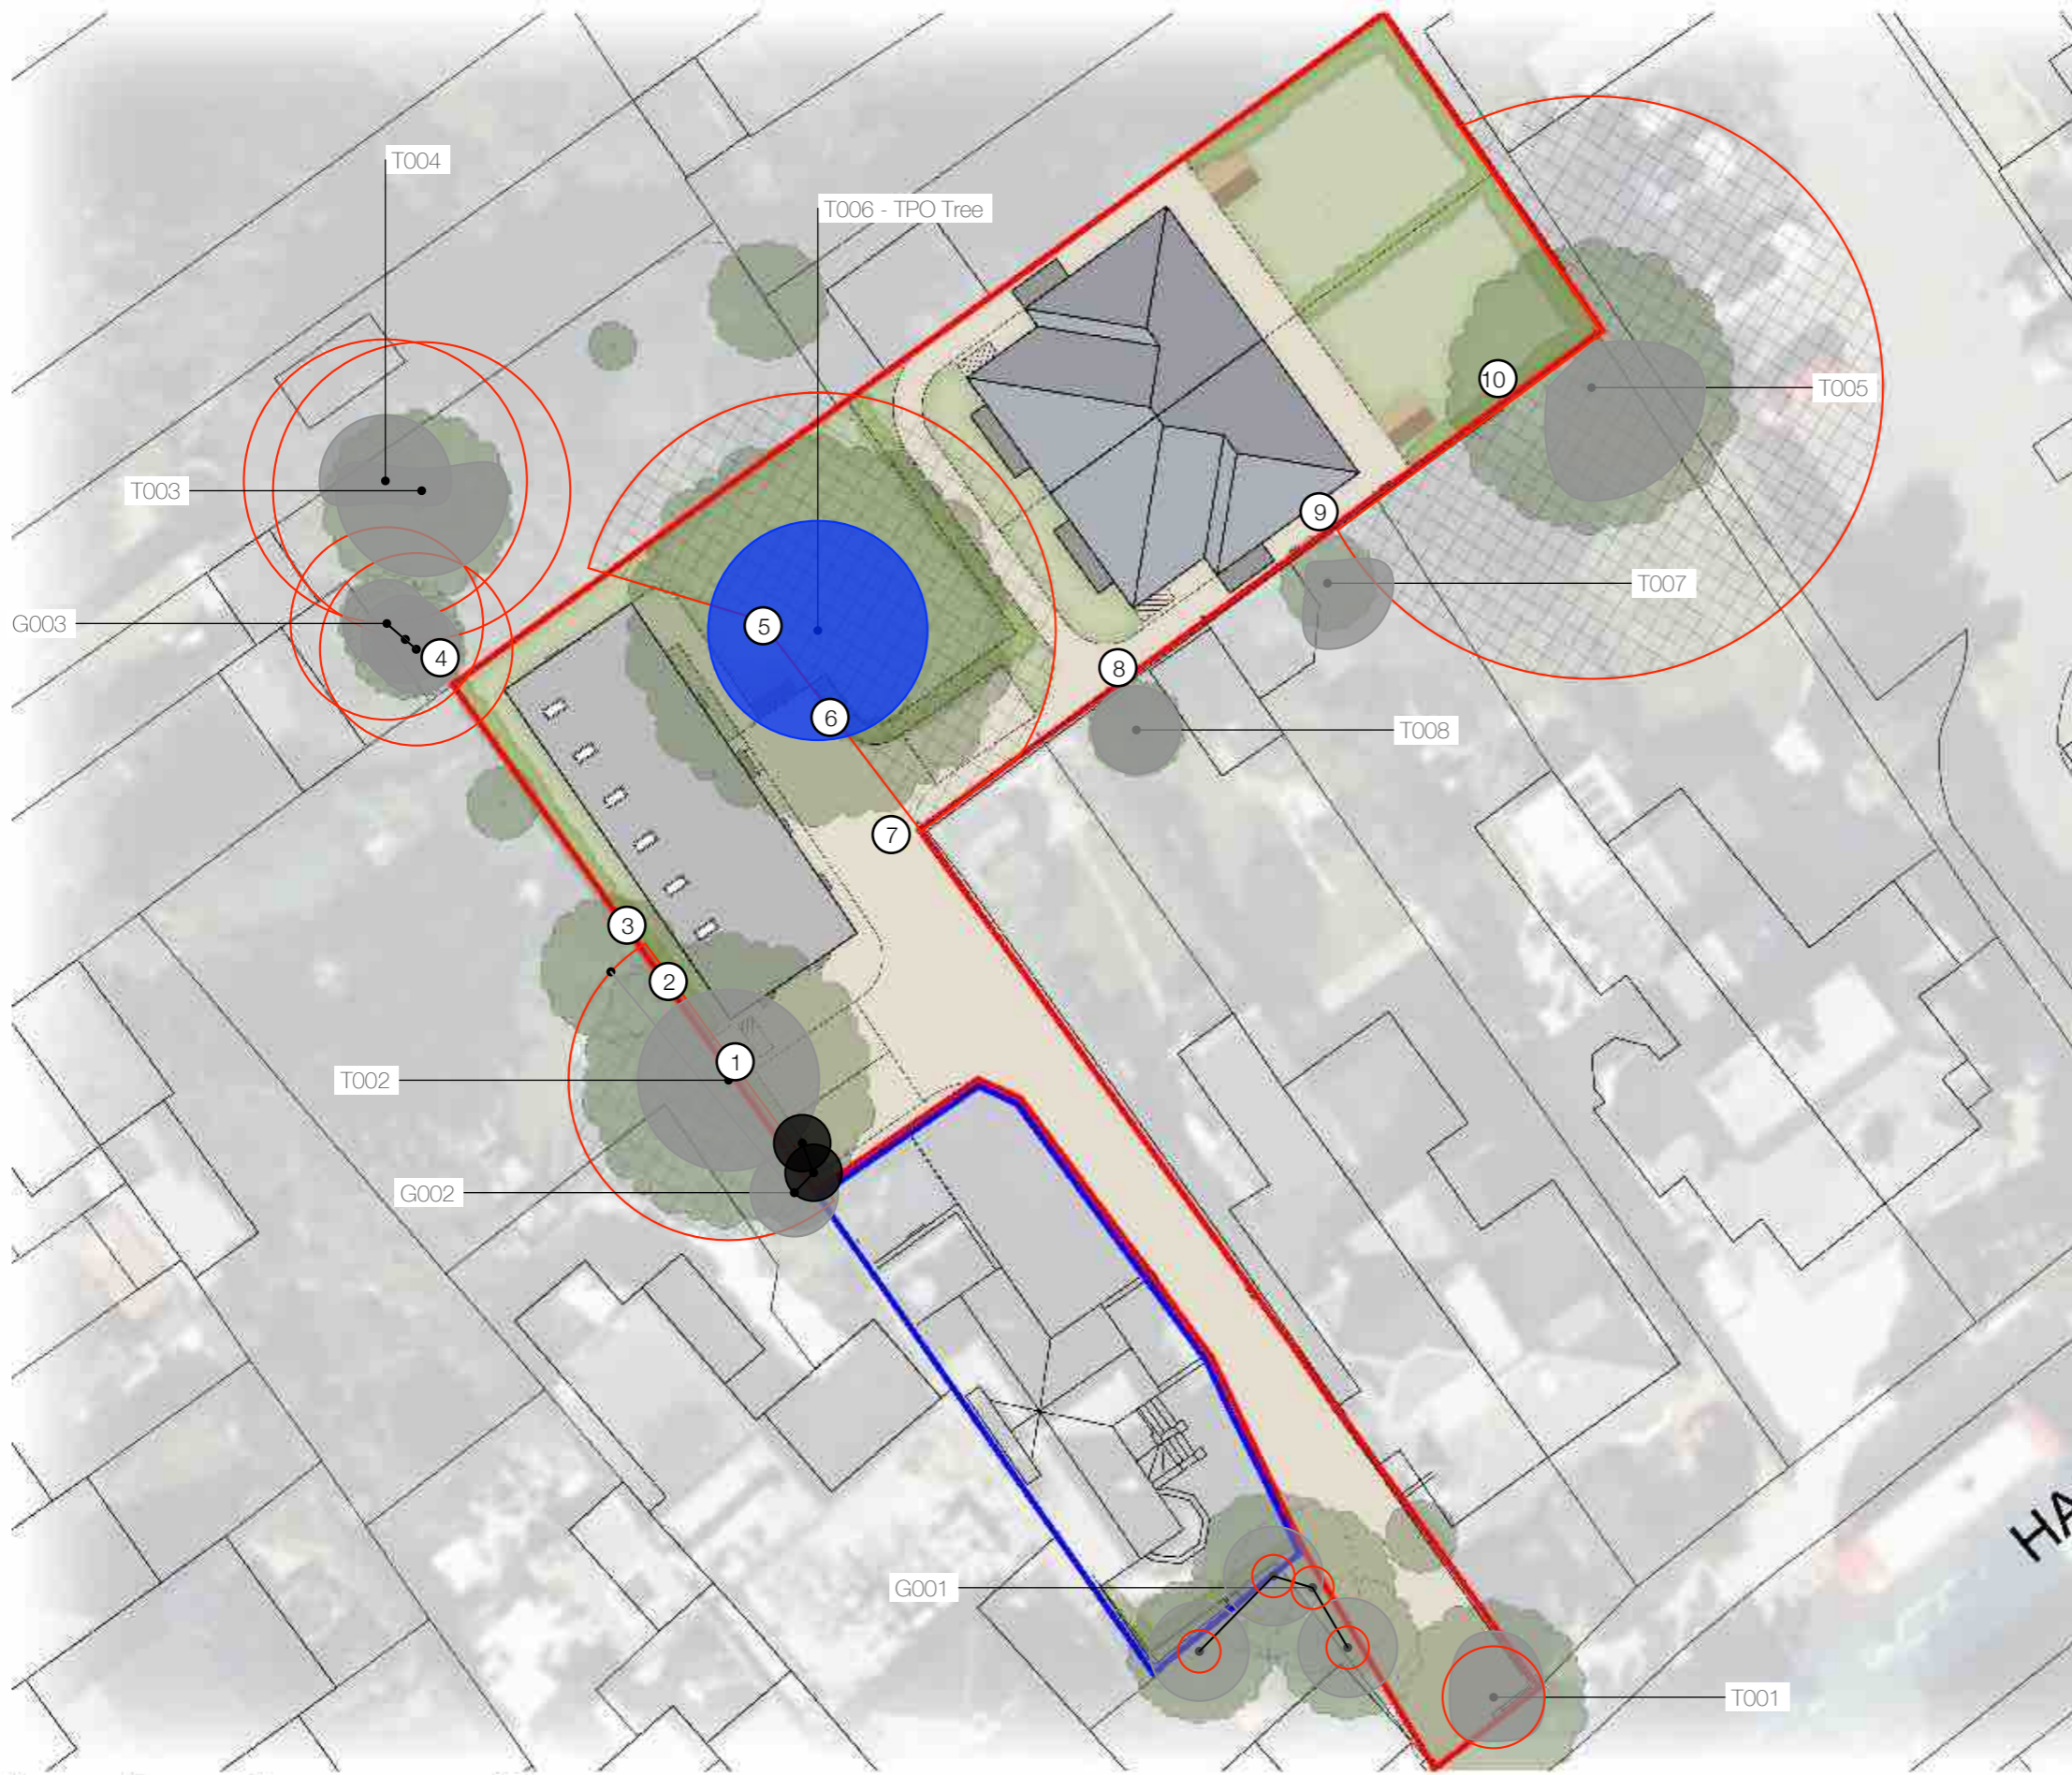
Drawing title
Trial hole plan - Appendix 4

- 1: Inside the site to the east of the boundary wall
- 2: As above
- 3: As above
- 4: Just outside site boundary, underground pipe visible
- 5: West of the wall adjacent to T06
- 6: West of the wall adjacent to T06
- 7: North of the boundary wall and west of wall adjacent T06
- 8: North of boundary wall adjacent to T008
- 9: North of boundary wall adjacent to T007
- 10: North of the boundary wall on the edge of current concrete base
