# Bridges Healthcare (Richmond) Limited

## RICHMOND INN

**50-56 Sheen Road, Richmond,  
TW9 1UG**

Revised Sustainable Drainage Strategy

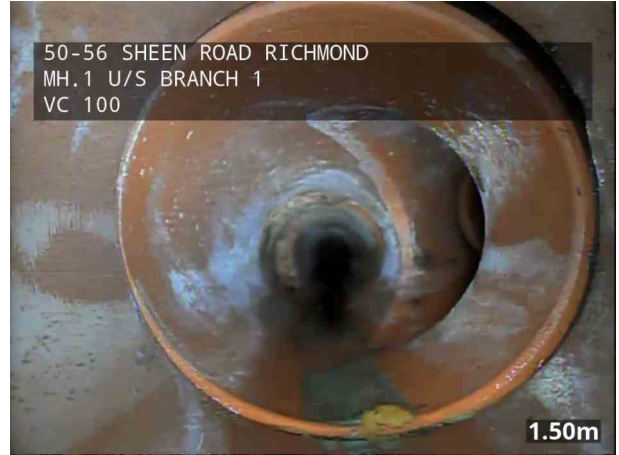
50-56 SHEEN ROAD RICHMOND  
 MH.1 U/S BRANCH 1  
 VC 100  
 1.50m  
 \_50-56 SHEEN ROAD\_RICHMOND\_1\_002.jpg, 00:00:09,  
 1.50 m  
 Joint displaced, medium

**Comments:**  
**Recommendations:** PATCH REPAIR REQUIRED

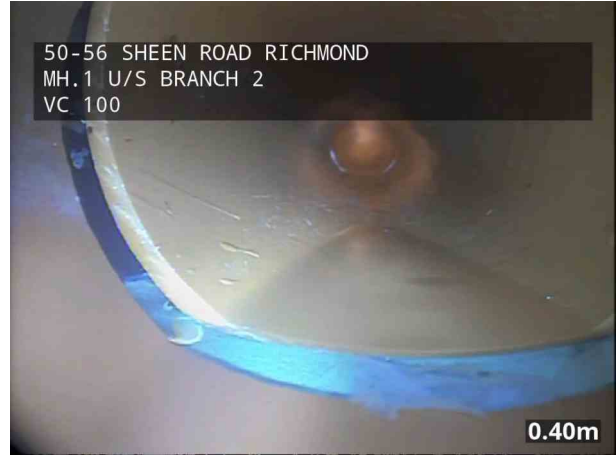
\_50-56 SHEEN ROAD\_RICHMOND\_2\_004.jpg, 00:00:00,  
 0.40 m  
 Joint displaced, medium

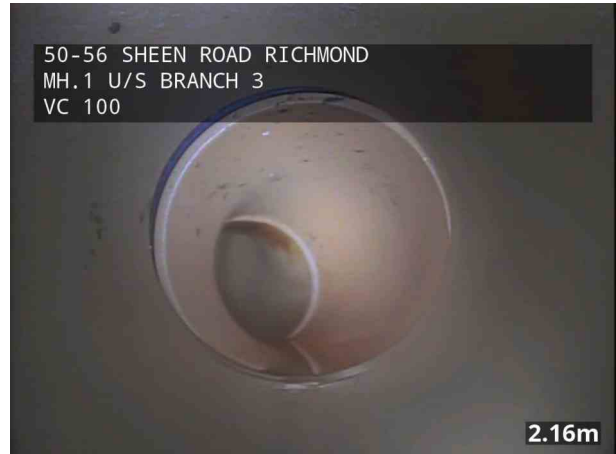
\_50-56 SHEEN ROAD\_RICHMOND\_3\_006.jpg, 00:00:11,  
 2.16 m  
 Joint displaced, medium

**Comments:**  
**Recommendations:** JETTING AND RESURVEY REQUIRED

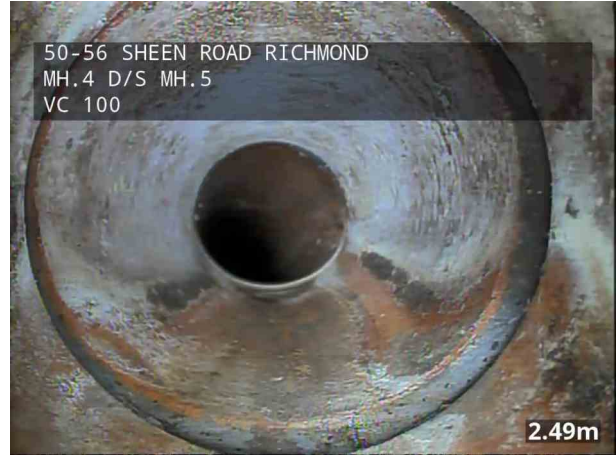
50-56 SHEEN ROAD\_RICHMOND  
 MH.4 D/S MH.5  
 VC 100  
 2.49m  
 \_50-56 SHEEN ROAD\_RICHMOND\_11\_017.jpg, 00:00:11,  
 2.49 m  
 Joint displaced, medium

**Comments:**  
**Recommendations:** REMEDIAL WORKS REQUIRED

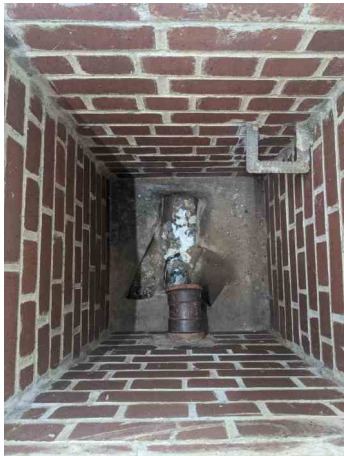
\_50-56 SHEEN ROAD\_RICHMOND\_11\_018.jpg, 00:00:22,  
 4.47 m  
 Finish node, manhole, reference: MH.5, DEBRIS IN

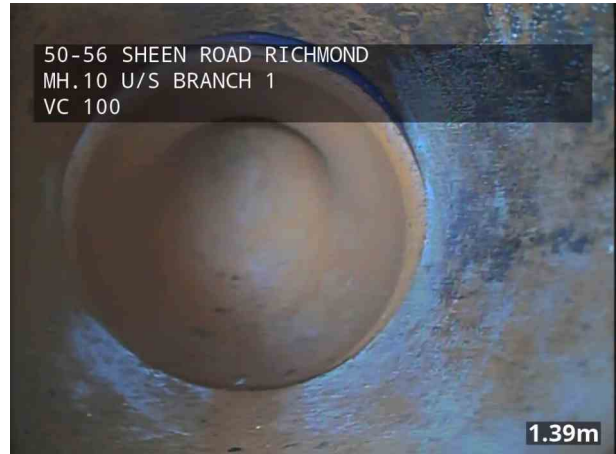
50-56 SHEEN ROAD RICHMOND  
 MH.10 U/S BRANCH 1  
 VC 100  
 1.39m  
 \_50-56 SHEEN ROAD\_RICHMOND\_25\_036.jpg, 00:00:08,  
 1.39 m  
 Joint displaced, medium
