# DESK STUDY / PRELIMINARY RISK ASSESSMENT REPORT

KNELLER HALL, KNELLER ROAD, RICHMOND

Job No: P4134J2485/AB

Date: 09/02/2022

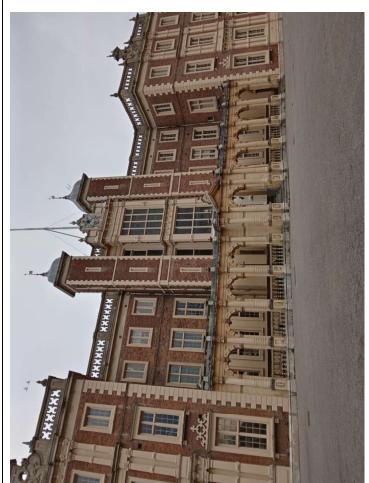
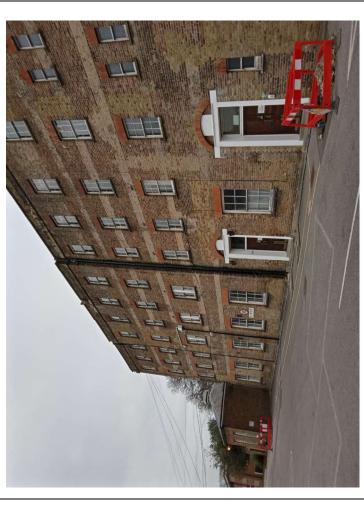
PROJECT NAME	Kneller Hall, 65 Kneller Road, Twickenham TW2 7DN	CLIENT	Radnor House School
TITLE	Photo Plan	FIGURE	3
Photo 1: Overview or	hoto 1: Overview of Kneller Hall from the south.	<b>Photo 2:</b> Western side	Photo 2: Western side of Kneller Hall with flat access into building.

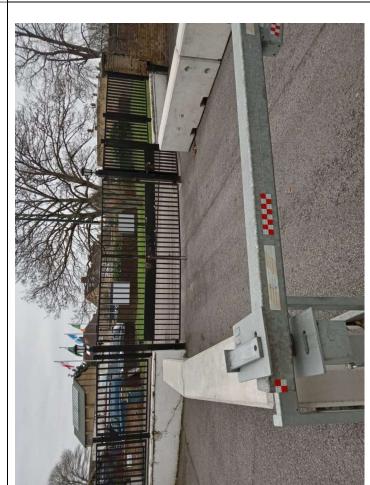
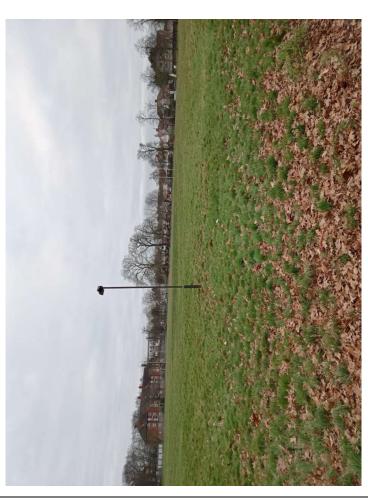
Radnor House School	3	Photo 4: Large sports field on eastern side of site.
CLIENT	FIGURE	<b>Photo 4:</b> Large sports
Kneller Hall, 65 Kneller Road, Twickenham TW2 7DN	Photo Plan	hoto 3: Access onto site from Kneller Road is wide and flat.
PROJECT NAME	TITLE	Photo 3: Access onto

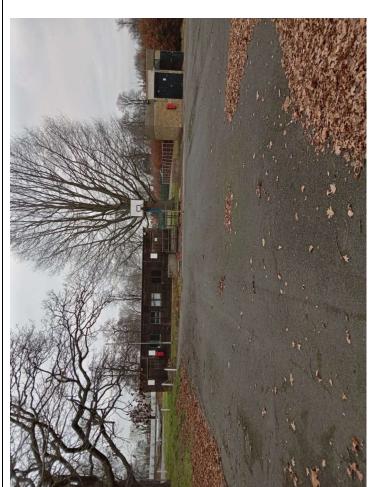
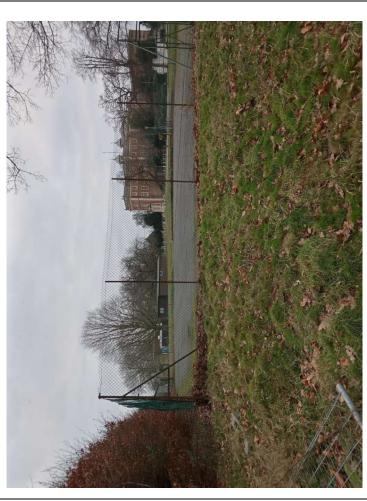
PROJECT NAME	Kneller Hall, 65 Kneller Road, Twickenham TW2 7DN	CLIENT	Radnor House School
TITLE	Photo Plan	FIGURE	3
Photo 5: Basketball	Photo 5: Basketball court and wooden mobile in east of site next to the sports	next to the sports   <b>Photo 6:</b> Asphalt court in north-east of site.	in north-east of site.
field.

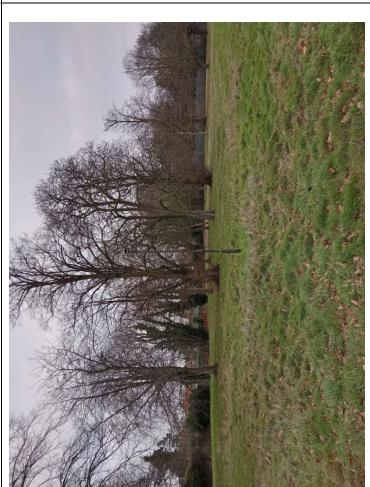
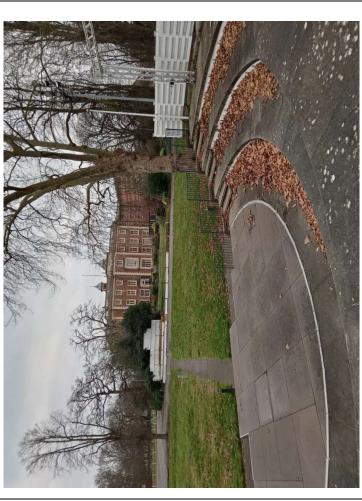
PROJECT NAME	Kneller Hall, 65 Kneller Road, Twickenham TW2 7DN	CLIENT	Radnor House School
TITLE	Photo Plan	FIGURE	3
Photo 7: Wooded ar	hoto 7: Wooded area in far north-east corner of site.	Photo 8: Outdoor theatre.	atre.

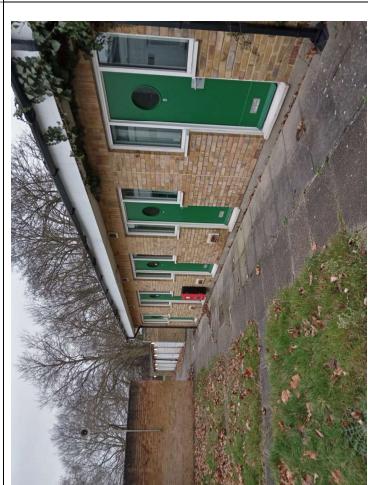
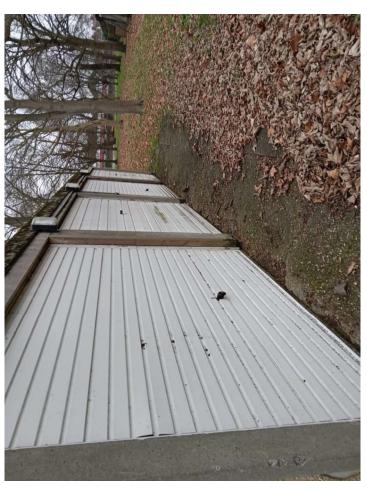
PROJECT NAME	Kneller Hall, 65 Kneller Road, Twickenham TW2 7DN	CLIENT	Radnor House School
TITLE	Photo Plan	FIGURE	3
Photo 9: Single room	Photo 9: Single room units in north of site.	Photo 10: Garages in north of site.	orth of site.

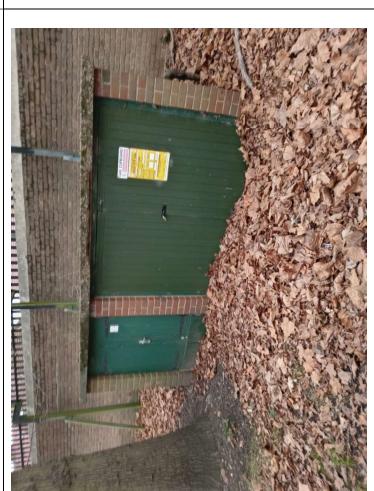
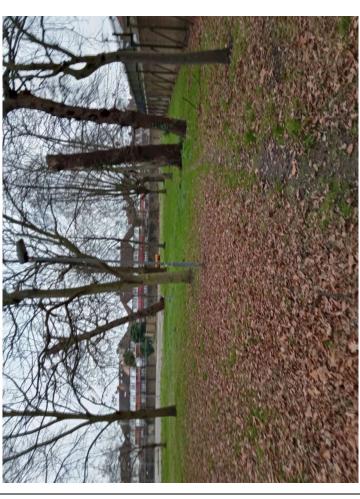
Radnor House School	3	Photo 12: North-west corner of site.
CLIENT	FIGURE	Photo 12: Nor
Kneller Hall, 65 Kneller Road, Twickenham TW2 7DN	Photo Plan	'hoto 11: Gas cupboard along northern site boundary.
PROJECT NAME	TITLE	Photo 11: Gas cupbo

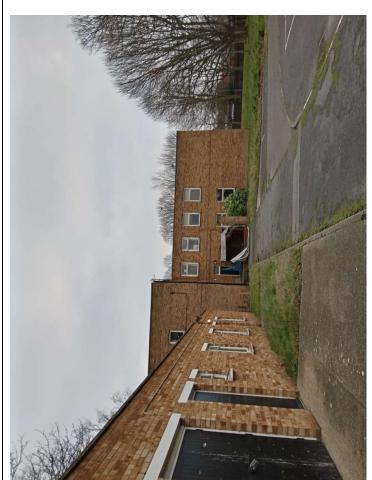
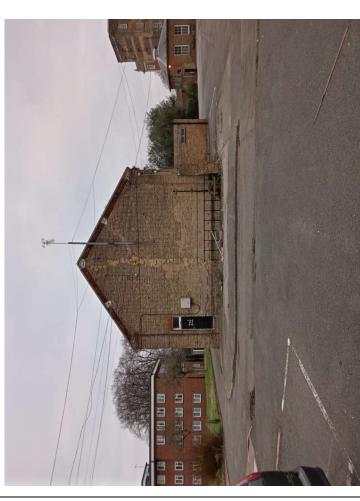
PROJECT NAME	Kneller Hall, 65 Kneller Road, Twickenham TW2 7DN	CLIENT	Radnor House School
TITLE	Photo Plan	FIGURE	3
Photo 13: Buildings	Photo 13: Buildings in the far west of site taken from in the car park looking	<b>Photo 14:</b> Grade II liste	Photo 14: Grade II listed studio building taken from car park looking east.
south.		Stairs lead down to basement plant room.	sement plant room.

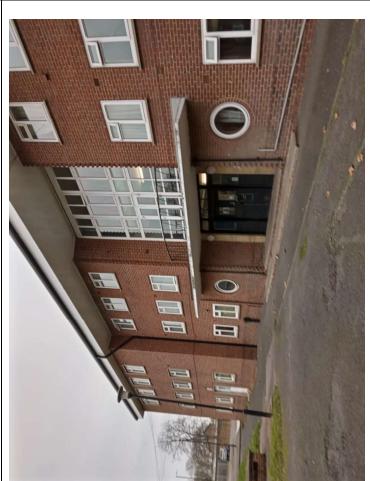
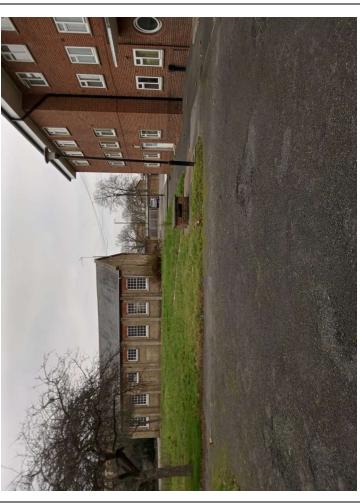
PROJECT NAME	Kneller Hall, 65 Kneller Road, Twickenham TW2 7DN	CLIENT	Radnor House School
TITLE	Photo Plan	FIGURE	3
Photo 15: 3-storey k	hoto 15: 3-storey building on western side of site next to canteen.	Photo 16: Grass courty	Photo 16: Grass courtyard taken from outside canteen looking south.

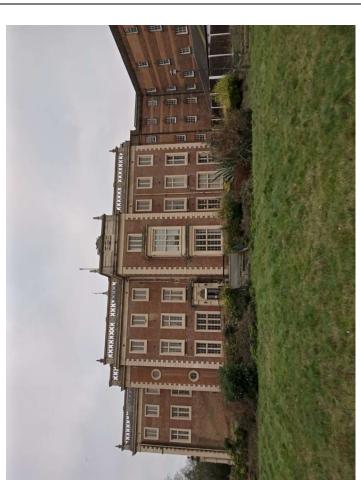
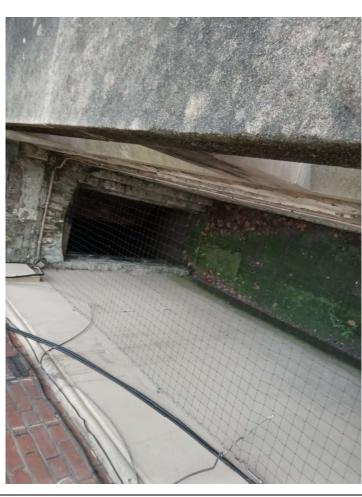
PROJECT NAME	Kneller Hall, 65 Kneller Road, Twickenham TW2 7DN	CLIENT	Radnor House School
TITLE	Photo Plan	FIGURE	3
Photo 17: Grassy are	hoto 17: Grassy area directly to the north of Kneller Hall.	<b>Photo 18:</b> Lower grour	Photo 18: Lower ground floor visible along the north side of Kneller Hall.

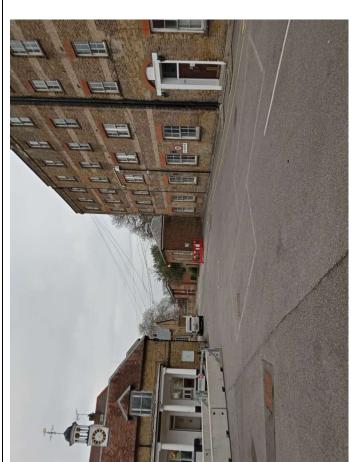
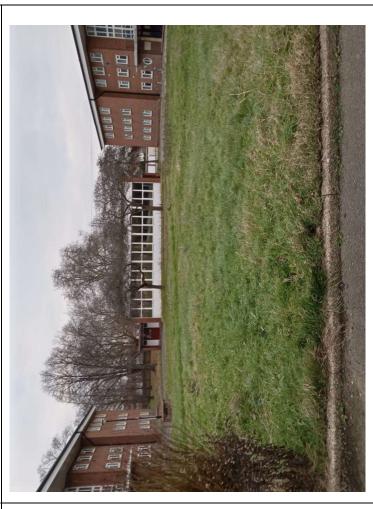
PROJECT NAME	Kneller Hall, 65 Kneller Road, Twickenham TW2 7DN	CLIENT	Radnor House School
TITLE	Photo Plan	FIGURE	3
Photo 19: Grade II li	•hoto 19: Grade II listed security building on left of image.	<b>Photo 20:</b> Canteen viewed looking north.	wed looking north.
