Kneller Hall School

001506-ADP-03-XX-SC-A-1050

Guards House - Room by Room Alterations Schedule

S2-P2

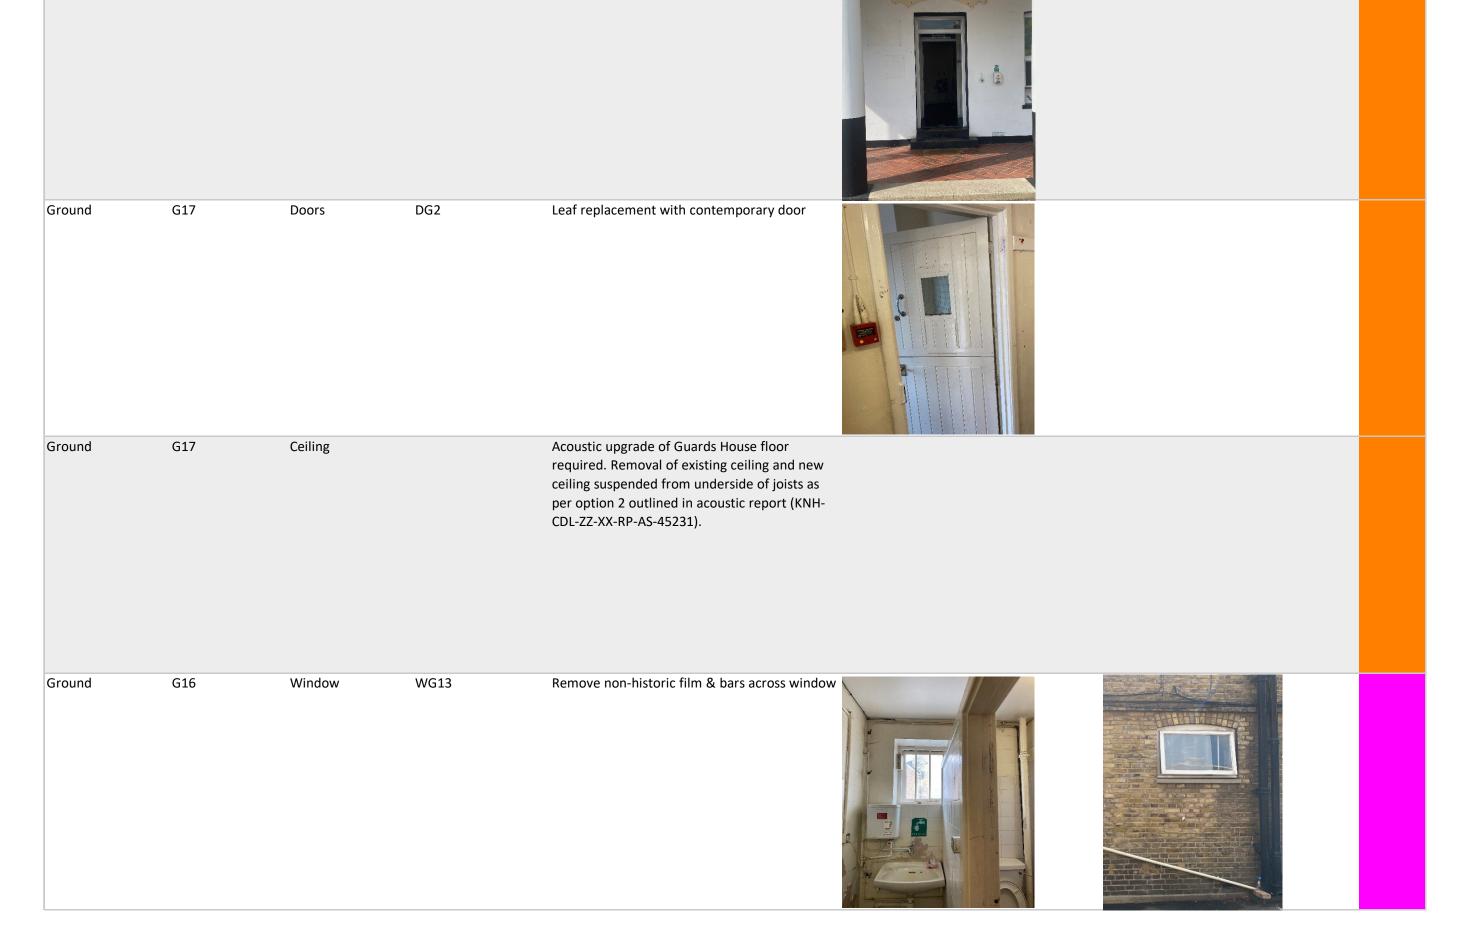
Level	Room No.	Element	Element Ref.	Comment	Picture	Column1
Ground	G18	Window	WG14	Remove non-historic film & bars across window. Remove paintwork and replace broken window pane		
Ground	G18	Window	WG15	Remove non-historic film & replace window pane with hatch in existing opening		
Ground	G18	Misc	MG2	Retain historic safe		
Ground	G18	Ceiling		Acoustic upgrade of Guards House floor required. Removal of existing ceiling and new ceiling suspended from underside of joists as per option 2 outlined in acoustic report (KNH- CDL-ZZ-XX-RP-AS-45231).		
Ground	G17	Doors	DG1	Leaf replacement with contemporary door
