Kneller Hall School

001506-ADP-01-XX-SC-A-1050

Kneller Hall - Room by Room Alterations Schedule

S2-P2

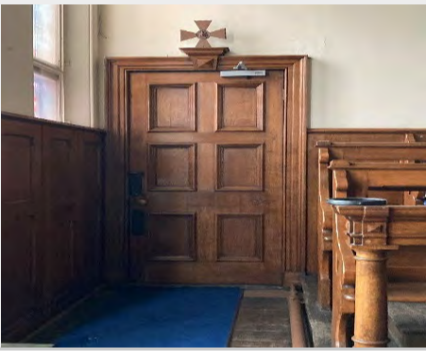
First	Chapel	Skirting	-	No existing or proposed skirting. Pipework to route at low level under seating.

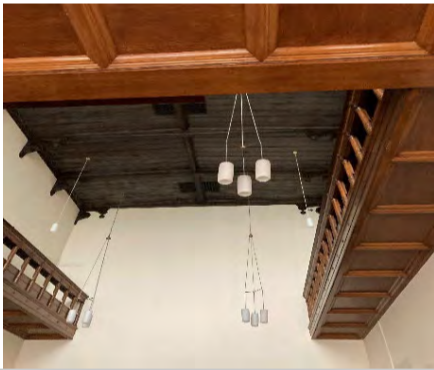
First	Chapel	Ceiling	-	No proposed alterations. Localised repairs where existing modern light fittings are removed if necessary.

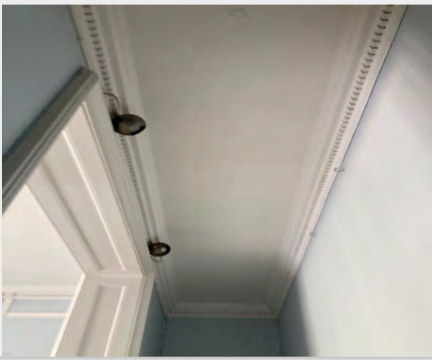
Ground	Circulation - G13	Ceiling	-	Existing ceiling and cornicing to be retained, refurbished with localised repairs where necessary. Proposed opening on south wall will not impact cornicing.

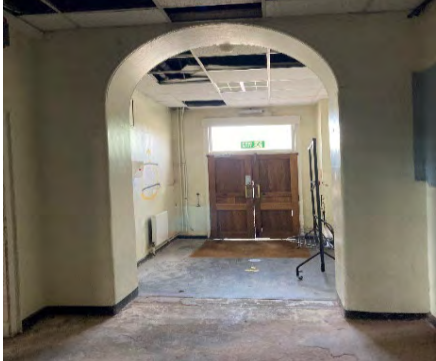
Ground	Circulation - Pupil Entrance	Ceiling	-	Remove existing grid ceiling. Presence of existing cornicing unknown as obscured by existing ceiling, opening up work required. New plasterboard ceiling proposed with opening for lantern in existing position.

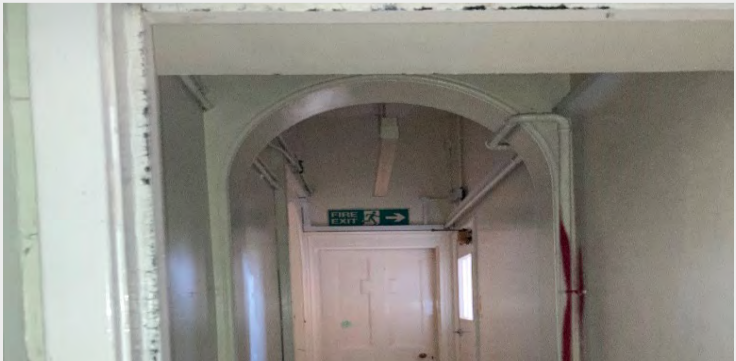
Second	Circulation S09	Ceiling	-	Low ceiling height, existing ceiling to be retained and repaired where required.

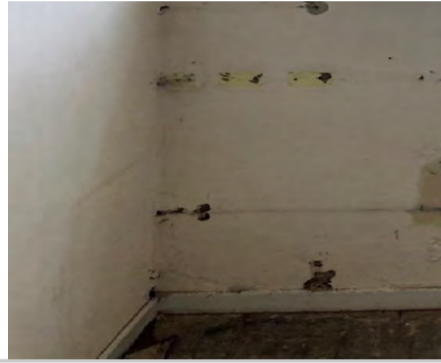
Proposed window to match WF30	
First	F01	Skirting	-	Existing skirting to be sanded down, with localised repairs where needed. All skirting redecorated. Pencil round skirting to match existing on new partition.

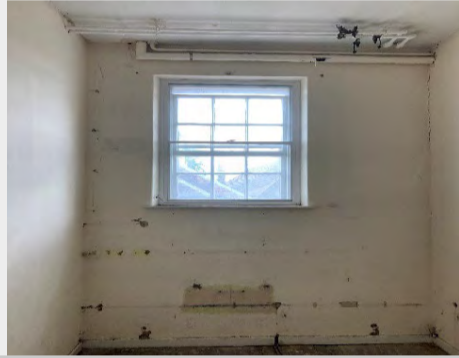
First	F01	Ceiling	-	No cornicing. New plasterboard ceiling proposed to conceal services.

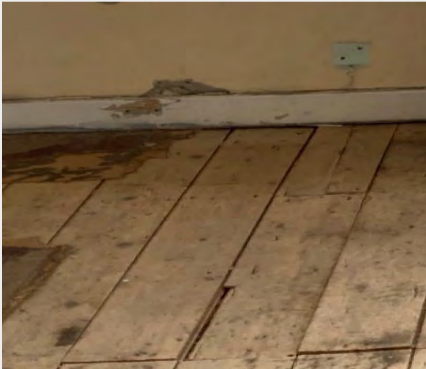
First	F02	Skirting	-	Existing skirting to be sanded down, with localised repairs where needed. All skirting redecorated

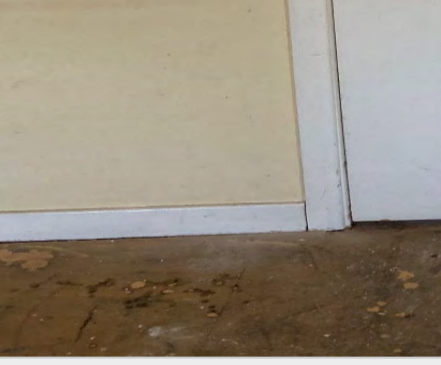
First	F03	Skirting	-	Existing skirting to be sanded down, with localised repairs where needed. All skirting redecorated. Pencil round skirting to match existing on new partition (detail 04).

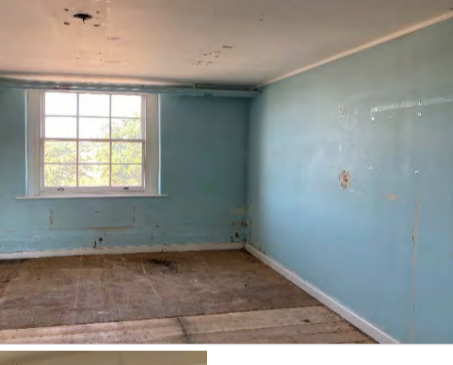
First	F03	Ceiling	-	Low ceiling height, existing ceiling to be retained. Opening up works required to access if services can be routed within the ceiling void. Opening up in localised areas and subsequent repair to existing plasterboard ceiling required.

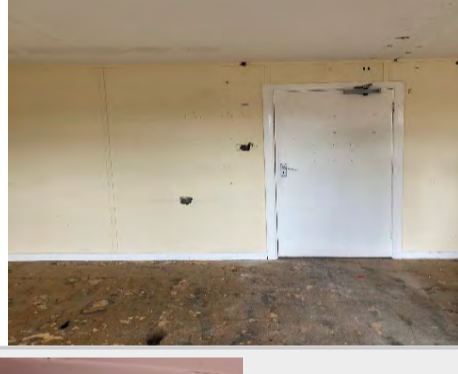
First	F04	Ceiling	-	Low ceiling height, existing ceiling to be retained. Existing boxed out services to be removed. Opening up works required to access if services can be routed within the ceiling void. Opening up in localised areas and subsequent repair to existing plasterboard ceiling required.

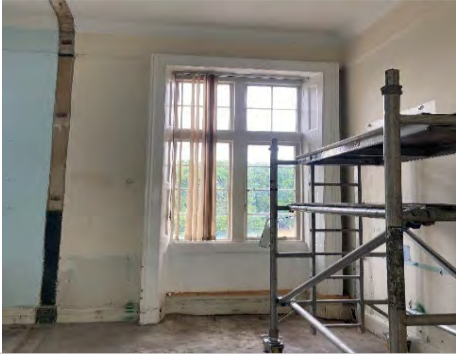
First	F08	Ceiling	-	Repair and make good existing cornicing where partitions have been removed. Locally repair existing plasterboard ceiling.

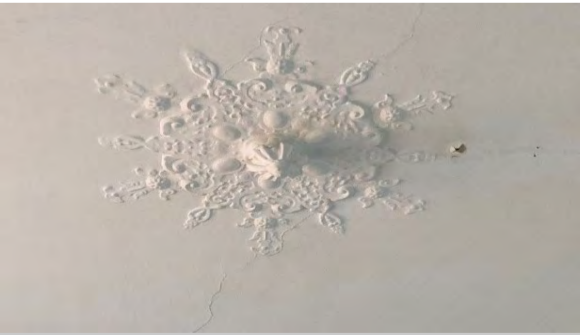
F09	Ceiling Rose	-	Retain and redecorate ceiling rose

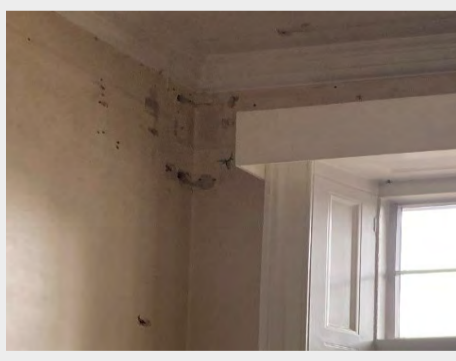
First	F10	Ceiling	-	<p>Existing ceiling and cornicing to be retained, refurbished with localised repairs where necessary. Ceiling rose to be refurbished.</p>

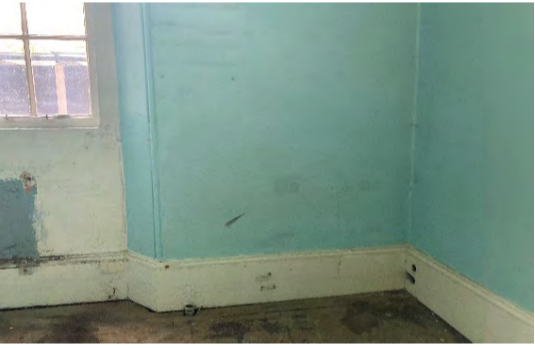
Ground	G10	Ceiling	-	No existing cornicing, new plasterboard ceiling proposed under existing beams. Ceiling level to be clear of existing marbles (see Section XX)	 				
Ground	G11	Skirting	-	Refurbish and locally repair existing historic skirting. Carefully remove non historic skirting on east wall (image 2) and replace with replica historic skirting profile (see A-1401-Level 00 Skirting Plans for location). Boxing on existing and replica skirting as per Detail 03.

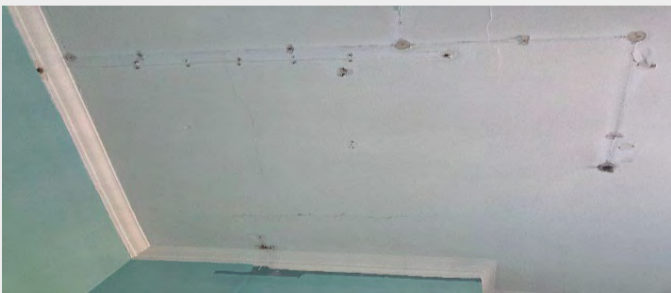
Ground	G11	Ceiling	-	Repair and make good existing cornicing, replicating the existing profile on new partitions. Locally repair existing plasterboard ceiling.

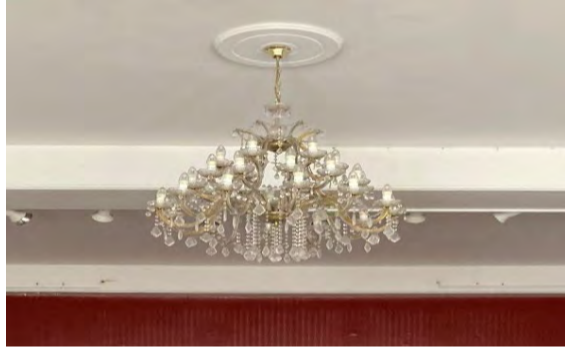
G14	Ceiling Rose	-	Retain and redecorate ceiling rose

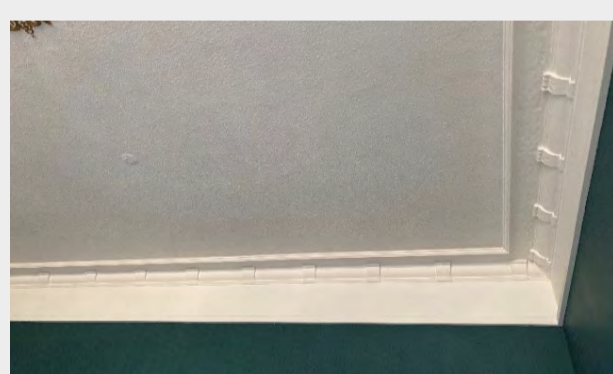
Ground	G15	Ceiling	-	Existing ceiling and cornicing to be retained, refurbished with localised repairs where necessary.

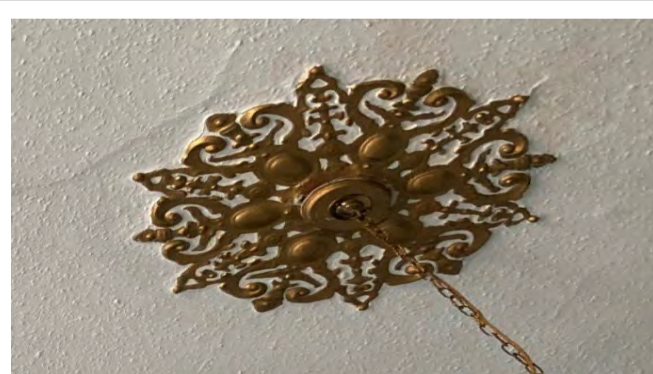
G15		Ceiling Rose	-	Retain and redecorate ceiling rose

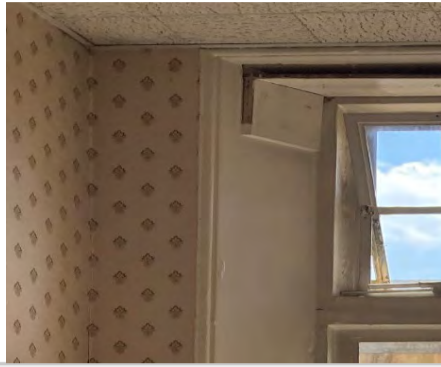
Ground	G16	Ceiling	-	Remove existing grid ceiling. Presence of existing cornicing unknown as obscured by existing ceiling, opening up work required. New plasterboard ceiling proposed.

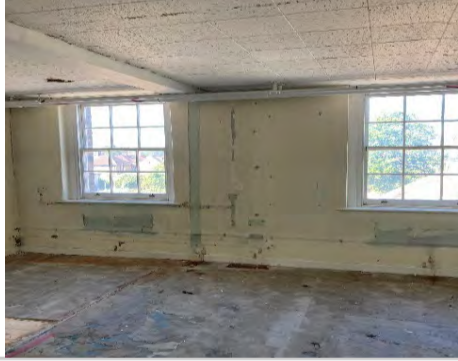
Mezzanine	M02	Ceiling	-	Low ceiling height, polystyrene ceiling tiles to be removed. Opening up works required to access if services can be routed within the ceiling void. Opening up in localised areas and subsequent repair to existing plasterboard ceiling required.

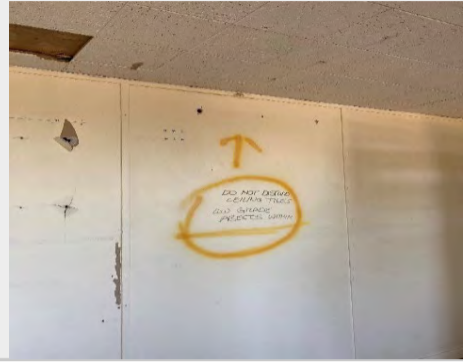
Mezzanine	M04	Ceiling	-	Low ceiling height, polystyrene ceiling tiles to be removed. Opening up works required to access if services can be routed within the ceiling void. Opening up in localised areas and subsequent repair to existing plasterboard ceiling required.

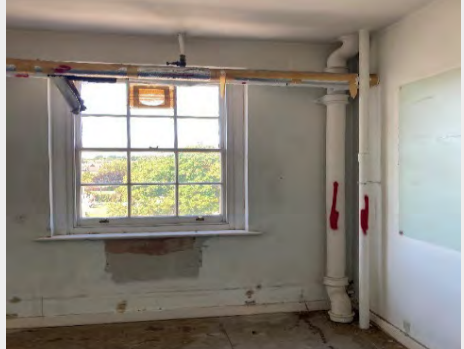
Mezzanine	M05	Ceiling	-	Low ceiling height, existing ceiling to be retained. Opening up works required to access if services can be routed within the ceiling void. Opening up in localised areas and subsequent repair to existing plasterboard ceiling required.

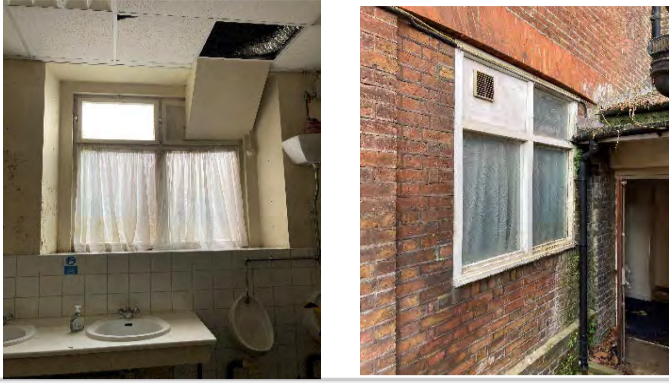
Ground	Main Stair	Window	WG21	Obscured from view by the proposed integrated plumbing system panels of G05. Remove the vent and reglaze top pane.

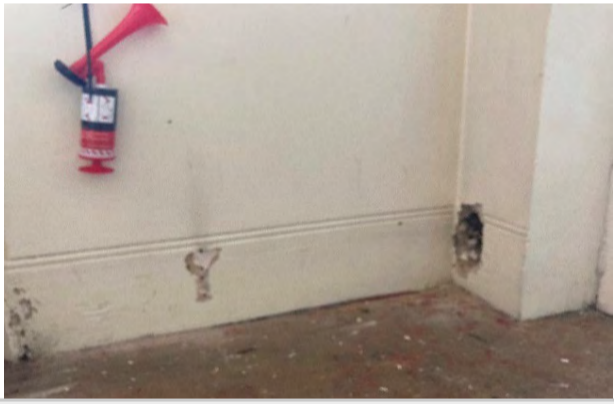
Ground	North Stair	Skirting	-	Localised repairs and refurbishment to existing skirting

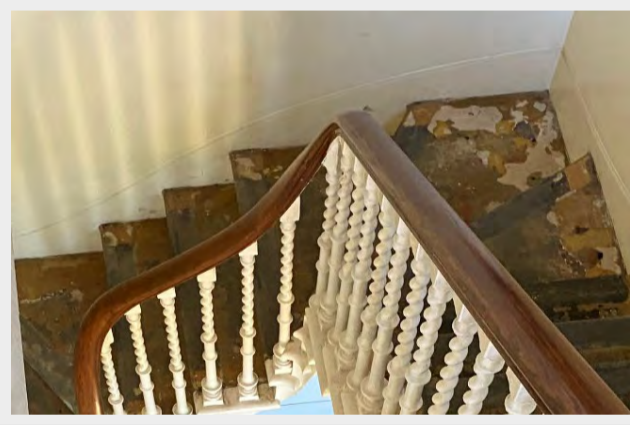
First	North Stair	Skirting	-	Localised repairs and refurbishment to existing skirting.

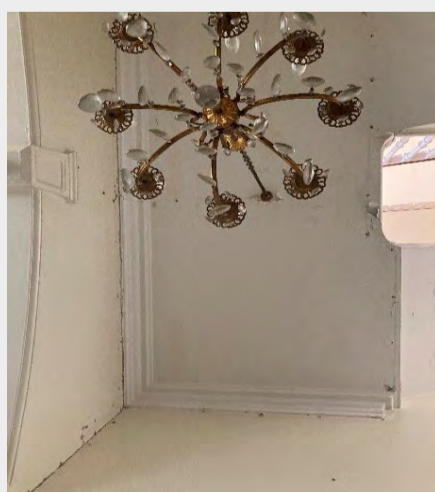
All levels	North Stair	Ceiling	-	Existing ceiling and cornicing to be retained, on all levels, refurbished with localised repairs where necessary.

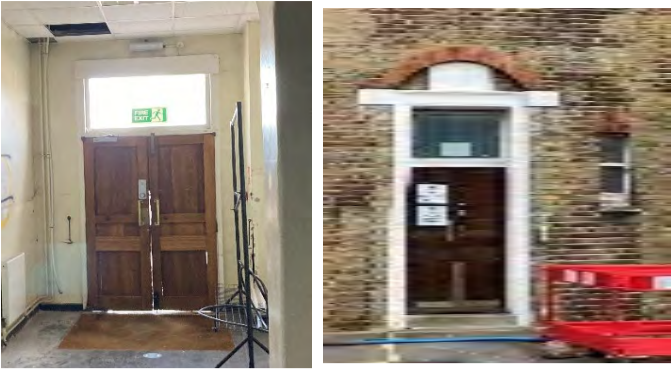
Ground	North Stair - Circulation	Ceiling	-	Existing ceiling and cornicing to be retained. Opening up in localised areas and subsequent repair to existing plasterboard ceiling required for MEP servicing.

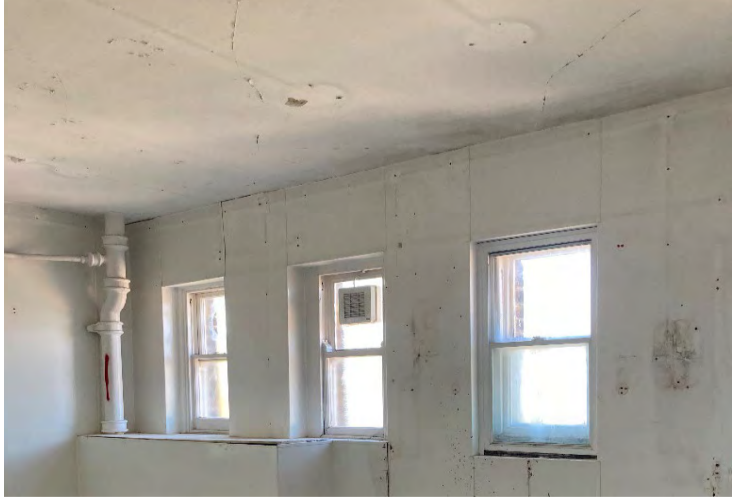
Second	S04	Ceiling	-	<p>Remove existing ceiling in poor condition. Replace with new plasterboard ceiling.</p>

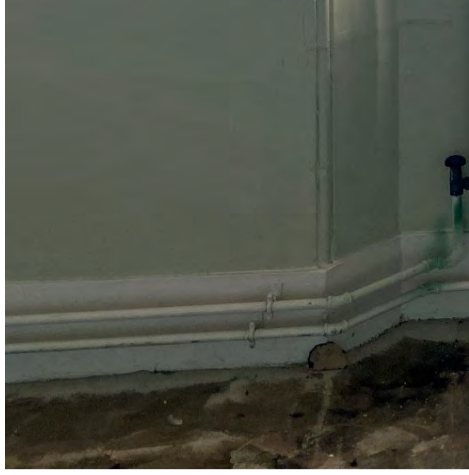
Second	S11	Skirting	-	<p>Skirting to be refurbished, sanded down, local repairs where necessary and redecorated. Boxed out skirting as per detail 03 for low level pipework. See 001506-ADP-01-02-DR-A-1404-LEVEL 02 - SKIRTING PLANS for locations.</p>

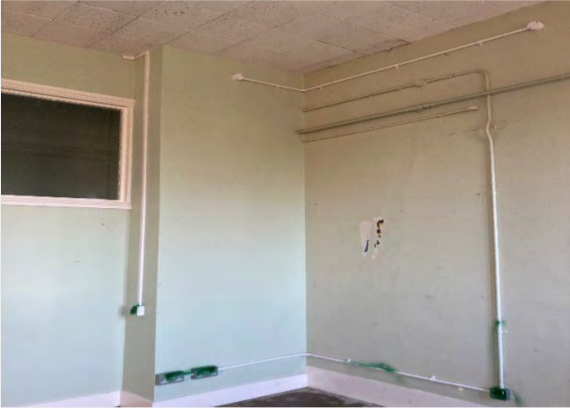
Second	S11	Ceiling	-	<p>Remove existing grid ceiling, condition above unknown as to whether there is an additional ceiling or exposed to the roof void. New plasterboard ceiling proposed.</p>

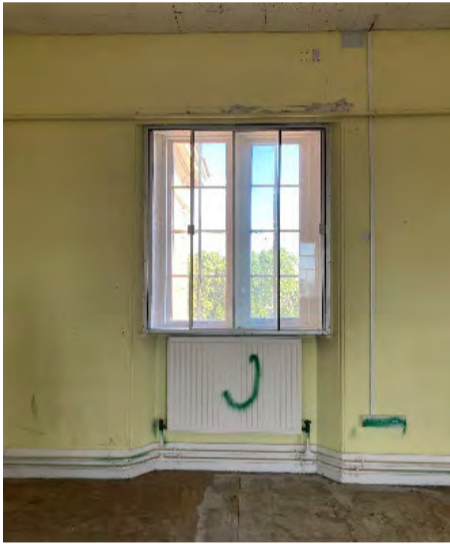
Second	S12	Window	WS46	<p>Refurbish, remove secondary glazing , textured plaster finish and window film. Window currently stuck and requires replacement 6 pane bottom sash to match existing. Carry out strengthening of all tenon joints. Ease, adjust, lubricate or renew pulley wheels where necessary. Renew sash cords throughout with waxed sash cord. Renew staff & parting beads and align mid rails. Install draught proofing.</p>

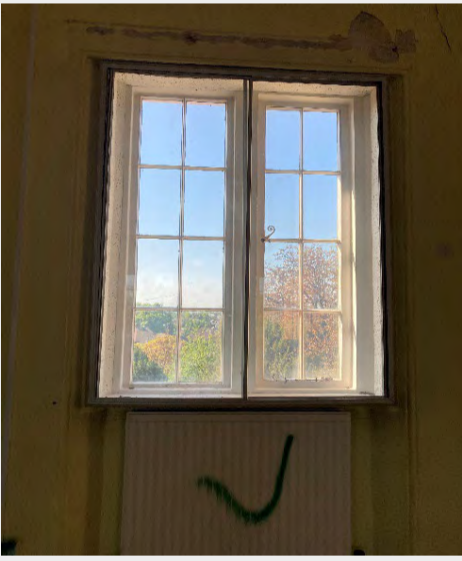
Second	S12	Window	WS47	<p>Refurbish, remove secondary glazing , textured plaster finish and window film. Metal frames will be checked for sitting water. Any weep holes along the base will be checked for blockages and cleared. Any light rust will be removed by hand with a wire brush or sandpaper and frames sanded prior to decoration. More severely corroded metal windows will be cleaned of loose material. Ironmongery will be both maintained and preserved where possible and re-used; it will be gently cleaned with soft cloths or brass brushes. Abrasive creams or solvents will not be used. Moving components of window furniture will be treated with a thin oil to keep on iron and steel window moving components to keep free. Glazing will be carefully cleaned and reinstated and replacement putty installed where needed. A zinc based paint will be used as a primer to provide a protective layer to bare metal prior to painting with a suitable system.</p>

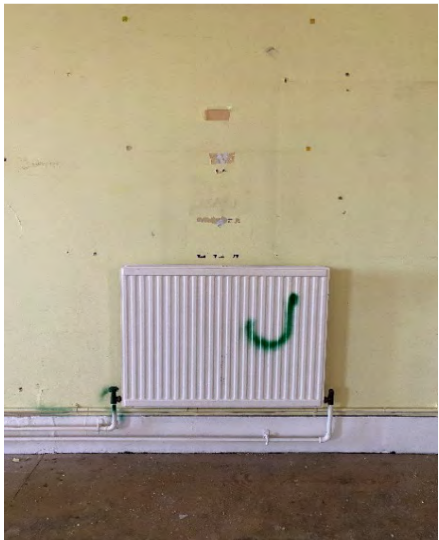
Second	S12	Skirting	-	Skirting to be refurbished, sanded down, local repairs where necessary and redecorated.

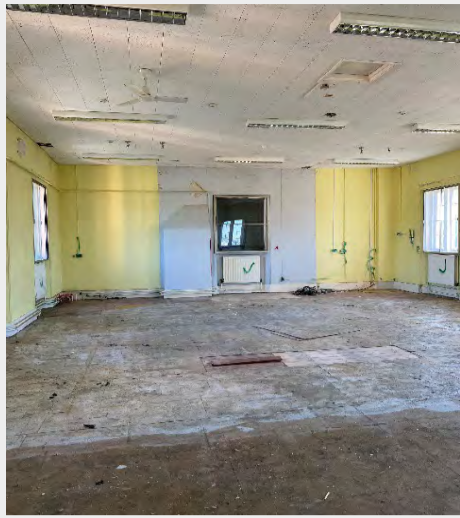
Second	S12	Ceiling	-	Remove existing grid ceiling, condition above unknown if there is an additional ceiling or exposed to the roof void. New plasterboard ceiling proposed.

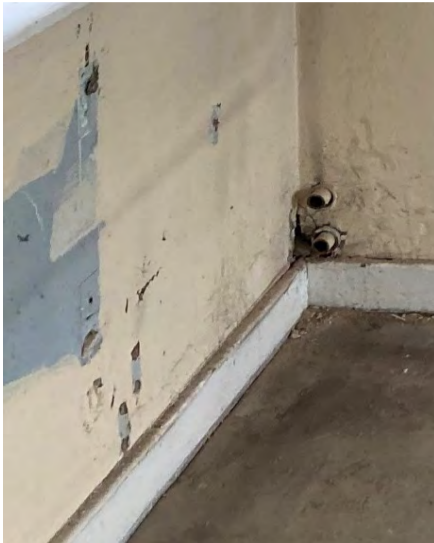
First	West Wing Circulation	Skirting	-	Skirting to be refurbished, sanded down, local repairs where necessary and redecorated.
