# Arboricultural Impact Assessment

St Margaret's Business Centre 3<sup>rd</sup> November 2022

Report No:	Date	Revision	Author	Checked	
13340_R02e	3 <sup>rd</sup> November 2022	Е	Jamie Pratt, BSc (Hons) MArborA	Jack Jewell, BA (Hons), MLA, CMLI

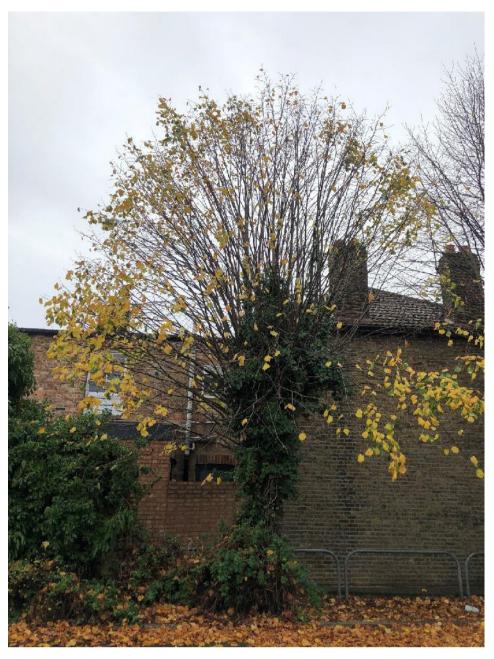
Tree T1 (lime): Heavily pollarded. New growth forming contained canopy.

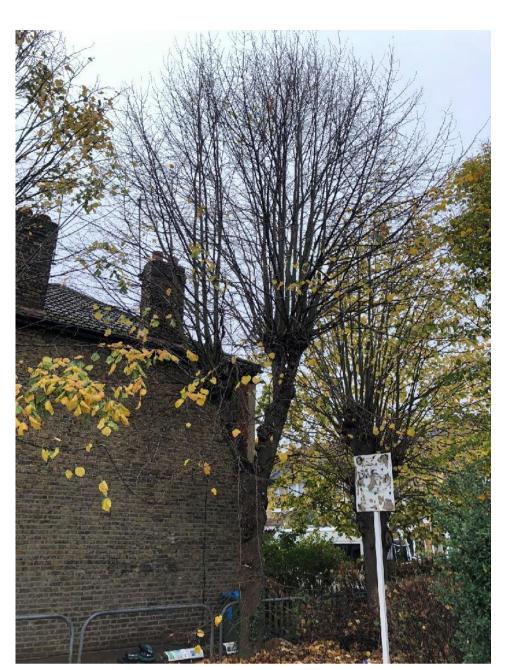
**Tree T2 (lime):** Heavily pollarded. New growth forming contained canopy.

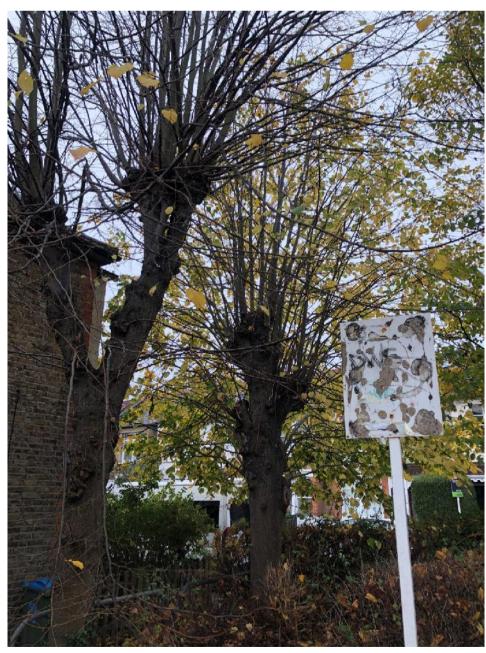
Tree T3 (lime): Heavily pollarded. New growth forming contained canopy.

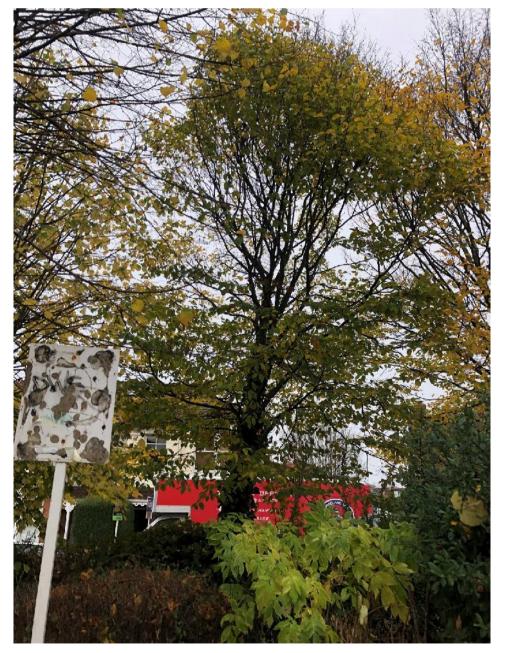
Tree T4 (hornbeam): Slightly mutually suppressed by adjacent trees.

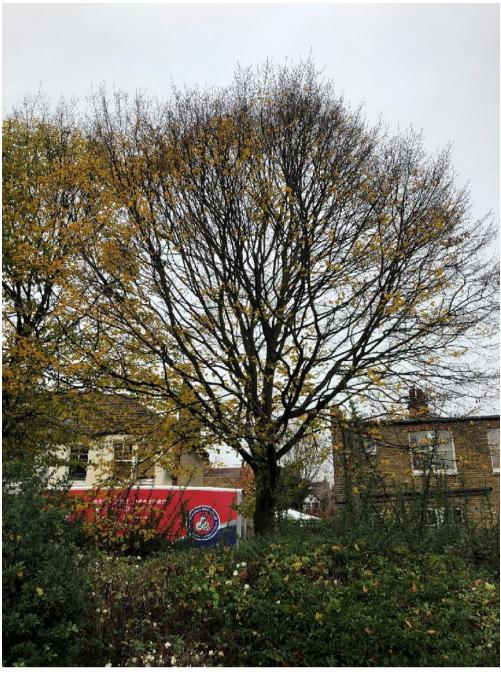
**Tree T5 (Hornbeam):** Selective minor crown lifting works observed.

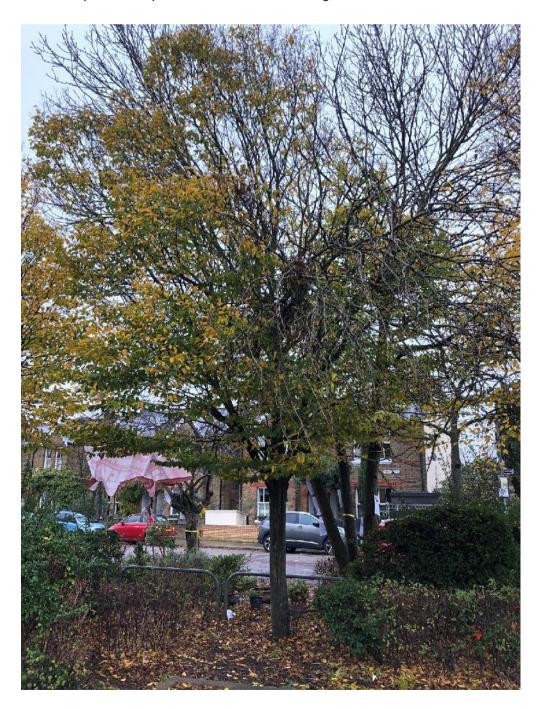
- 2.10 Tree T8 is a semi mature hornbeam located within the raised planter. Its canopy and crown is slightly suppressed from the adjacent dominant ash and has been damaged by a fallen branch of the ash. There is a large degree of bark loss in the stem and within the crown with exposed / decayed heartwood. The cause of the damage is unknown however it appears to be squirrel or fire damage. The extent and severity of the damage reduces its quality and life expectancy.

**Tree T8 (hornbeam):** Minor crown lifting works and slightly suppressed / damaged crown from dominant ash / fallen branch. Note major squirrel damage in stem reducing life expectancy.

Proposed works	Description
Retain / Remove	Remove due to proximity to the proposed building and to provide openness within the front garden space. The tree has severe bark damage in the stem from squirrel damage, so its retention is not considered appropriate in the proposed context.
Compensation Response	A replacement tree in this location is not proposed due to the limited space available. The larger adjacent ash tree is being retained to maintain tree presence in this location. Replacement tree planting will be provided on-site in line with item 3 of local policy LP 16. Five new trees will be planted, including two cherries and three Silver birch 'fastigiata', two of which will be located in the front gardens to reinstate canopy cover to the street scene of Winchester Road. The Silver birch trees will be planted at an extra heavy standard nursery size stock to provide instant impact.
Tree canopy works	Not required.

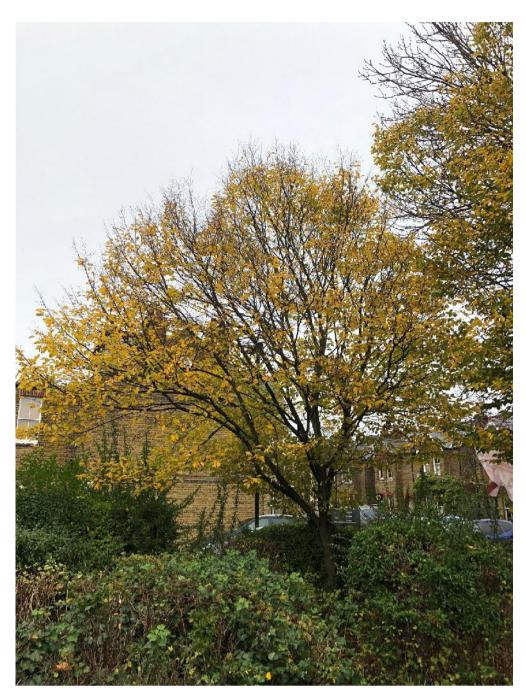
Tree T6 (Hornbeam): Selective minor crown lifting works observed.

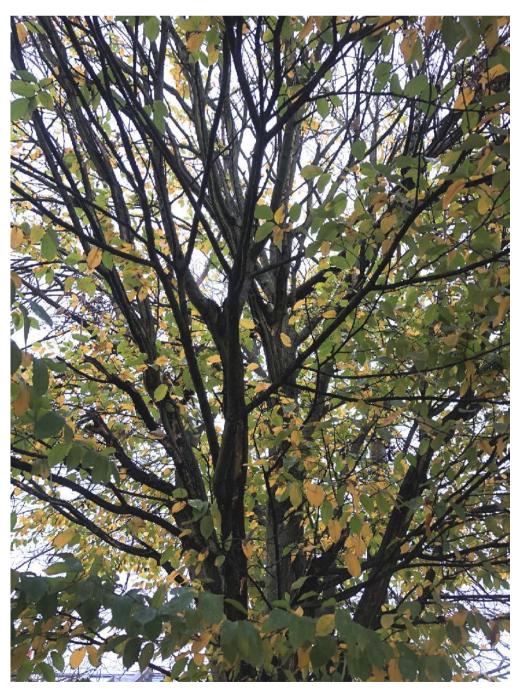
$\textbf{Tree T8 (hornbeam):} \ \textbf{close-up of extensive squirrel damaged in crown.}$

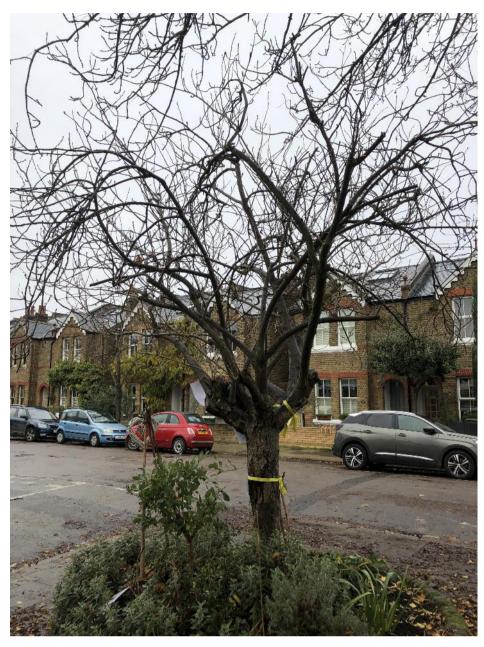
- 2.9 Tree T7 is a mature cherry tree located within a purpose-built planter in the pavement. Significant decay is present at the base / lower stem of the tree with further bark delamination up the stem. This is symptomatic of bacterial canker. The tree has been poorly pruned and there is low vitality in its canopy. The tree has a very limited functional life expectancy of less than 10 years.

**Tree T7 (cherry):** poorly pruned, particularly low vitality in crown / canopy with dieback.

Proposed works	Description
Retain / Remove	Removal due to poor condition. The tree does not require removal to facilitate the development. Replacement planting as part of the new development is considered to most beneficial option in order to reinstate heathy canopy cover.
Compensation Response	A new feature sweet gum tree will be planting in the same location. This will provide a visually appealing tree at this focal point of the street scene.
Tree canopy works	Not applicable.
Works within rooting areas	Not required.
Long-term management implications	Not applicable.
Overall impact	Negligible – as a Category U tree, its early loss is expected. There will be a short-term reduction of canopy cover experienced however this will be reinstated and improved in the longer term via the new planting.

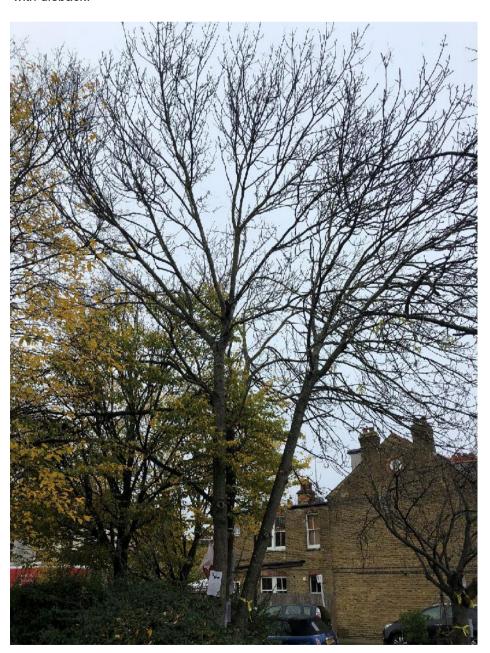
- 2.11 Tree T9 is a semi-mature ash tree located within the raised planter. It has 3 co-dominant stems forming from its base. It has been heavily crown lifted over the adjacent pavement and potentially as an effort to reduce dominance over adjacent trees. The canopy also shows reduced vitality, being sparse and showing above average dieback for its age. It does not represent a good example of the species and is likely to decline over the coming years as opposed to prospering. The canopy condition is symptomatic of ash dieback.

Tree T9 (ash): Heavily crown lifted over pavement. Minor dieback in canopy.

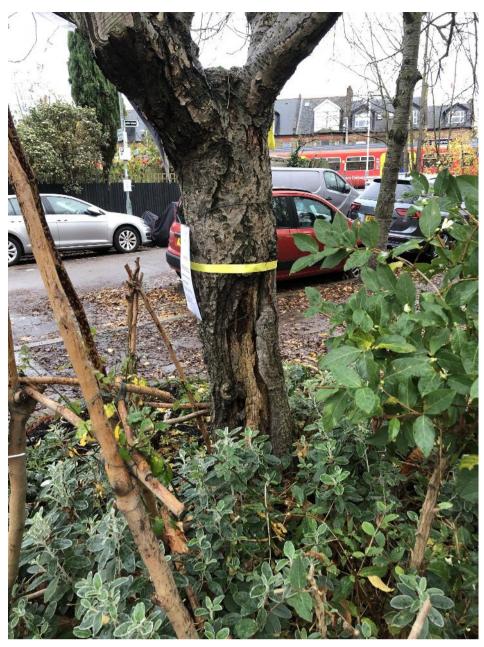
Tree T7 (cherry): Major decay at base of stem. Symptomatic of bacterial can-

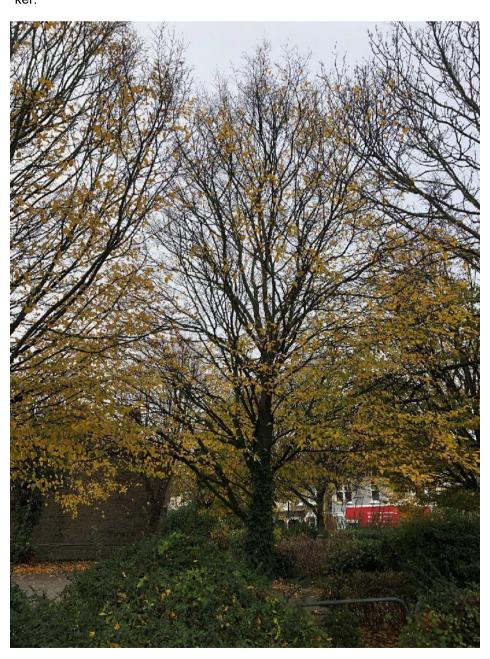
- 2.12 Trees T10 and T11 are early mature hornbeam located within the raised planter at the western boundary. The crown of T10 is slightly suppressed by the adjacent trees with evidence of minor crown lifting works and some exposed heartwood from previous fire damage. Tree T11 is of a slightly larger scale, forming a broader canopy spread. The crown of tree T11 has been lifted over the pavement to the east.

**Tree 10 (hornbeam):** Slightly suppressed with minor crown lifting works observed.

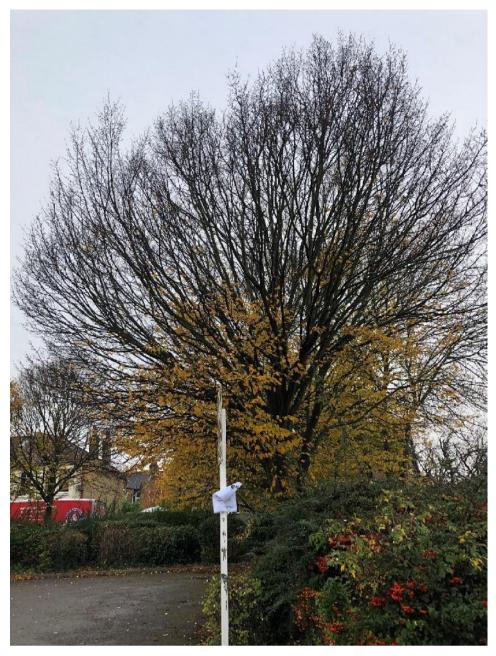
Tree T11 (hornbeam) crown lifted over pavement.

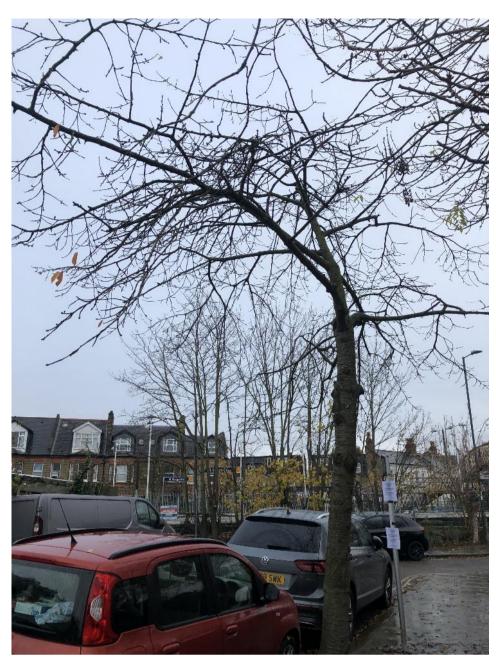
Tree T12 (cherry) off-site street tree with poor form.

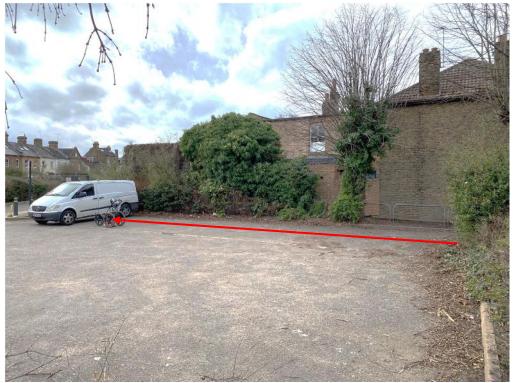
Photo 2. Survey area for 0001.0001-0007. Arrow shows location of 0001.0005.

- 4.1.1.Results: Along the western edge of the survey area, roots are initially found in moderate rooting densities, with the density rapidly dropping to low by 0001.0003 and very low by line 0001.0005 (4.5m from the kerb). Densities remain very low across the car park, starting to slowly rise in line 0001.0012, but remaining low out to 0001.0015, only rising to moderate/low in line 0001.0016. The distribution of tree roots along the length of the scan lines is very uneven, with the majority of the tree roots found in the first 5m from the northern kerb edge. Root density drops dramatically along the length of the lines, with the exception of along the 0001.0001-0002 lines which show a slower decline, and even along the 0001.0015-0016 which have trees growing in the shrub beds immediately to their east.
