**Sand Arena Extension - Ham Polo Club,
Richmond**
Arboricultural Assessment

Client: Ham Polo Club Ltd

18th January 2023 – Issue 3

Ref: GL1457

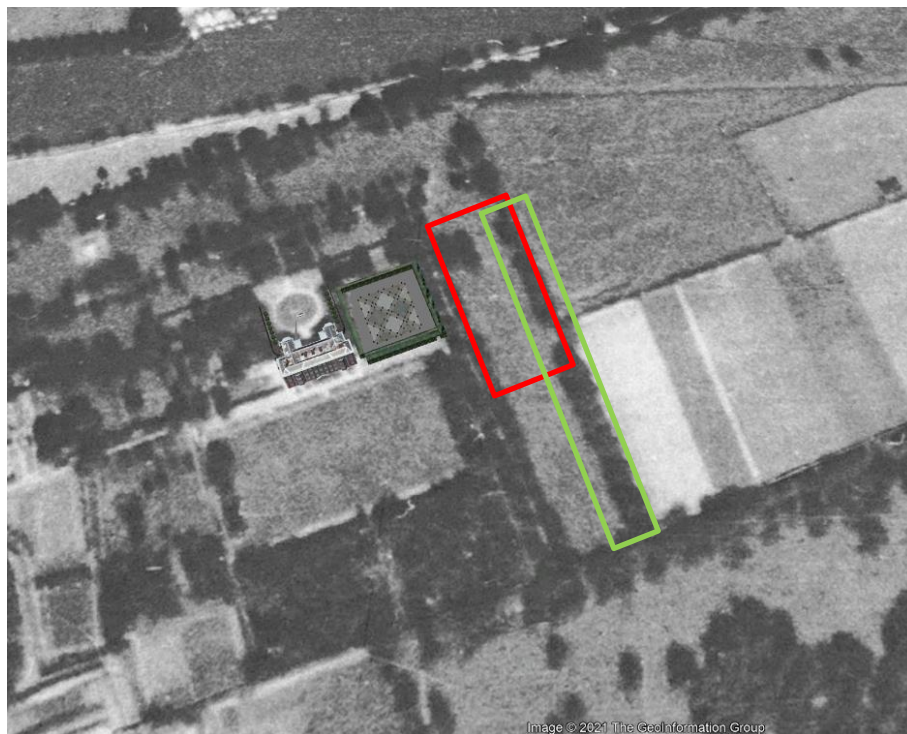
Image 4: Taken from Google Earth, 1945 aerial photography of London. The image illustrates Ham House and the surrounding area. The Ham Polo Club is undeveloped fields. The River Thames is visible to the north. The approximate extent of the site is outlined red and the tree cover referred to outlined green.

- 4.18 The proposal provides a significant opportunity to secure the replanting of part of this arboricultural feature. This planting would contribute to restoring tree cover that once formed part of the historic setting of Ham House. Appropriate species selection could be used to ensure the planting is consistent with the composition of trees present in the Registered Park & Garden. For instance, the planting of lime (*Tilia* sp.) as present along the western site boundary.
- 4.19 Such benefits could not otherwise be secured without the delivery of the development and would, in turn, assist in assimilating the sand arena into its immediate setting.
