Planning Statement

For the installation of an external lift and refurbishment works at:

Blocks M and L
St Mary's University
Waldegrave Road
Strawberry Hill
Twickenham
TW1 4SX

Fire Risk Assessment

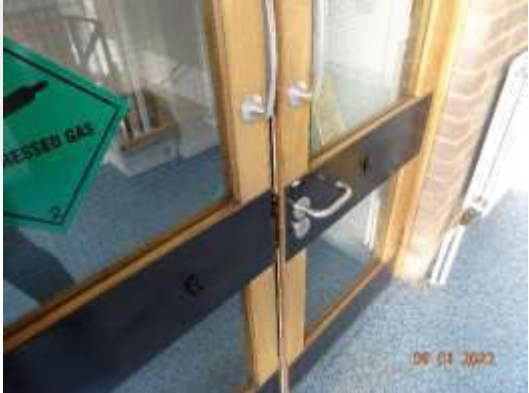
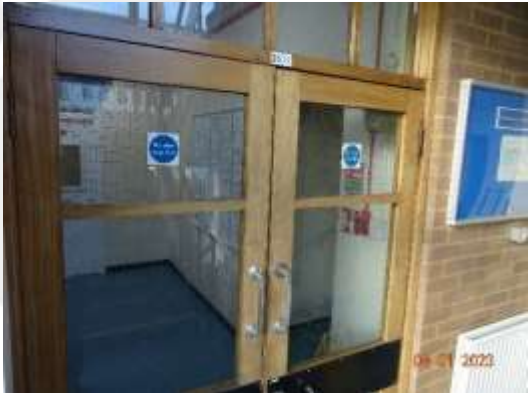
| 1 Q8 | Significant Findings | | |

| | <p>The fire doors leading directly onto the protected staircase for L block are in poor condition and are not sufficient to control smoke seepage and other products of combustion from entering the staircase enclosure.</p> | | |
| <p>Medium One Month</p> | | <p>Location</p> <p>1st and 2nd floor lab entrance in L Block</p> | |

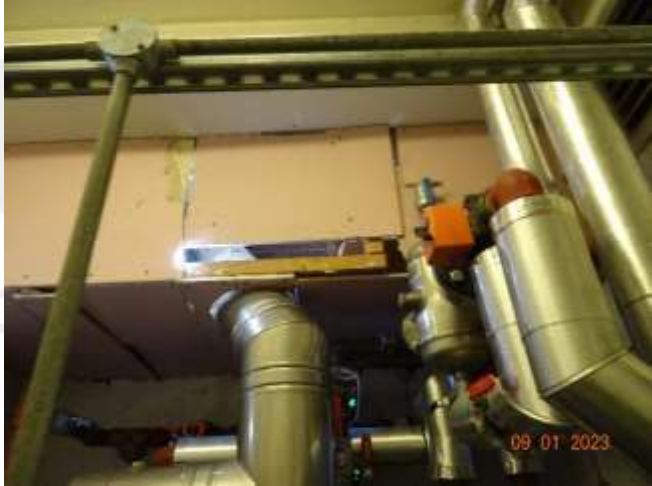
| 2 Q8 | Significant Findings | | |

| | The boiler house in L block has insufficient fire stopping in place to prevent the spread of fire into the void above the room. | | |

| Medium | One Month | Location Room M102 | |

| | The ceiling area in the boiler house requires repair to prevent fire spread into the void above the room. | | |

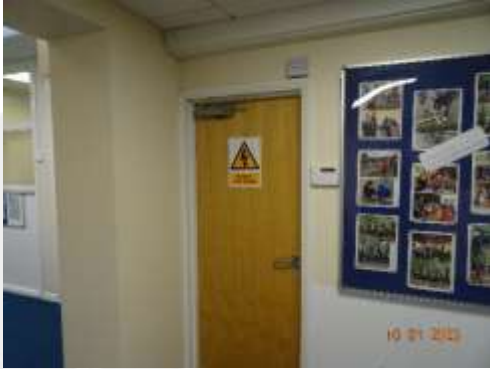
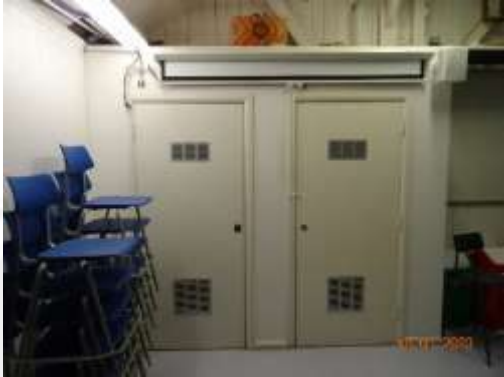
| 4 Q51 | Significant Findings | | |

| | Fire alarm System installed to BS5839 L2m with coverage to all internal open space facilities however the detection in the L block single storey extension does not cover the electrical cupboard opposite L38 or the boiler cupboard in L28 classroom. | | |
| | | Electrical cupboard and boiler cupboard L Block | |

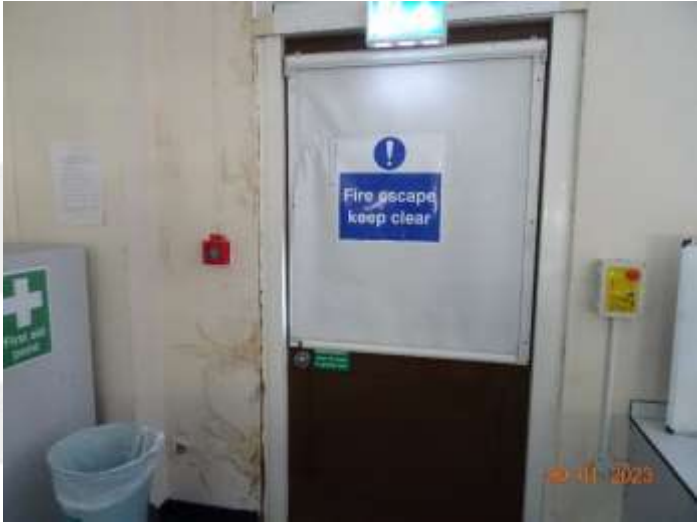
| 5 Q55 | Significant Findings | | |

| | There is no call point signage in the 1 st Floor laboratory L102. | | |
| Medium | One Month | Location Room L102 | |

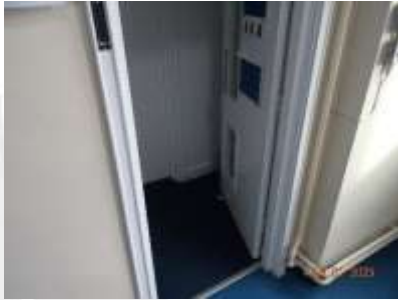
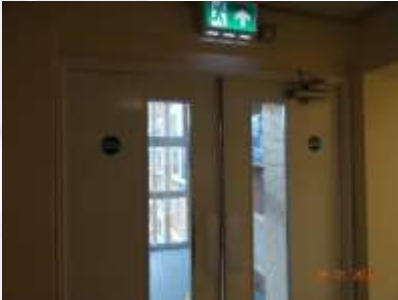
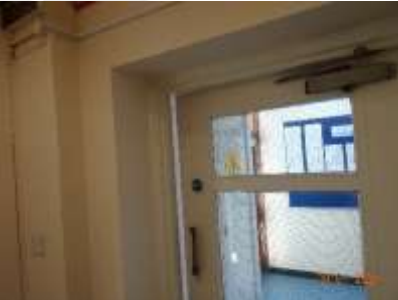
| 6 Q64 | Significant Findings | | | |

| | <p>There are a number of fire doors across both Blocks which require attention to ensure they close fully to maintain the fire separation design within the building,</p> <ul style="list-style-type: none"> • M 203 door to the staircase wedged open • M201 Fire door to Laboratory has excessive gapping and missing passive fire protection. • 2nd floor L block, white door not closing onto staircase • L block 1st floor fire door next to riser cupboard is not closing • L block g/floor corridor doors not closing and door leading to L4 • Laundry room doors not closing together to prevent lateral fire spread to obstruct the exit from L Block. | | | |
| | Medium | One Month | | Example of defective and wedged open fire doors |

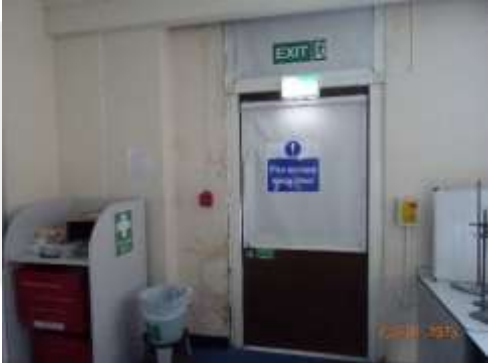
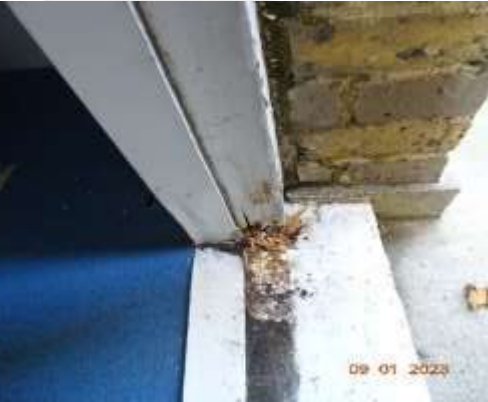
| 8 Q69 | Significant Findings | | |

| | Fire exit door from the from L102 was found to be stiff and difficult to open. | | |
