**BS 5837:2012 Tree Survey & Arboricultural Impact of  
Proposed New Pedestrian Route**

**Address: Landmark Arts Centre  
Teddington**

**Date 22<sup>nd</sup> February 2021**

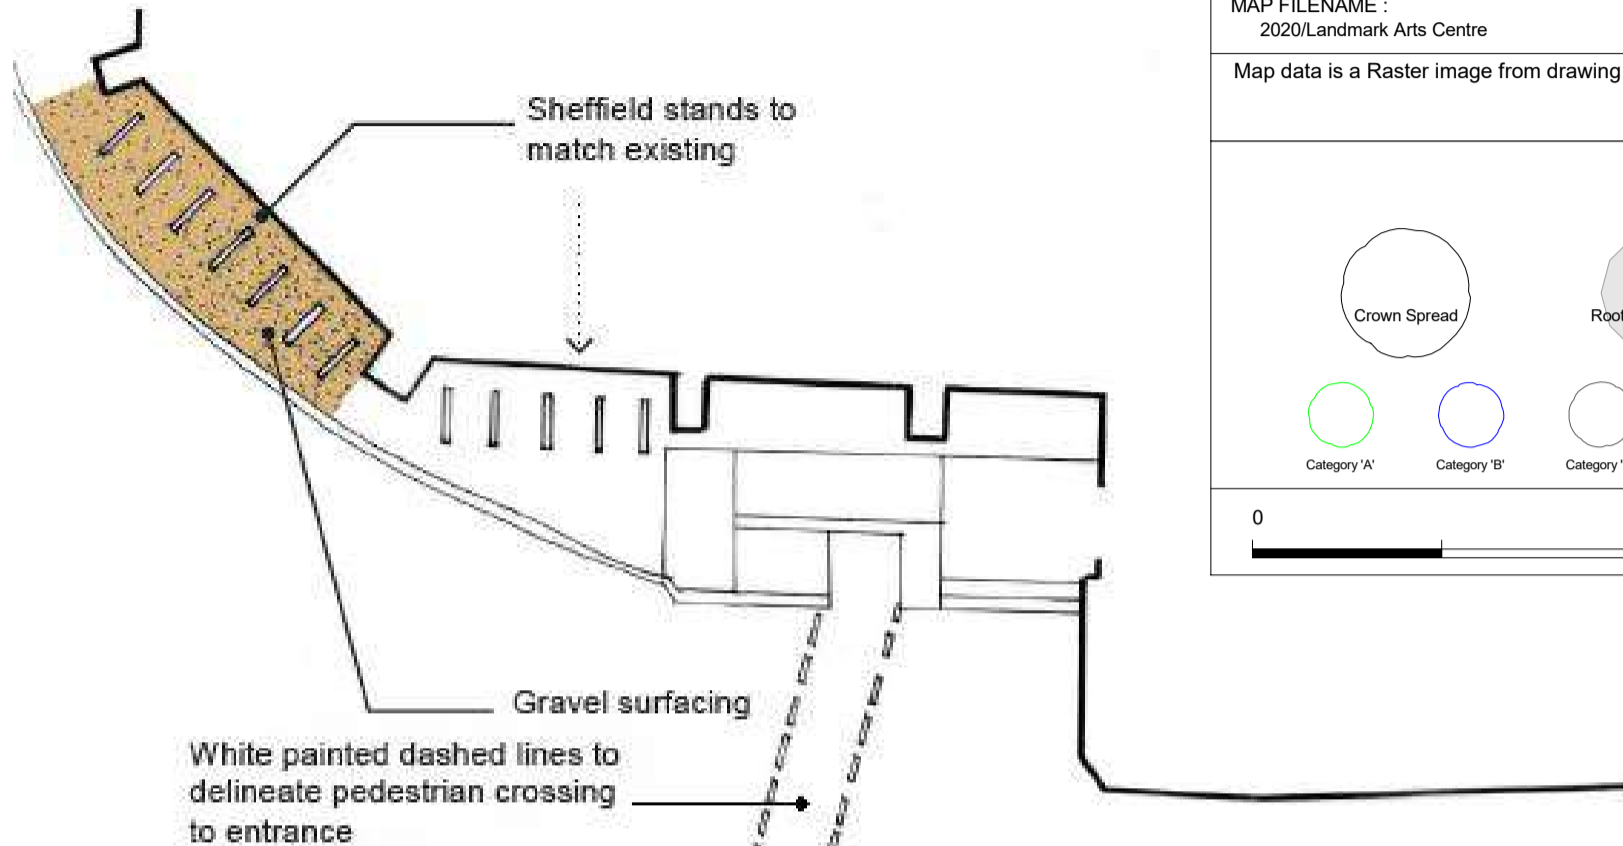
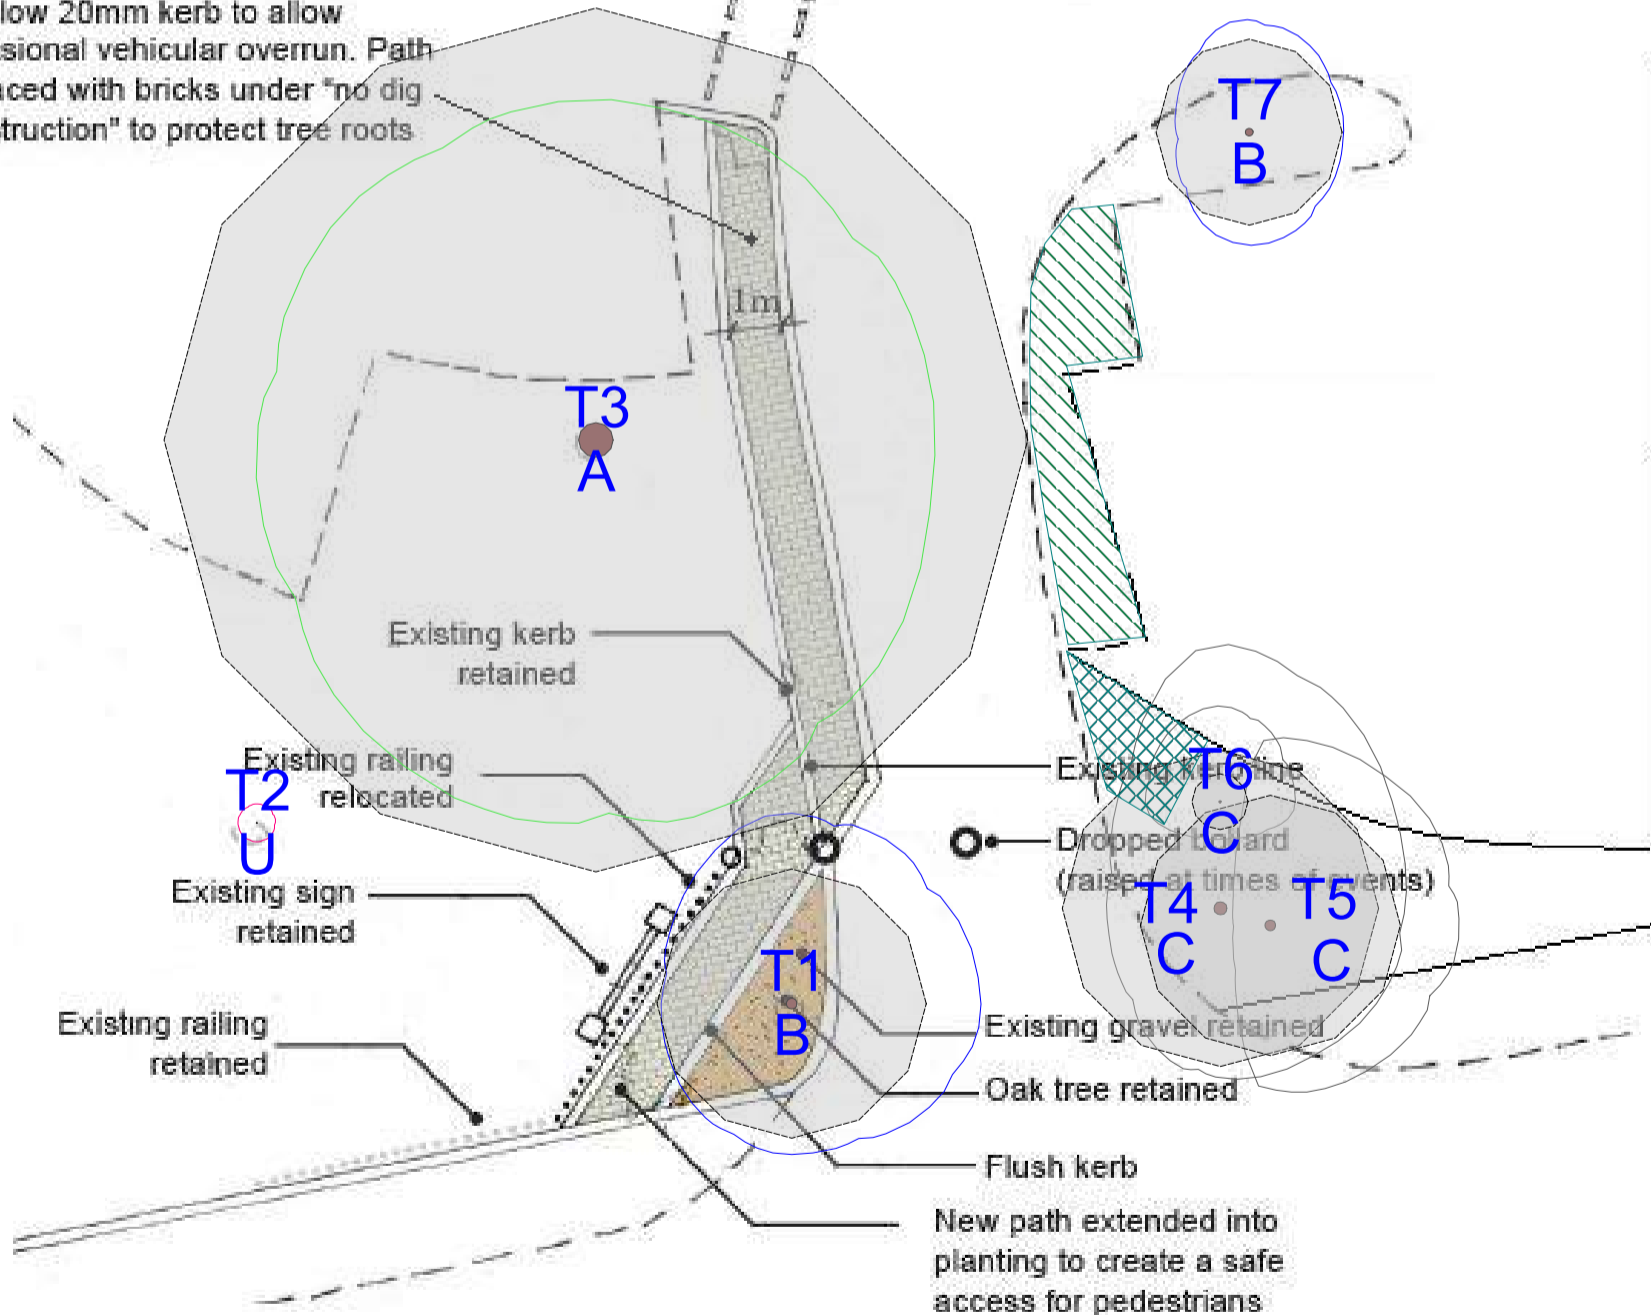
## Landmark Arts Centre Proposed Plan & Tree Constraints

New path extending into road with low 20mm kerb to allow occasional vehicular overrun. Path surfaced with bricks under "no dig construction" to protect tree roots
