# Preliminary Bat Roost Assessment

Thames Young Mariners, Riverside DR, London

A Report To: Pick Everard Report Number: RT-MME-160594-02 Date: July 2023

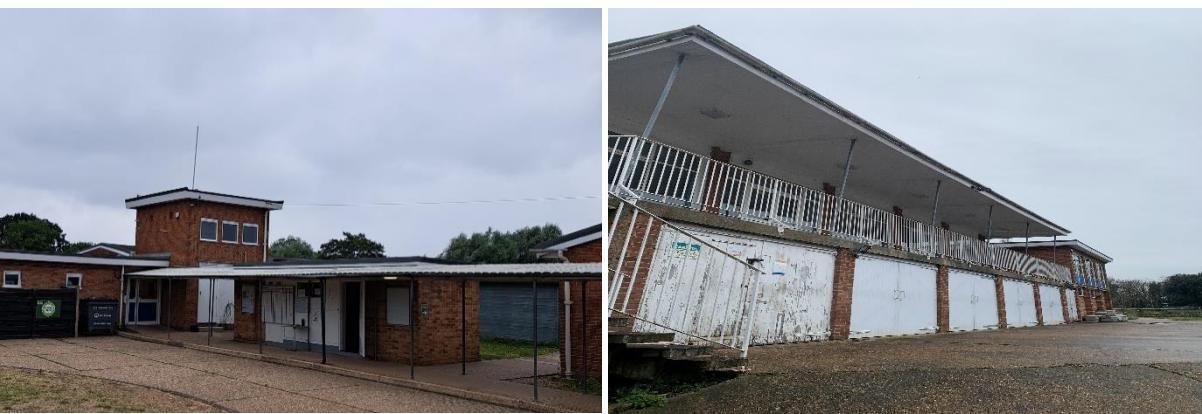
Consistent with the findings from the 2022 Preliminary Bat Roost Assessment, Building B1 (Main Building) consisted of an irregular shaped single storey brick-built building (Plate 4.1). The majority of the building had a flat felt roof, though one portion of the building on the eastern extent featured a pitched roof. The entire building featured a plastic soffit/fascia board, and all windows were double glazed. Building B1 included a storage tower on the western aspect, containing the buildings heating system, as well as a residential dwelling on the south-eastern aspect. A sheltered porch area was located on the north-eastern extent of the building, below which was a set of garages (Plate 4.2).

Southern Elevation)

Plate 4.1: Building 1 (Main Building - Plate 4.2: Western Elevation of Building 1 (Main Building)

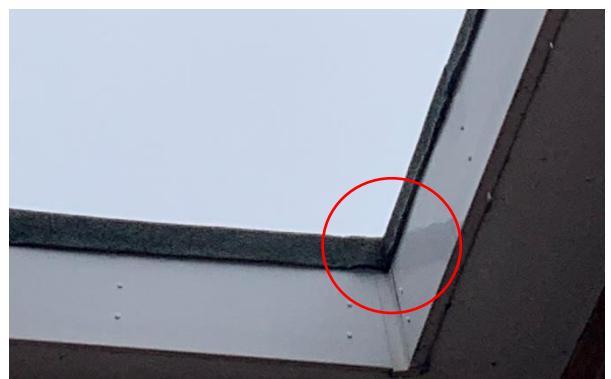
As previously, areas of lifted roofing felt were present on the western and eastern aspects of the building (Plates 4.3 to 4.5), albeit a detailed torchlight inspection from the balcony below recorded those gaps on the western elevation to contain no evidence of roosting bats, while these features were not considered to extend sufficiently to form suitable roosting features. As such, this elevation was not considered to provide suitable features for roosting bats. On the eastern aspect of the building, gaps in the soffit board and soffit box were noted, which could permit entry into an enclosed space behind the soffit/fascia board (Plate 4.6). Bird boxes were also present on the eastern elevation of the residential property, while a bat box was present on the south-facing wall of the residential dwelling, however, these were fully inspected using a torch and endoscope, and no associated evidence of roosting bats was recorded. Other features included a large gap in the soffit box on the southern elevation, a small gap in the brickwork on the southern elevation (Plate 4.7) and several areas of damaged brickwork surrounding the courtyard (Plates 4.8, 4.9).

Plate 4.3: Lifted Roofing Felt (Western Aspect)

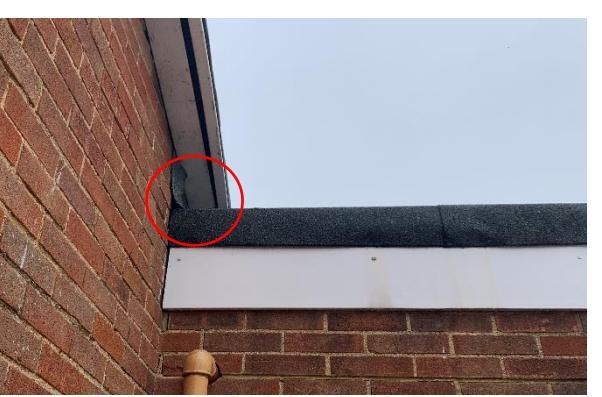
Plate 4.4: Lifted Roofing Felt (Western Aspect)

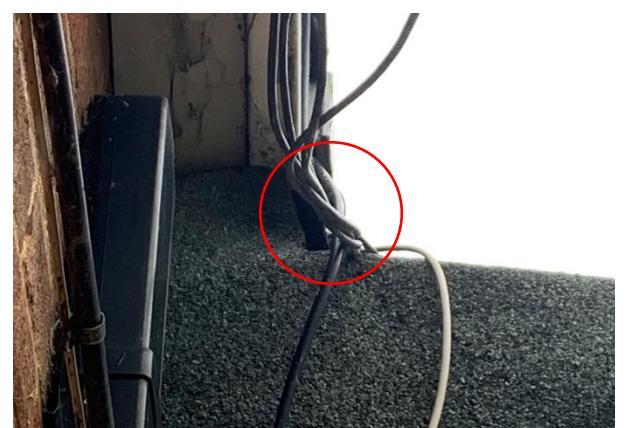
Plate 4.5: Lifted Roof Felt (Eastern Elevation)

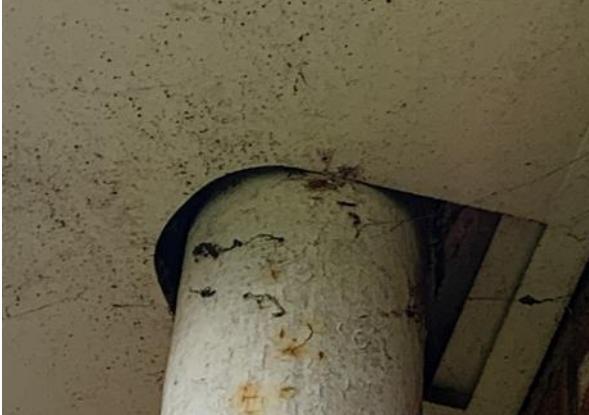
Plate 4.6: Gap in the Soffit (Eastern Elevation)

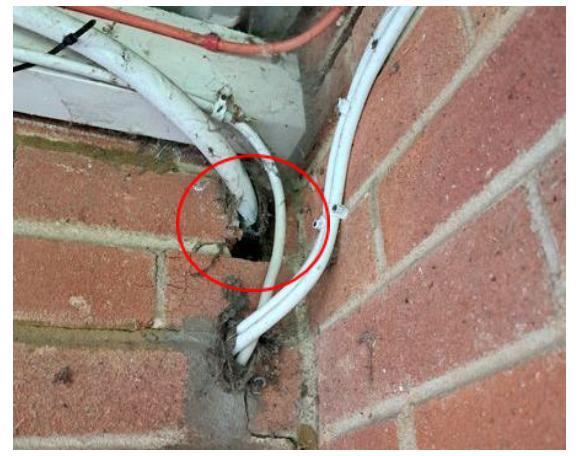
Plate 4.7: Gap in the brickwork (Southern Elevation)

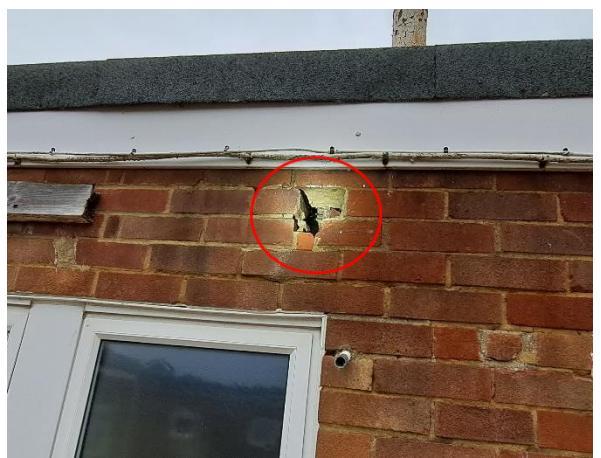
4.8: Damaged Brickwork (Northern Elevation/Southern Edge of Courtyard)

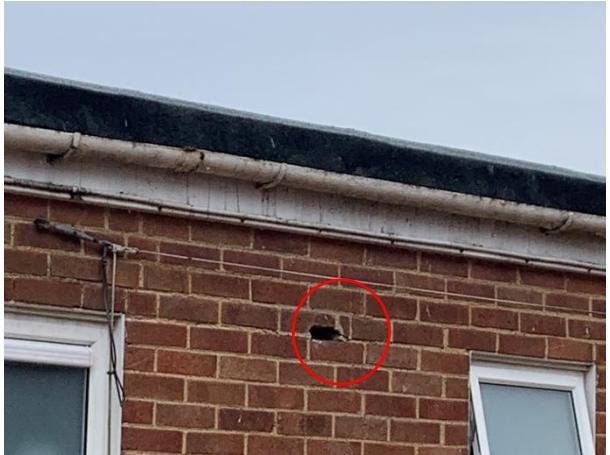
Plate 4.9: Hole in the Brickwork (Northern Elevation/Southern Edge of Courtyard)

No evidence of roosting bats, e.g. droppings, urine staining, feeding remains or scratch marks, was recorded during the internal and external inspections of the building. Overall, this building supported low potential for roosting bats.

- **R1 Buildings B1, B3, B4, and B5:** Buildings B1, B3, B4 and B5 were identified as having low potential to support roosting bats. Bat Surveys: Good Practice Guidelines, published by the Bat Conservation Trust (Collins, 2016), recommends that for structures with low bat roosting potential at least one survey (consisting of either a dusk emergence survey or a dawn re-entry survey) be undertaken during the peak season for emergence/re-entry surveys (May to August) to determine the presence/absence of roosting bats within the structures. Should this survey confirm the presence of roosting bats, it will be necessary to undertake additional surveys in order to inform a Natural England licence application. In addition, should the survey identify the presence of significant levels of bat activity at the site, it may be necessary to undertake further survey visits to comprehensively assess the value of the site to bats.

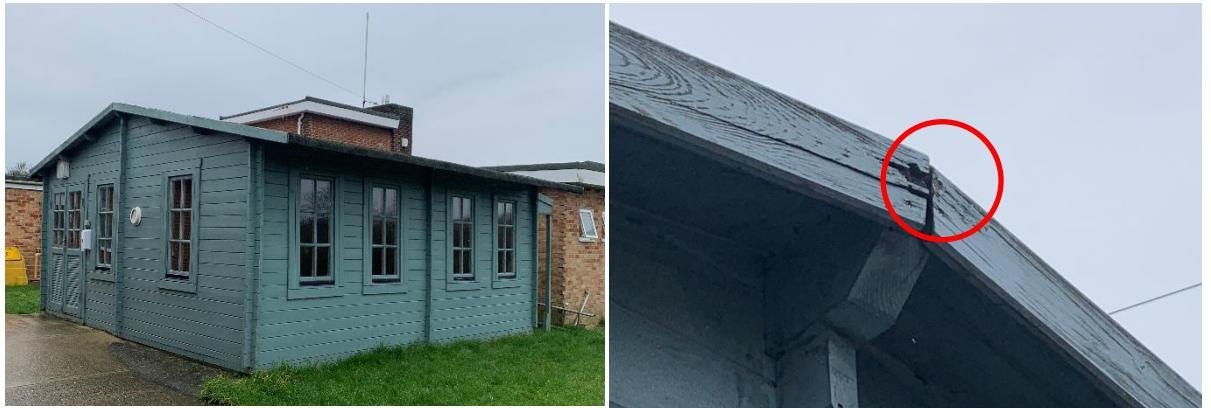
As previously, one of the wooden beams at the west-facing roof apex was damaged (Plate 4.11), albeit a detailed inspection identified this feature not to provide access to gaps or crevices suitable for roosting bats.

Plate 4.10: Building 2 (Wooden Cabin - North-Eastern Aspect)

Plate 4.11: Damage to Wooden Roof Apex (Western Aspect)

No evidence of bats, e.g., droppings, urine staining, feeding remains or scratch marks, was recorded during the internal and external inspections of the building. Overall, this building supported low potential for roosting bats, while the only identified PRF (lifted wooden panel on the northern elevation) was fully inspected, with no evidence of roosting bats recorded.

- R2 Building B2: Buildings B2, despite having low potential features to support roosting bats, was fully inspected, with no evidence of roosting bats recorded. As such, no further survey work of this building is required at present. The survey data obtained for the site is valid for 12 months from the survey date. If development works to the surveyed buildings have not commenced within this timeframe it will be essential to update the survey effort to establish if suitable features have developed and if bats have colonised the buildings in the interim. In the unlikely event that a bat is found during demolition works all works must immediately cease and a suitably qualified ecologist should be contacted.

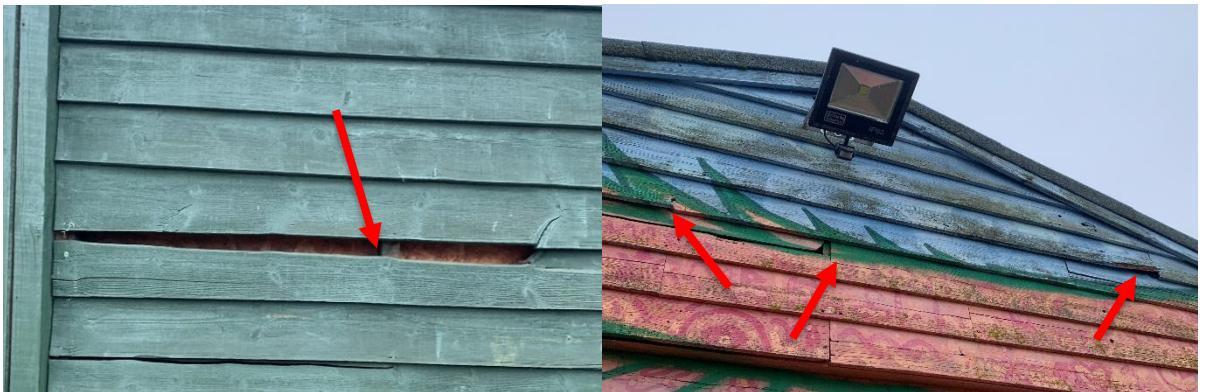
As previously, Building 3 was in generally poor condition. Much of the wooden cladding was damaged or missing, there were holes at the eaves, loose fitting joins and cracks in the brickwork (Plate 4.12-4.16). The damage observed in the wooden cladding led to an enclosed area between the wooden cladding and internal ply lining. A bird nest was also noted in a gap in the wooden cladding on the southern facet of the building. A metal storage container was present adjacent to the northern elevation of the building, likely blocking access for bats from the majority of this elevation.

Plate 4.12: Missing Wooden Cladding (Southern Aspect)

Plate 4.13: Damaged Wooden Cladding (Eastern Aspect)

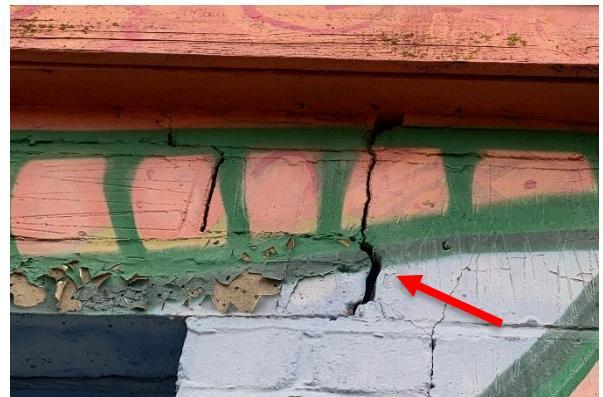
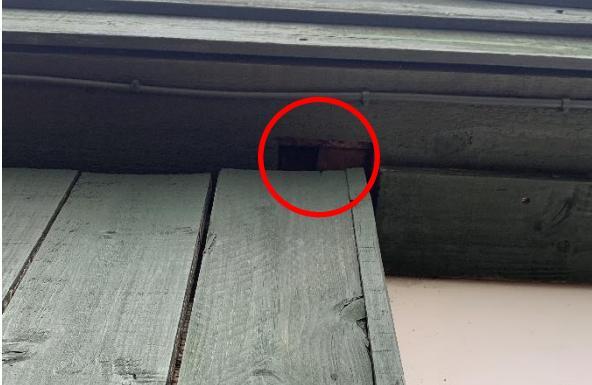
Plate 4.14: Damaged Brickwork (Eastern Aspect)

Plate 4.15: Loose Fitting Joins (Southern Aspect)

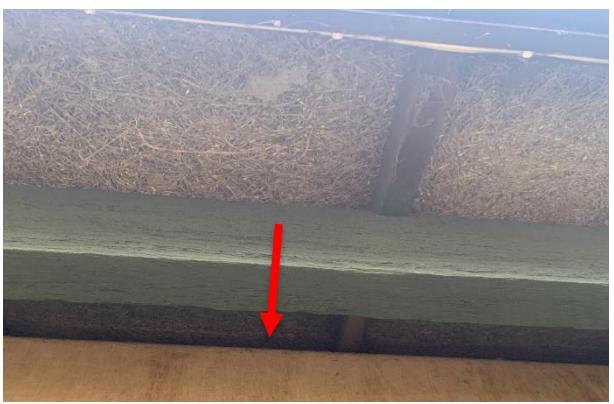
Plate 4.16: Gaps At The Eaves (Southern Aspect)

No evidence of bats, e.g., droppings, urine staining, feeding remains or scratch marks, was recorded during the internal and external inspections of the building. Overall, this building supported low potential for roosting bats.

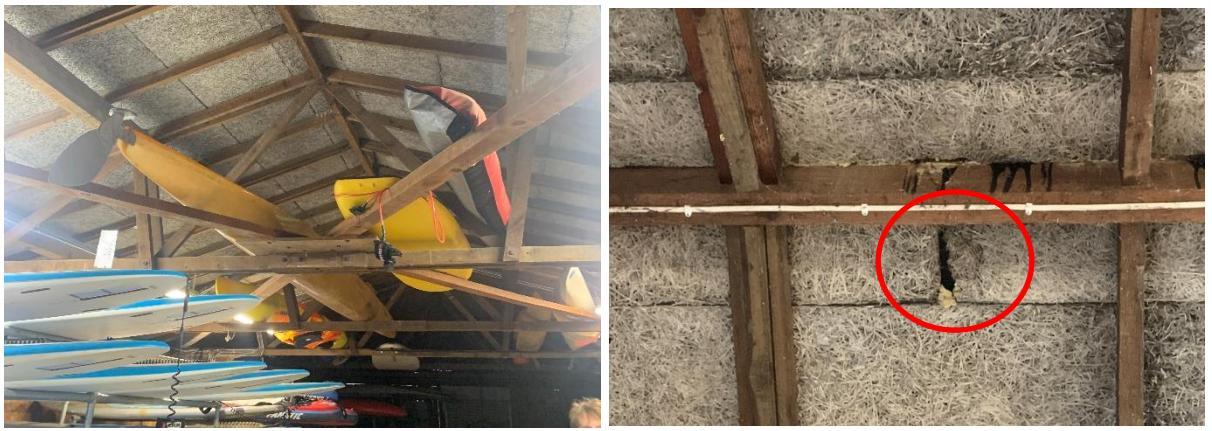
The interior of Building 3 consisted of a large open space with exposed treated timber roof beams (Plate 4.17). The building was poorly insulated with only the ceiling possessing any form of insulation. There were holes in the ceiling insulation, but none appeared to extend into significant enclosed cavities capable of supporting larger numbers of bats (Plate 4.18).

Plate 4.17: Interior of Building 3

Plate 4.18: Gap in The Ceiling Insulation

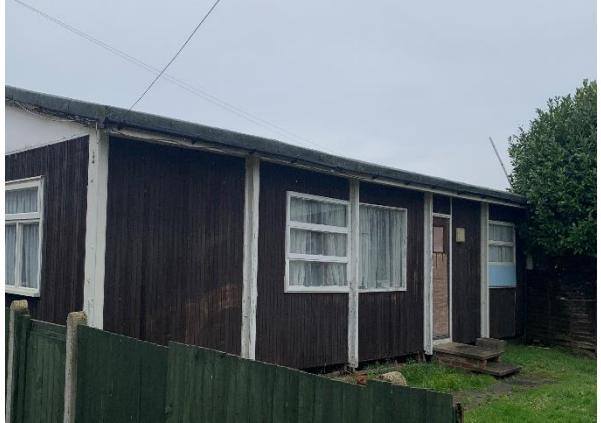
Building 4 consisted of a single storey wooden building with a pitched felt roof (Plate 4.19). The building had a series of single glazed windows with wooden frames. The building was in generally poor repair at the time of the survey. The external vents on the north-facing wall had sustained damage, granting access into the internal space (Plate 4.20). A pipe hole was also present on the north-facing wall, and appeared to extend into the wall structure (Plate 4.21).

Plate 4.19: Building 4 (Cedar House).

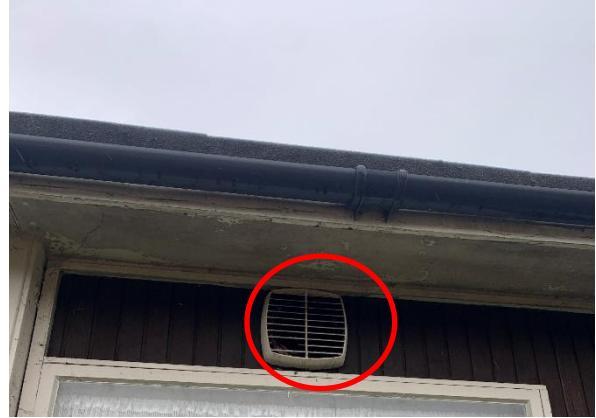
4.20: Damaged Roof Vent (Northern Aspect)

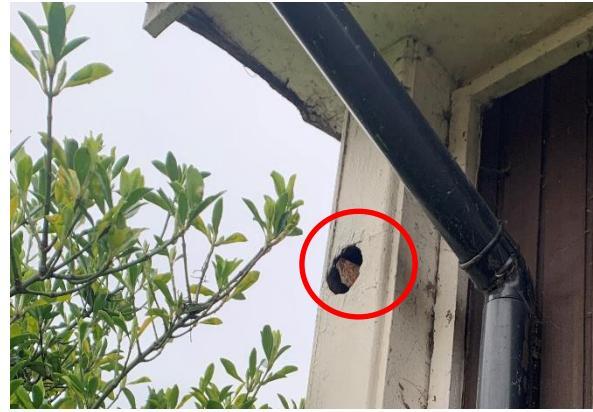
Plate 4.21: Pipe Hole (Northern Aspect)

No evidence of bats, e.g., droppings, urine staining, feeding remains or scratch marks, was recorded during the internal and external inspections of the building. Overall, this building supported low potential for roosting bats.

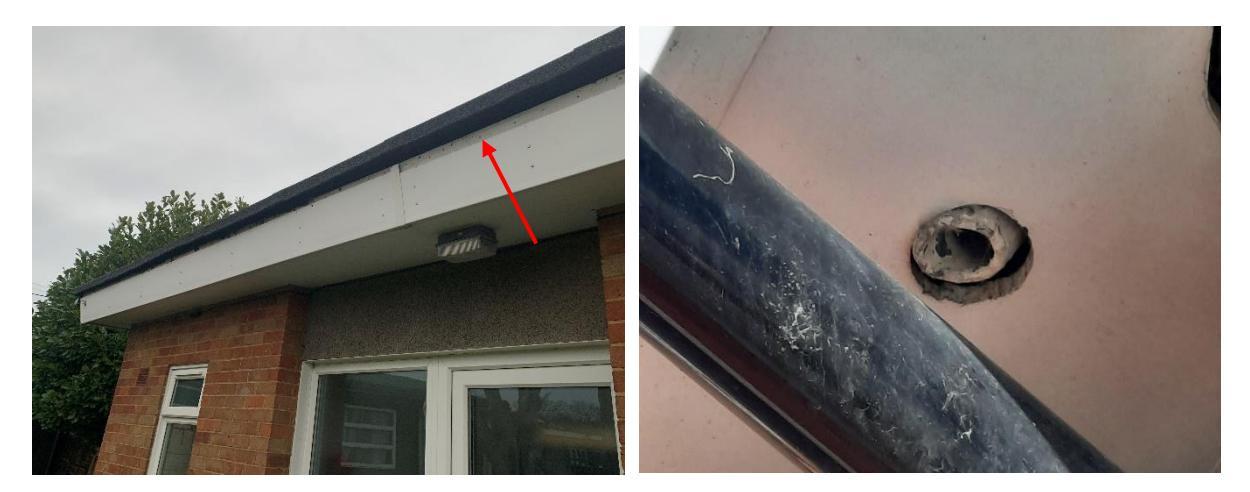
As previously, areas of lifted roofing felt were present at all aspects, presenting limited opportunities for bats to roost under the roofing material (Plate 4.22). A pipe hole was identified in the soffit box at the southern extent of the property (Plate 4.23).

Plate 4.22 Lifted Roofing Felt (Western Aspect)

Plate 4.23: Pipe Hole (Southern Aspect)

No evidence of bats, e.g., droppings, urine staining, feeding remains or scratch marks, was recorded during the external inspection of the building. Given the findings of the external inspection were consistent with those recorded by Middlemarch in 2022, with no additional PRFs recorded during the latest survey, this building is considered, as previously, to support low bat roosting potential.
