**BS5837 Arboricultural Report and
Arboricultural Impact Assessment**

OUR REFERENCE	AC.2024.411
CLIENT	Mr Somesh Mitra
SITE	66 Mount Ararat Road, Richmond TW10 6PJ
REPORT BY	I S Thompson (known as Tom) M. Arbor. A., BSc. (Hons) Arb, MSc. eFor
DATE	15th June 2024
DATE OF SITE VISIT	13th June 2024

66 Mount Ararat Road, Richmond TW10 6PJ

Application Ref No Unknown Single storey rear extension to existing semi-detached dwelling.

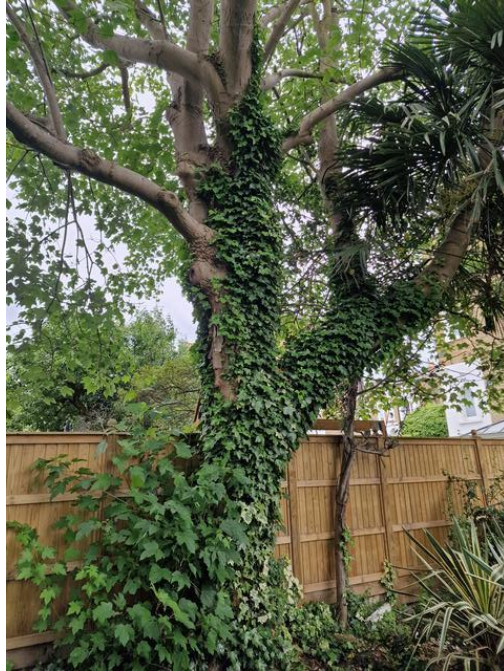
Image 1 Multi stemmed sycamore tree T01, which is a lapsed pollard.

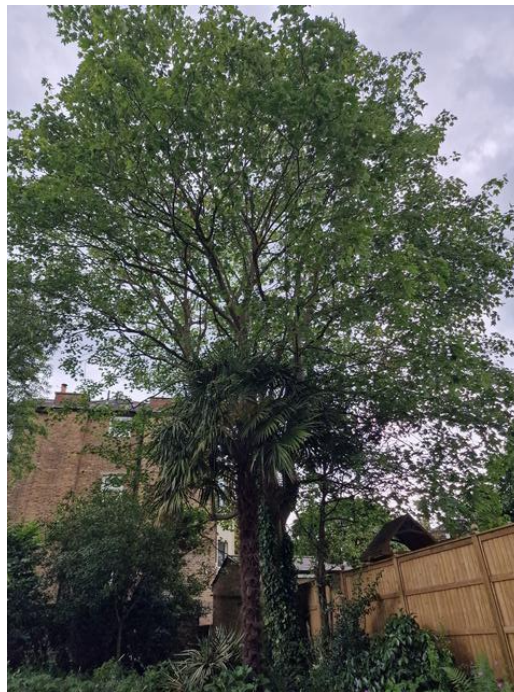
Image 2 T01 a sycamore tree, at the rear.

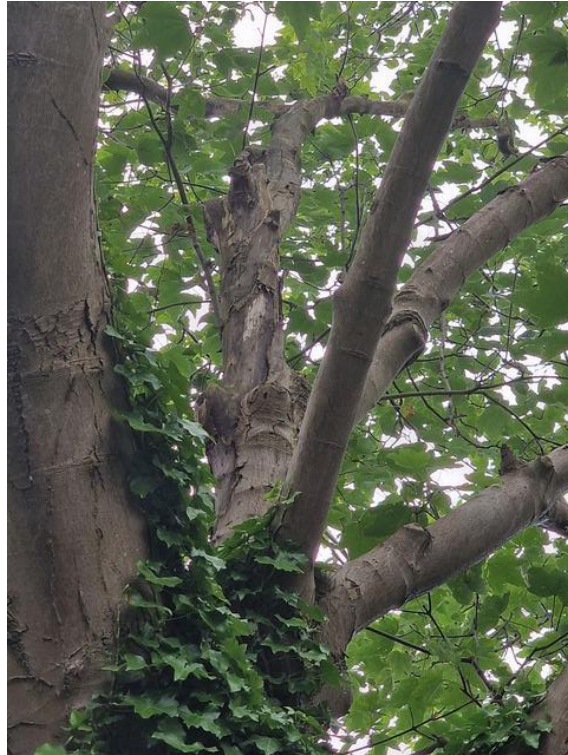
- 2.2.4** There were a total of seven individual trees and one group of shrubs surveyed. This comprised of C1/2 category sycamore that was a lapsed pollard and had been recently crown reduced, See Images 1 and 2 in Appendix III. This tree has some deadwood and necrotic bark, and there is some crown dieback, see Images 3 and 4.

Image 3 Deadwood and necrotic bark in the crown of T01.

There are some recommendations for tree work. This is in Section 12 of the AMS, Remedial Tree Work.

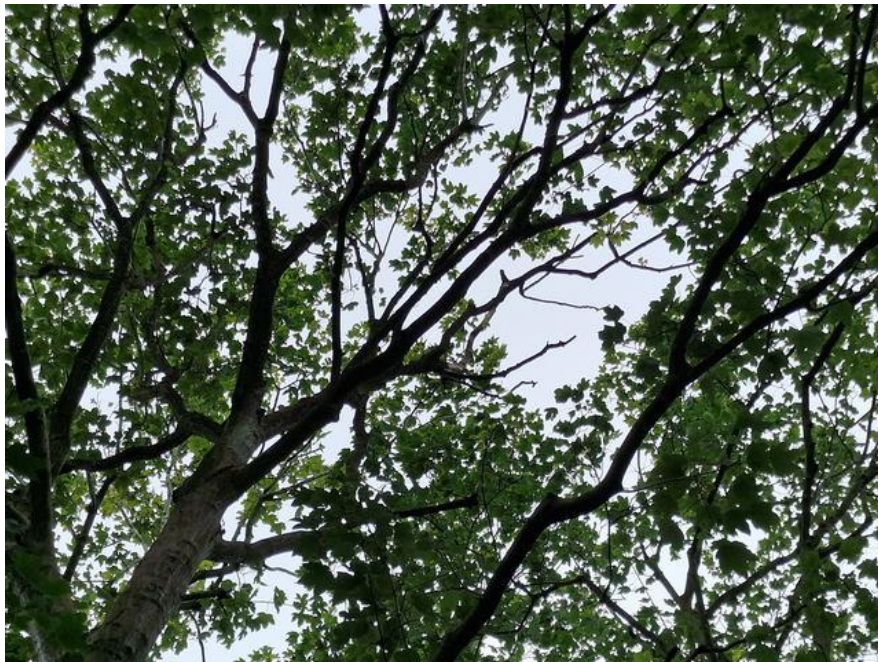
Image 4 dieback in the crown of T01.

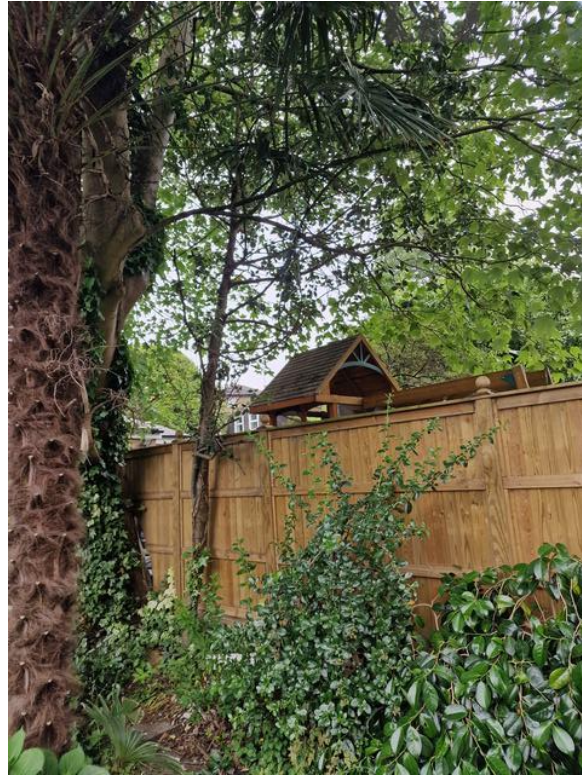
Image 5 T02 a small holly tree growing under the sycamore T01.

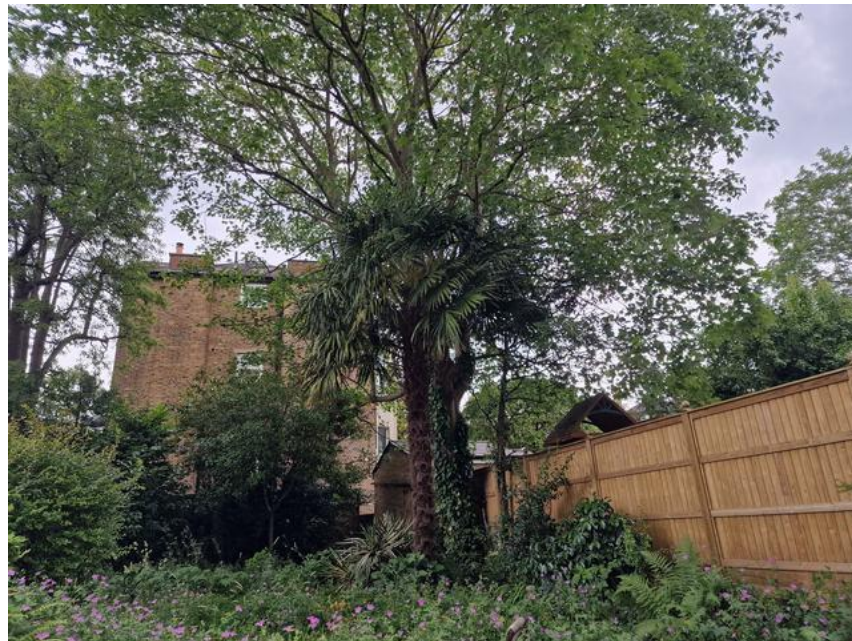
Image 6 T03 a Chinese fan palm in the foreground with T01 behind it.

3.2.1 There are only three small trees and a group of shrubs that are proposed for removal as part of this application. These are T03 a small palm tree, T04 a small low spreading yew tree and T06 a small Portuguese laurel.

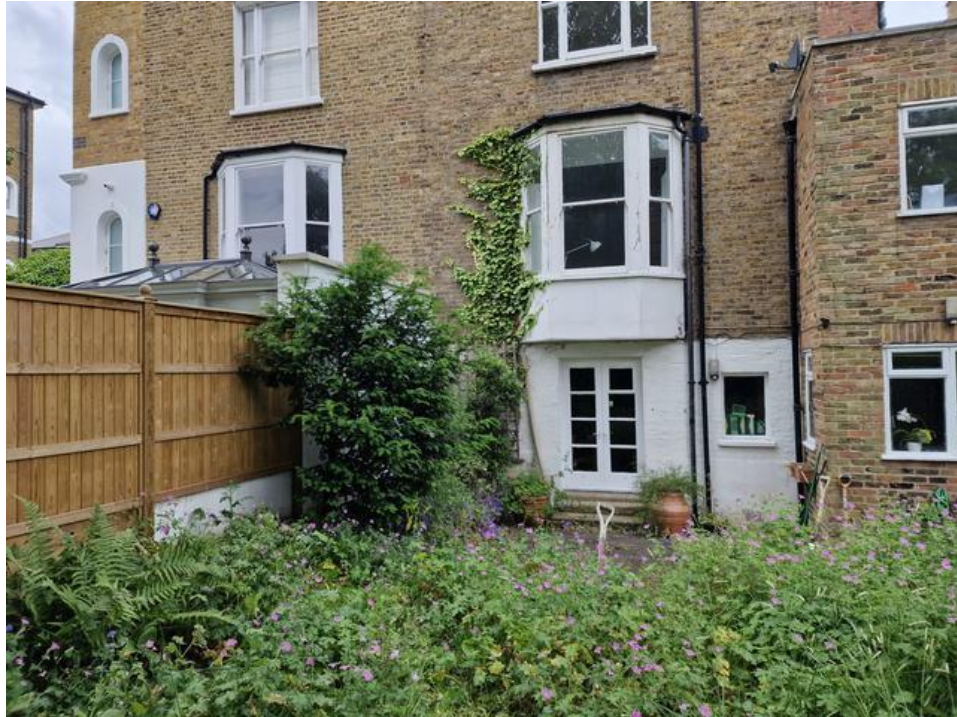
Image 7 T04 a small yew tree near to the existing building.

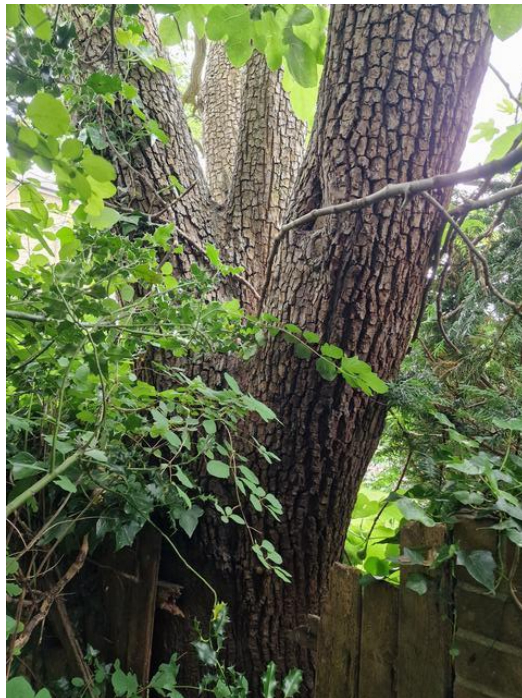
Image 8 Multiple stems of T05 a pear tree on the adjacent property.

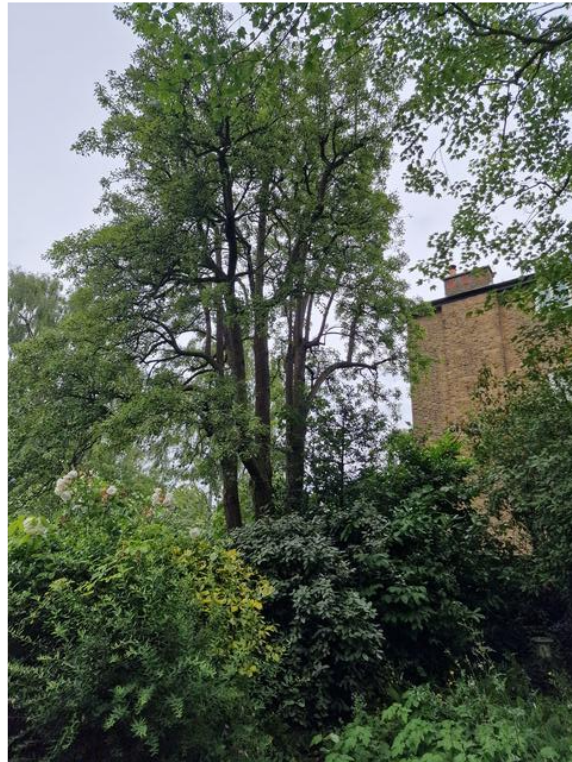
Image 9 Crown of T05 a pear tree on the adjacent property.

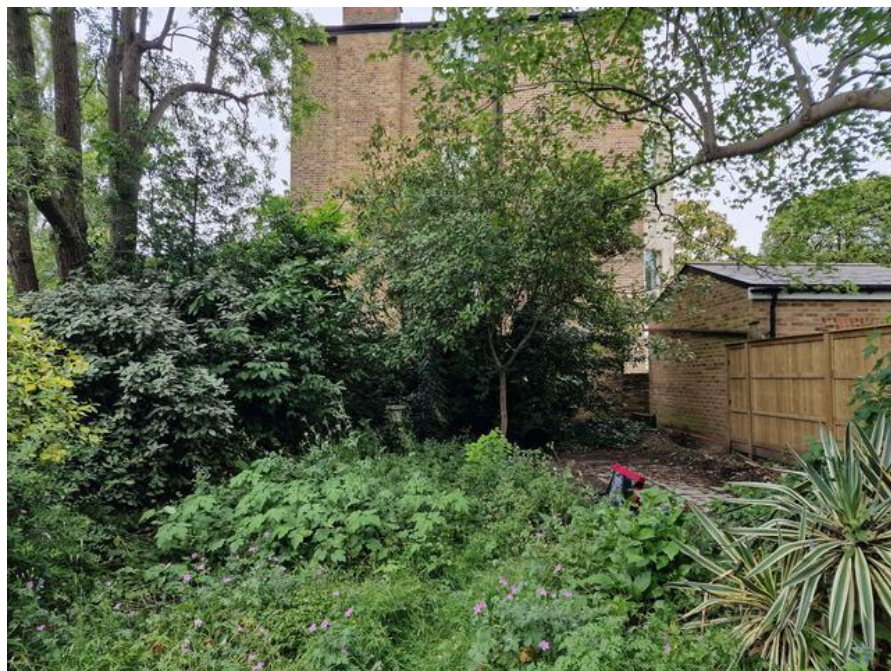
Image 10 T06 a Portuguese laurel in the foreground with G01 behind it and to the left.

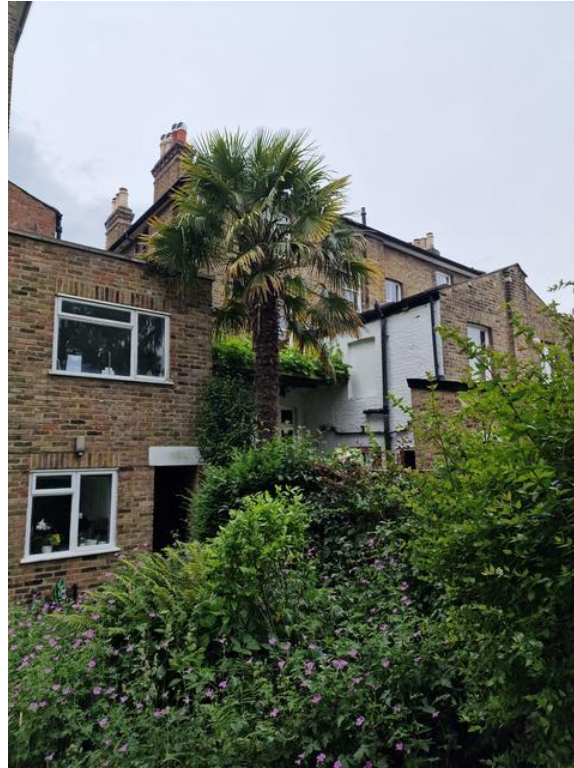
3.3.1 There is no proposed construction of foundations within the RPA of any retained trees. The only exception to this is T07 the Chinese fan palm on the adjacent property. There is an incursion into the calculated RPA of T07, but this is a palm tree with a dense fibrous rooting system, and it is more like a giant grass plant. This will not be impacted by the encroachment to any great extent.

Image 11 T07 a Chinese fan palm in conflict with the roof.

Ref	Species	Measurements	Spread	General Observations	Retention Category	RPA	Recommendations	Condition	Reinspect
T07	Chinese fan palm (<i>Livistona chinensis</i>)	Height (m): 9 Stem Diam(mm): 200# Spread (m): 2.5N, 2.5E, 2.5S, 2.5W Crown Clearance (m): 7 Life Stage: Semi Mature Rem. Contrib.: 10+ Years	N:2.5 E:2.5 S:2.5 W:2.5	Chinese fan palm in the adjacent garden. Conflict with the roof.	C1	Radius: 2.4m. Area: 18 sq. m.	Cut clear of the roof.	Physiological Cond: Good Structural Cond: Fair Bat Habitat: None	3 Yrs.

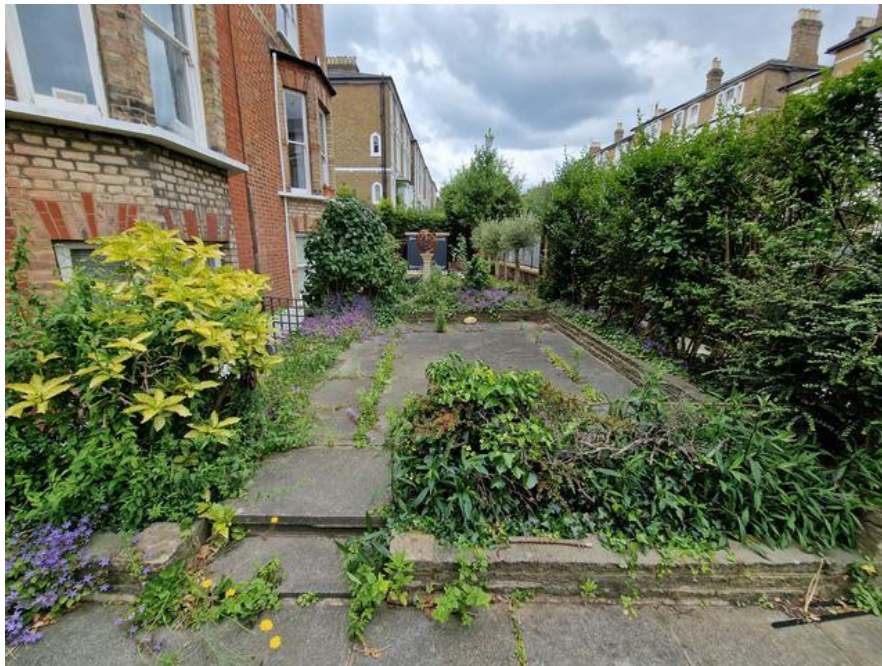
Image 12 Storage area in the front garden.
