**Roehampton Gate Café and Car Park,
Richmond Park**

**Arboricultural Impact Assessment and Draft
Method Statement**

July 2024

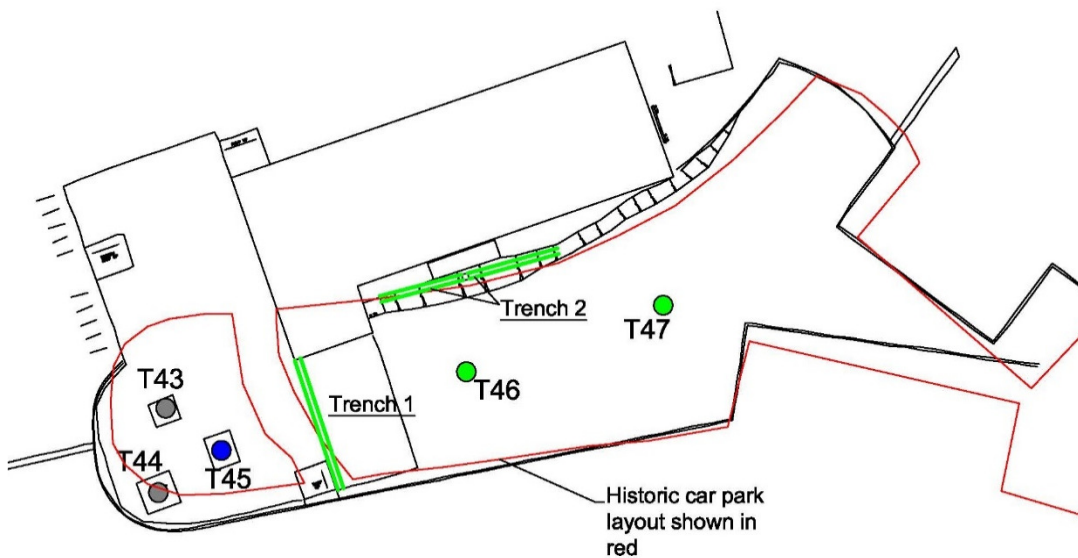
Figure 3: Trench Location Plan

On the 29th April to the 2nd May 2024, exploratory trenches were carefully excavated by hand along the edge of the former car park to the north of T46 and at the location of the former footpath to the west of T46 in order to inform the RPAs of T46 and T47. The location of the trenches is shown in Figure 3 below.

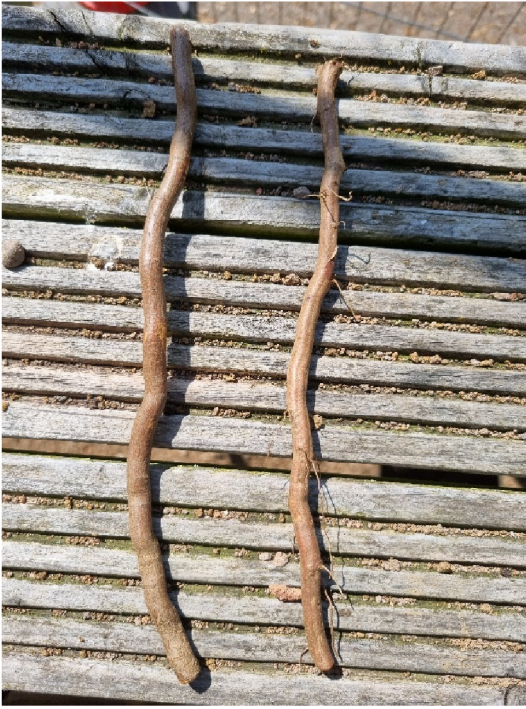
Trench 1 was excavated to a depth of 700mm beneath the existing decking. The make-up of the soil removed was 'made ground' to a depth of 700mm as rubble and aggregate was found within the soil. Numerous oak roots were uncovered which originate from T45. Once identified as oak roots, they were pruned back to the edge of the trench and removed. Oak and sweet chestnut roots are similar in appearance, the difference being that oak roots have a thin, papery upper cortex and sweet chestnut roots do not. See Figure 4 below.

Figure 4: Difference between oak and sweet chestnut roots. Oak is on the right and has a thin, papery upper cortex that easily peels. Not present on sweet chestnut roots.

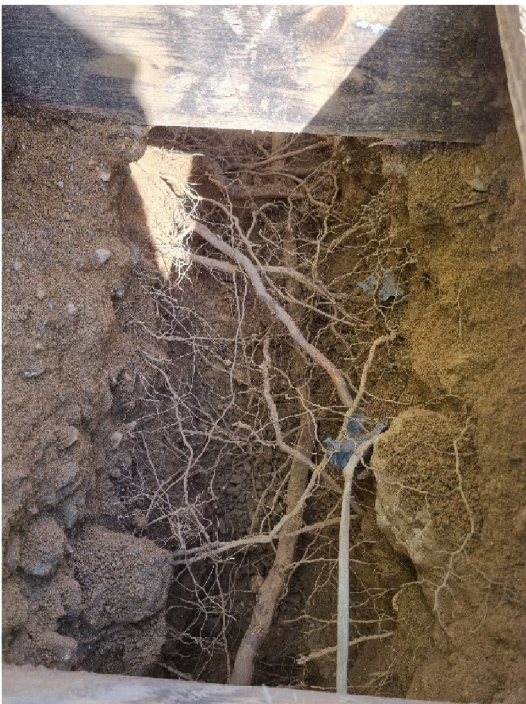
Figure 5: Numerous oak roots uncovered from T45 before pruning.

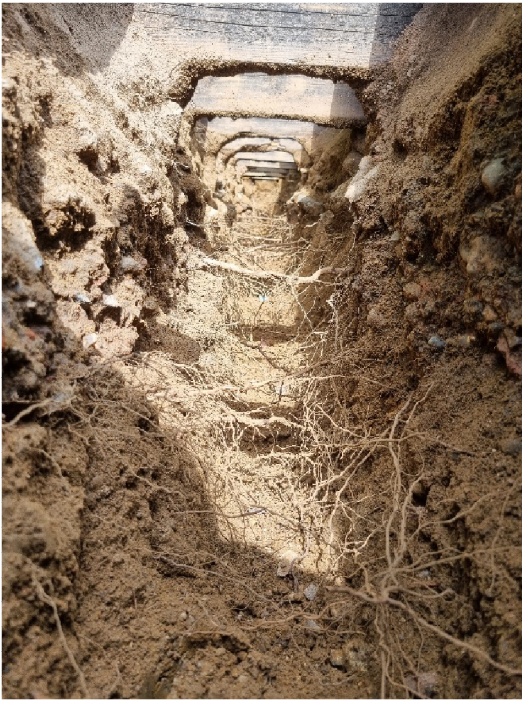
Figure 6: Extent of trench looking north. Fibrous roots from T45 present.

No significant sweet chestnut roots were uncovered. The composition of the soil removed from the trench was 'made ground', suggesting that the soil was removed to a minimum depth of 700mm at some point and replaced with a mixture of soil and rubble, likely as a subbase for the footpath or possibly before that. In removing the soil, it is likely that roots from T46 were also removed and have not grown back in the area. This could be due to historic trenching as there is an inspection chamber located in the soft landscaped area to the southwest of T46.

The RPA of T46 can therefore be adjusted to not include the area to the west of Trench 1.

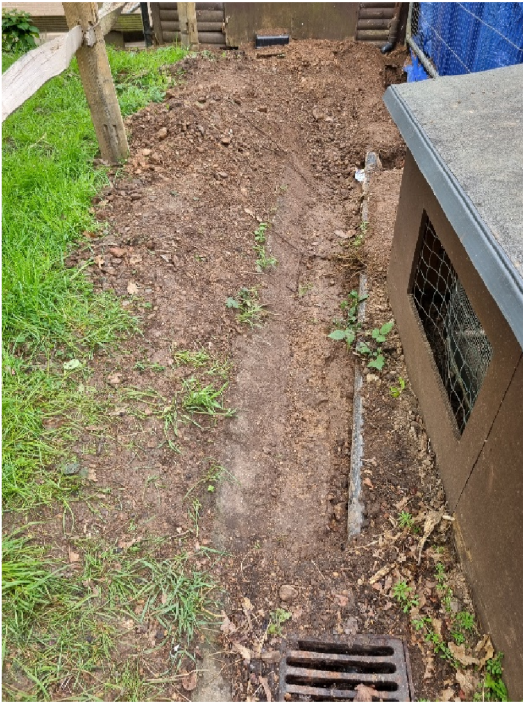
Attempts were made to excavate Trench 2 along the outer edge of the existing granite kerb running east to west, to the north of T46. Concrete was uncovered 200mm below the surface that appears to run the entire length of the kerb. Excavations continued closer to the café building to find the edge of the concrete, which was found approximately 1 metre to the north of the kerb. A trial hole was then excavated in order to determine the depth of concrete which was found at a depth of 700mm.

Figure 7: Uncovered concrete to the north of the kerb.

The presence of concrete to the depth of 700mm beneath the kerb of the former car park would have resulted in the severance of any roots from T46 and T47 when the car park was built. The depth of the concrete and the conditions beneath the café building mean that the presence of roots beyond the kerb line is unlikely.

The RPA of T46 and T47 can therefore be adjusted to not include the area to the north of the kerb of the former car park.

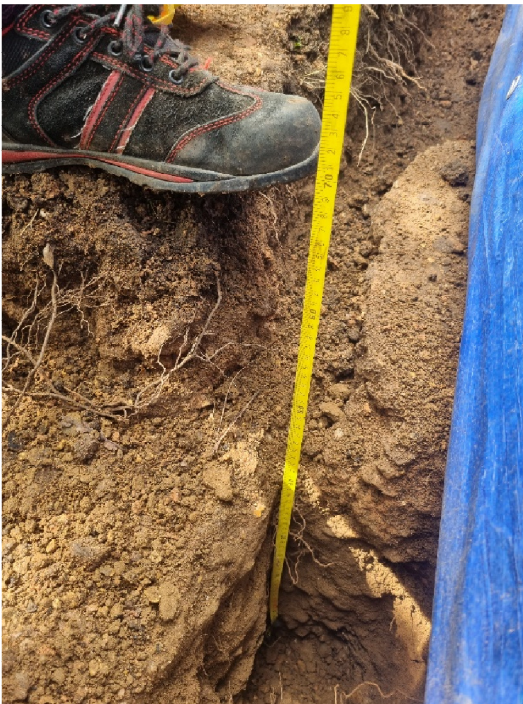
Figure 8: Depth of concrete recorded at 700mm.
