<u>Arboricultural Impact</u> <u>Assessment</u>

- Tree Survey
- Tree Protection Plan
- Arboricultural Method Statement

Hampton Police Station Station Road Hampton TW12 2AX

Survey Date: Report Date: Project no: 28th November 2019 1st July 2024 1435

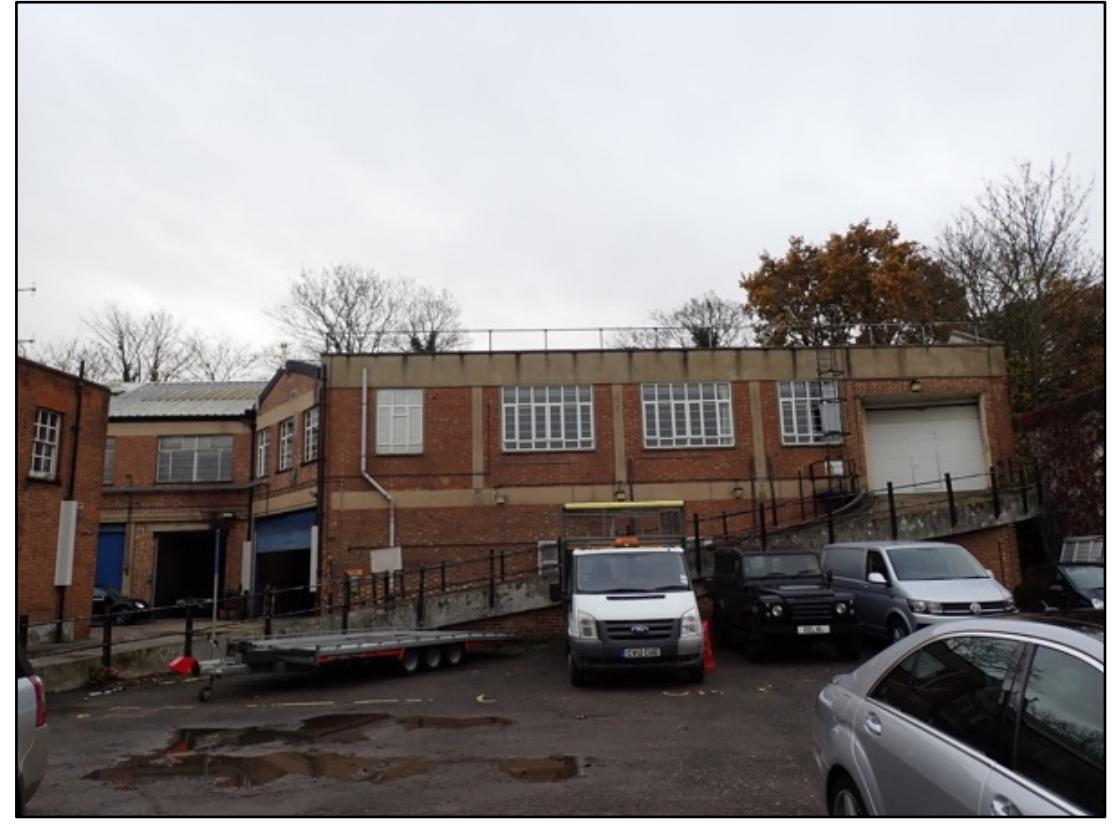
Existing building to be demolished. Trees in view to the back and side of the building are located in adjacent sites.

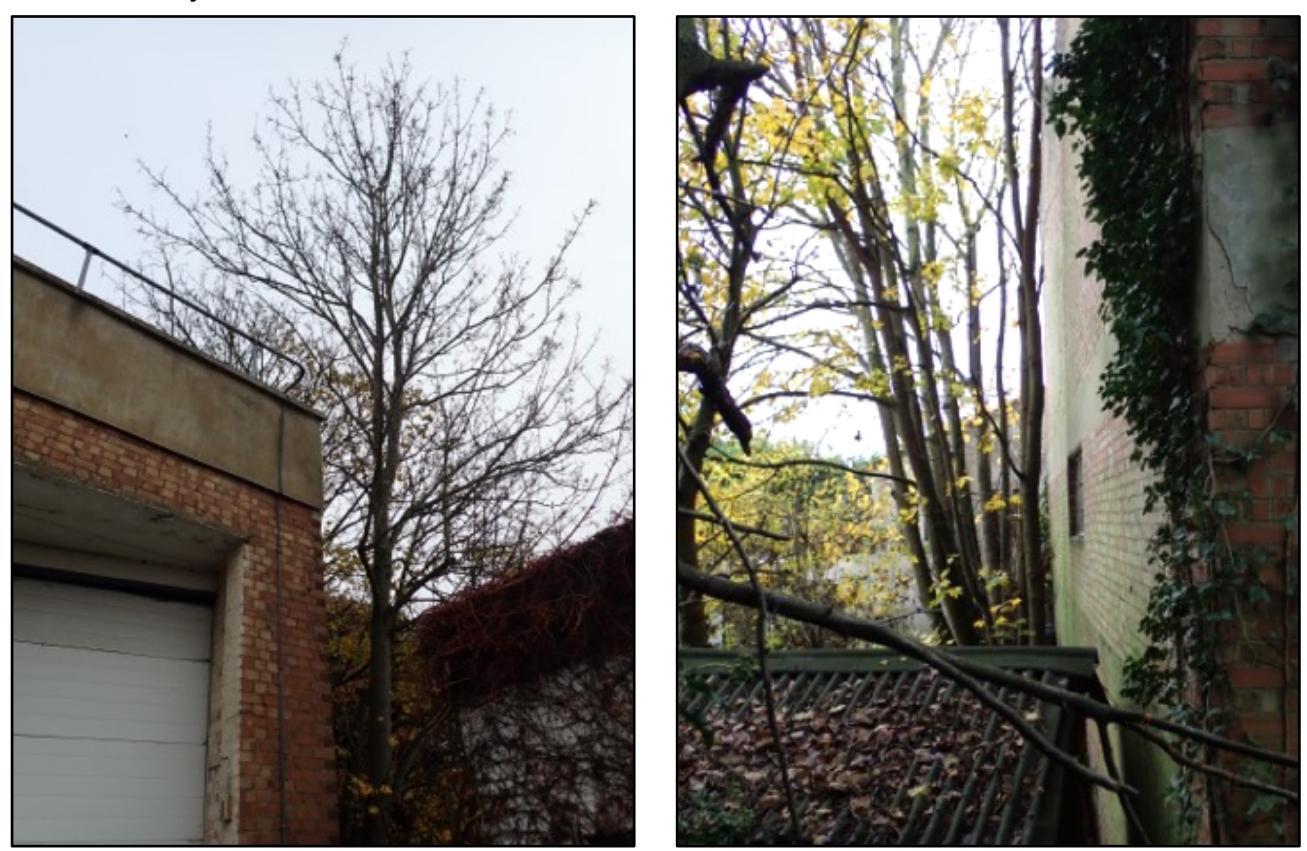
- 5.1.3 There is a line of sycamore trees (G1) growing within the adjacent property to the northeast. The tree bases are in quite close proximity to the building wall. No access was gained to survey the trees and their exact positioning is not known. Crown growth is predominantly to the east however there is some oversailing of the building to the west. Photos are included in Appendix F.

Sycamore, G1, in adjacent property to east. Tree stems are in close proximity to building.

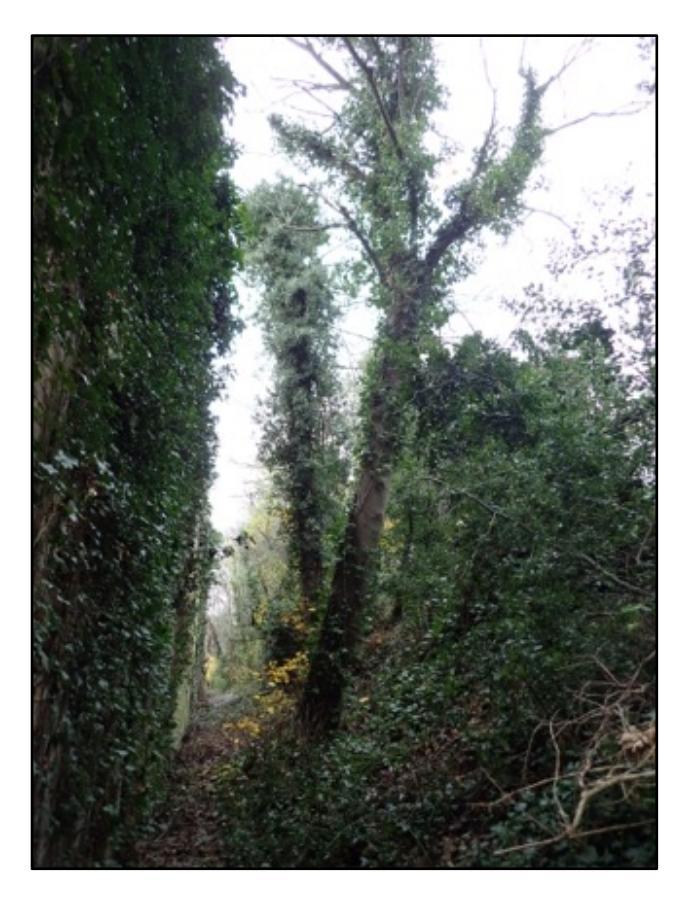
Views of rear wall of building that is to be demolished. Trees located in Beveree Wildlife Site will require tree protection measures for the duration of the demolition and construction period.
