BS5837 Tree Survey Report, Arboricultural Impact Assessment & Arboricultural Method Statement

Site: 39 Second Cross Road, Twickenham, TW2 5QY

**Prepared by: Tree Craft Ltd, Hillside Farm, Rushmore Hill,
Knockholt, Kent, TN14 7NL.**

Issued: 07.08.2024

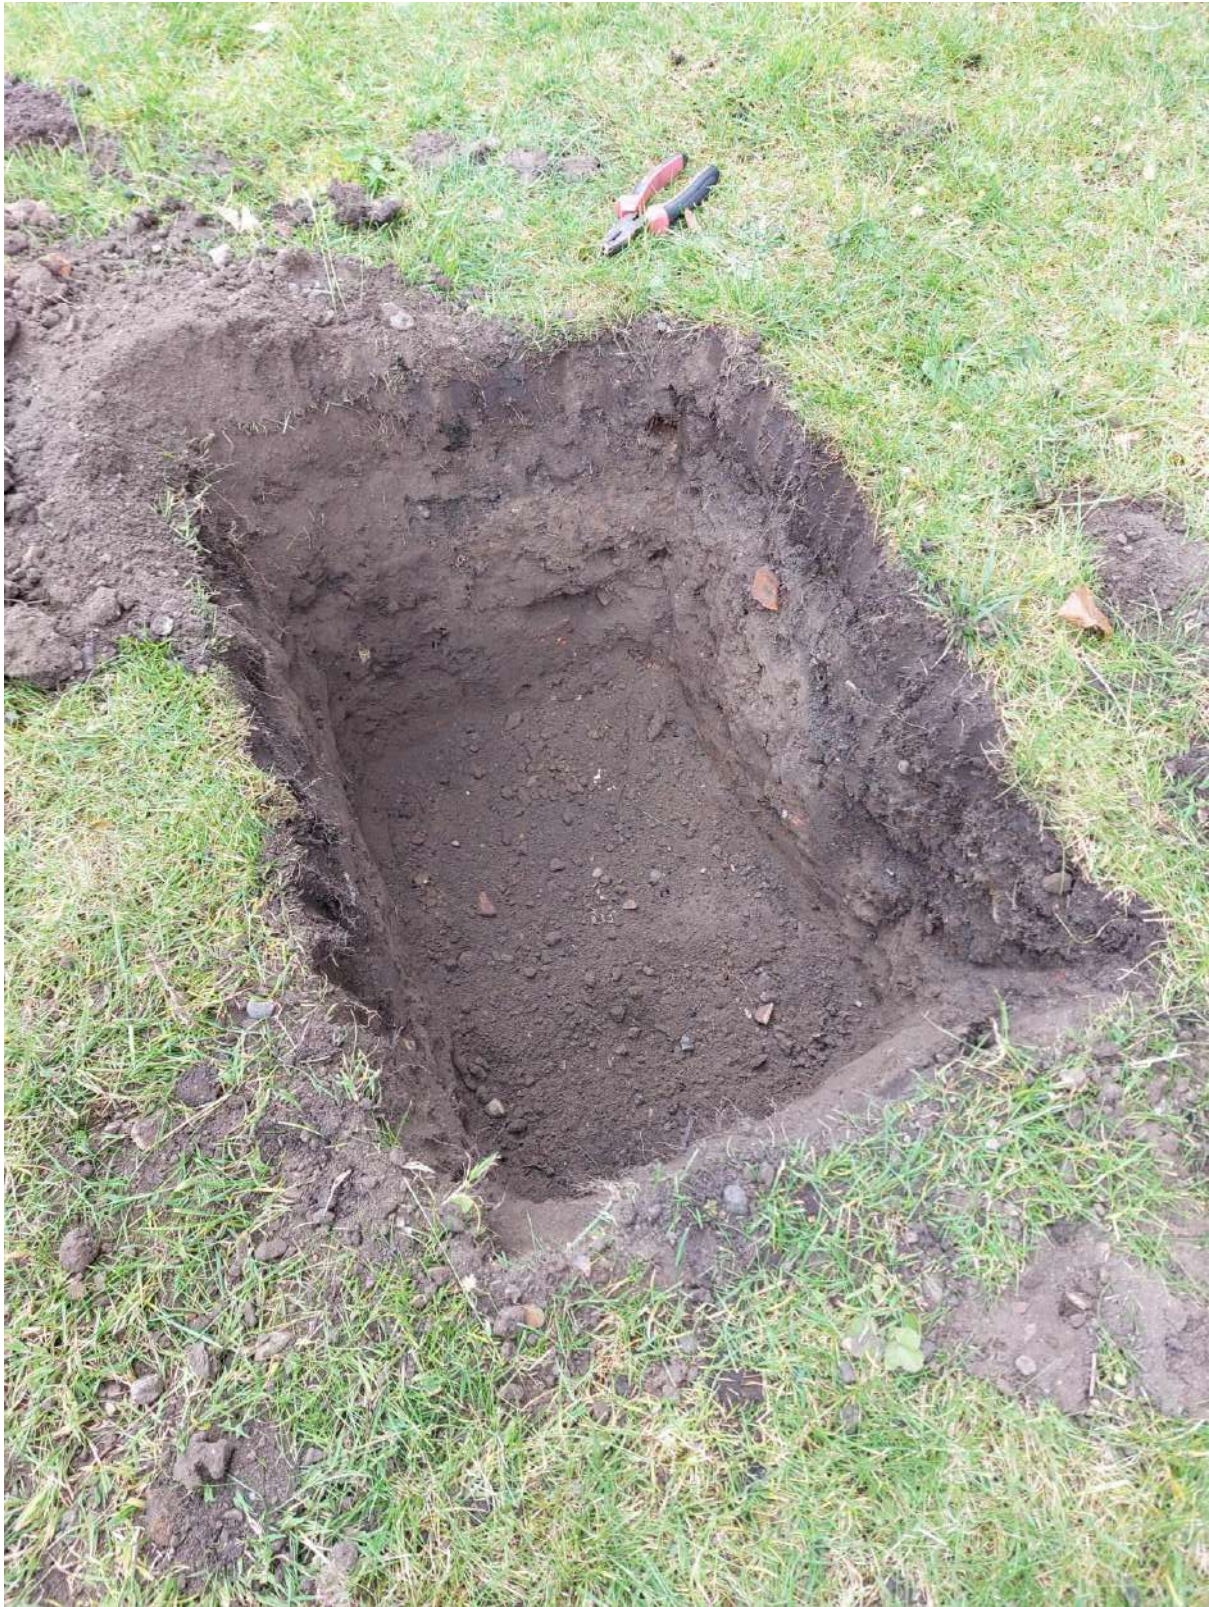
Measures have, however, been taken to further investigate and – if needed – mitigate the likely impact on trees T1 and T3. A trial pit was carefully dug, by hand, in the incursion area of T3’s RPA, in order to check for the presence of major roots and/or large clusters of minor roots. No such roots were encountered or observed within this pit, or at its edge; compacted soil layers were encountered during this process, consistent with the historic industrial usage of the site. Such compaction often corresponds with a lack of any significant rooting mass being present. A similar pit is to be dug within the incursion area of tree T1’s RPA. The approximation locations of these pits are marked on the Tree Protection Plan (**Appendix C**), and a photograph of T3’s trial pit is attached below as part of **Appendix E**.

The absence of roots in T3’s trial pit further reinforces the conclusion that no disruption or other detriment will be caused by the current proposal.

Showing trial pit dug in approximate location marked on Tree Protection Plan, where proposed elevation of new building intersects edge of tree T3's RPA. No roots encountered when digging pit, or visible in edges/base.

Although no roots were encountered in T3's trial pit, and a similar result is expected for T1, works within the Root Protection Areas will nonetheless be conducted using hand tools only, in order to avoid damage to any roots which are present and can be preserved. Furthermore, should major roots be encountered within either incursion area, a beam foundation will be used in order to preserve the root(s) in question. A sketch diagram demonstrating this proposal is included as part of **Appendix E**. Should no major roots be encountered within any of the incursion areas, standard trench foundations will be used throughout.
