# STOKES HOUSE, HAM STREET

## Heritage, Design and Access Statement Planning Application

Stokes House  
Ham Street,  
Richmond  
TW10 7HR

August 2024

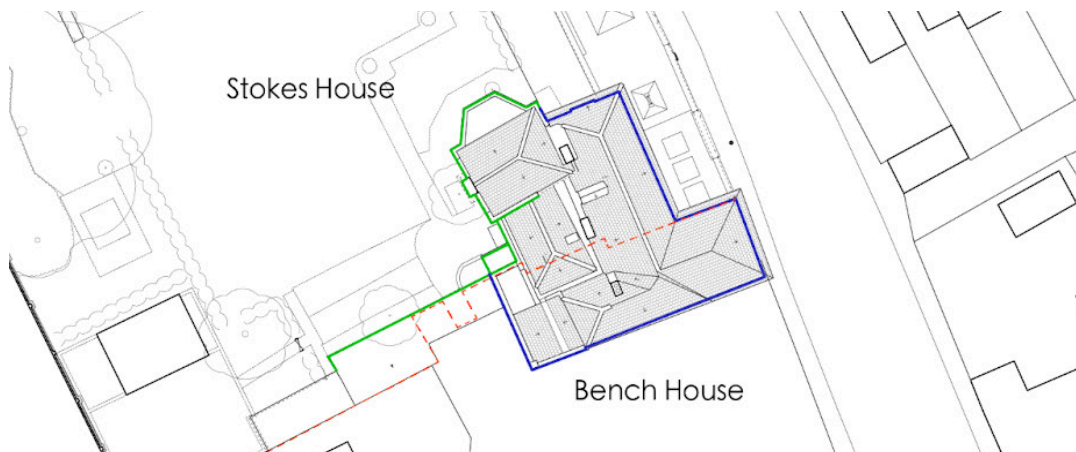
Fig.09 - Painted brick indicated in green; Render indicated in blue

The precise evolution of the external finishes of this building is unclear. Today, when examining the two properties, it is evident that the render covers the entirety of Bench House, extending into the three-storey section of Stokes House. However, at this junction, the render is interrupted; the lower section of the bay retains render, which then transitions to painted brick and cement.

Based on the evidence from the maps and images, we conclude that the entire building may have initially been lime-rendered as originally the brickwork would never have been painted. Over time, sections were likely stripped away, exposing bricks that may have been damaged in the process. As a quick fix to maintain the overall aesthetic, the exposed bricks and damaged areas were cemented and painted over, which account for the irregular patches of render and brick observed today. Even if these walls were not originally rendered the exposed brick has clearly

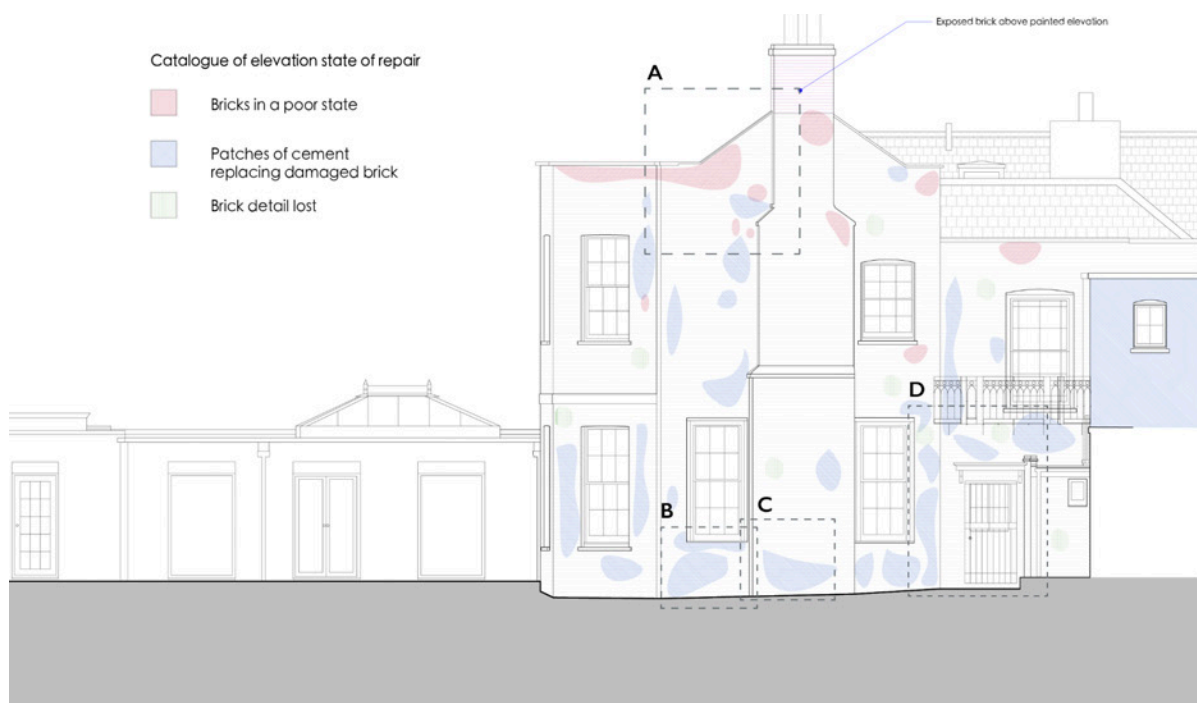
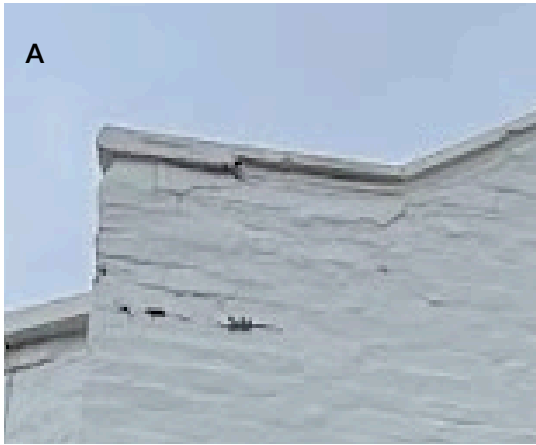
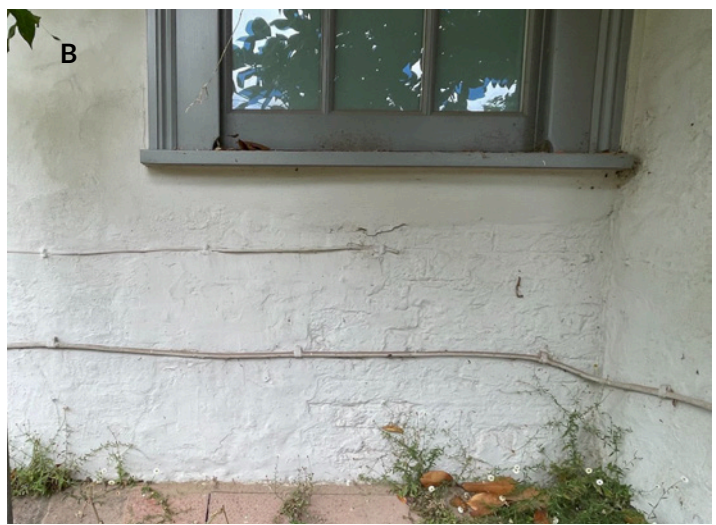
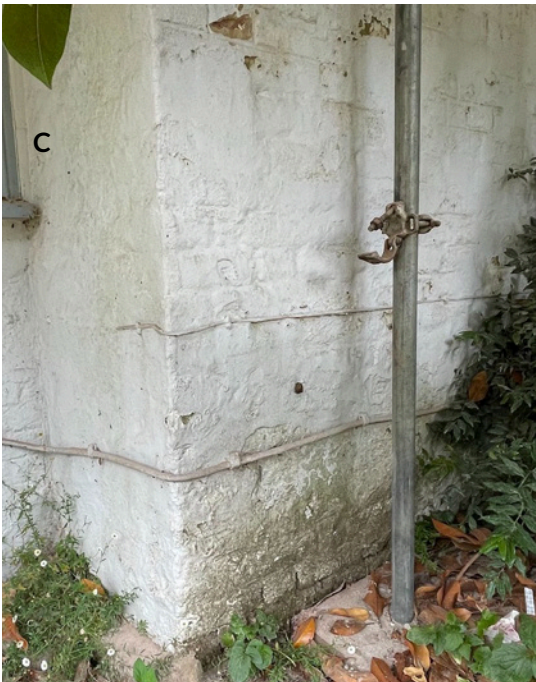
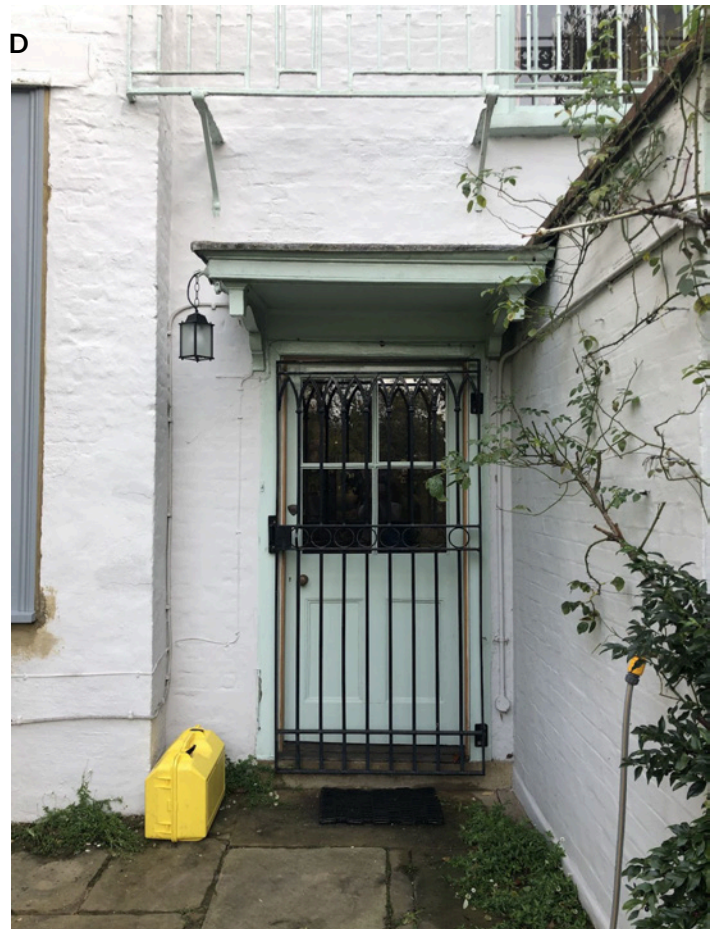
Fig.10: Existing Western Elevation - Diagram.

### Area 1 - Western Elevation encompassing the front entrance to Stokes House

*Detail shows: significant cement patches around the front entrance door. Bricks splitting at the parapet level and the deterioration of brick and cement around the windows*

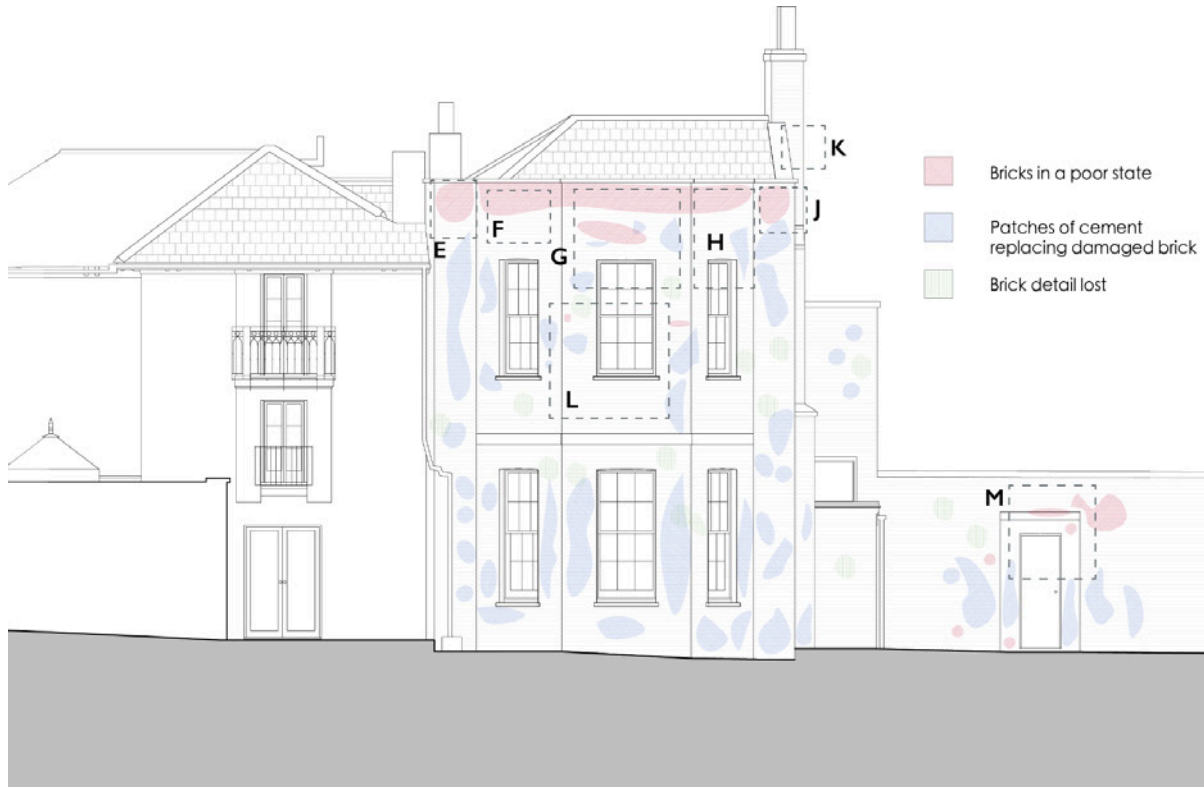
Fig.11: Existing Northern Elevation - Diagram

### Area 2 - Northern Elevation encompassing the Main Bay section and boundary wall to Stokes House

Detail shows: the bubbling near the top towards the parapet area. Poor bricks around the window and significant brick damage on the boundary wall areas.
