**Arboricultural Implications
Assessment
for a proposed development
at
Sevenoaks
101a High Street
Hampton
TW12 2SX
Rev A**

**Client: Holland Green Architecture
The Old Grammar School
Church Road
Thame
OX9 3AJ**

Date
11/09/2024

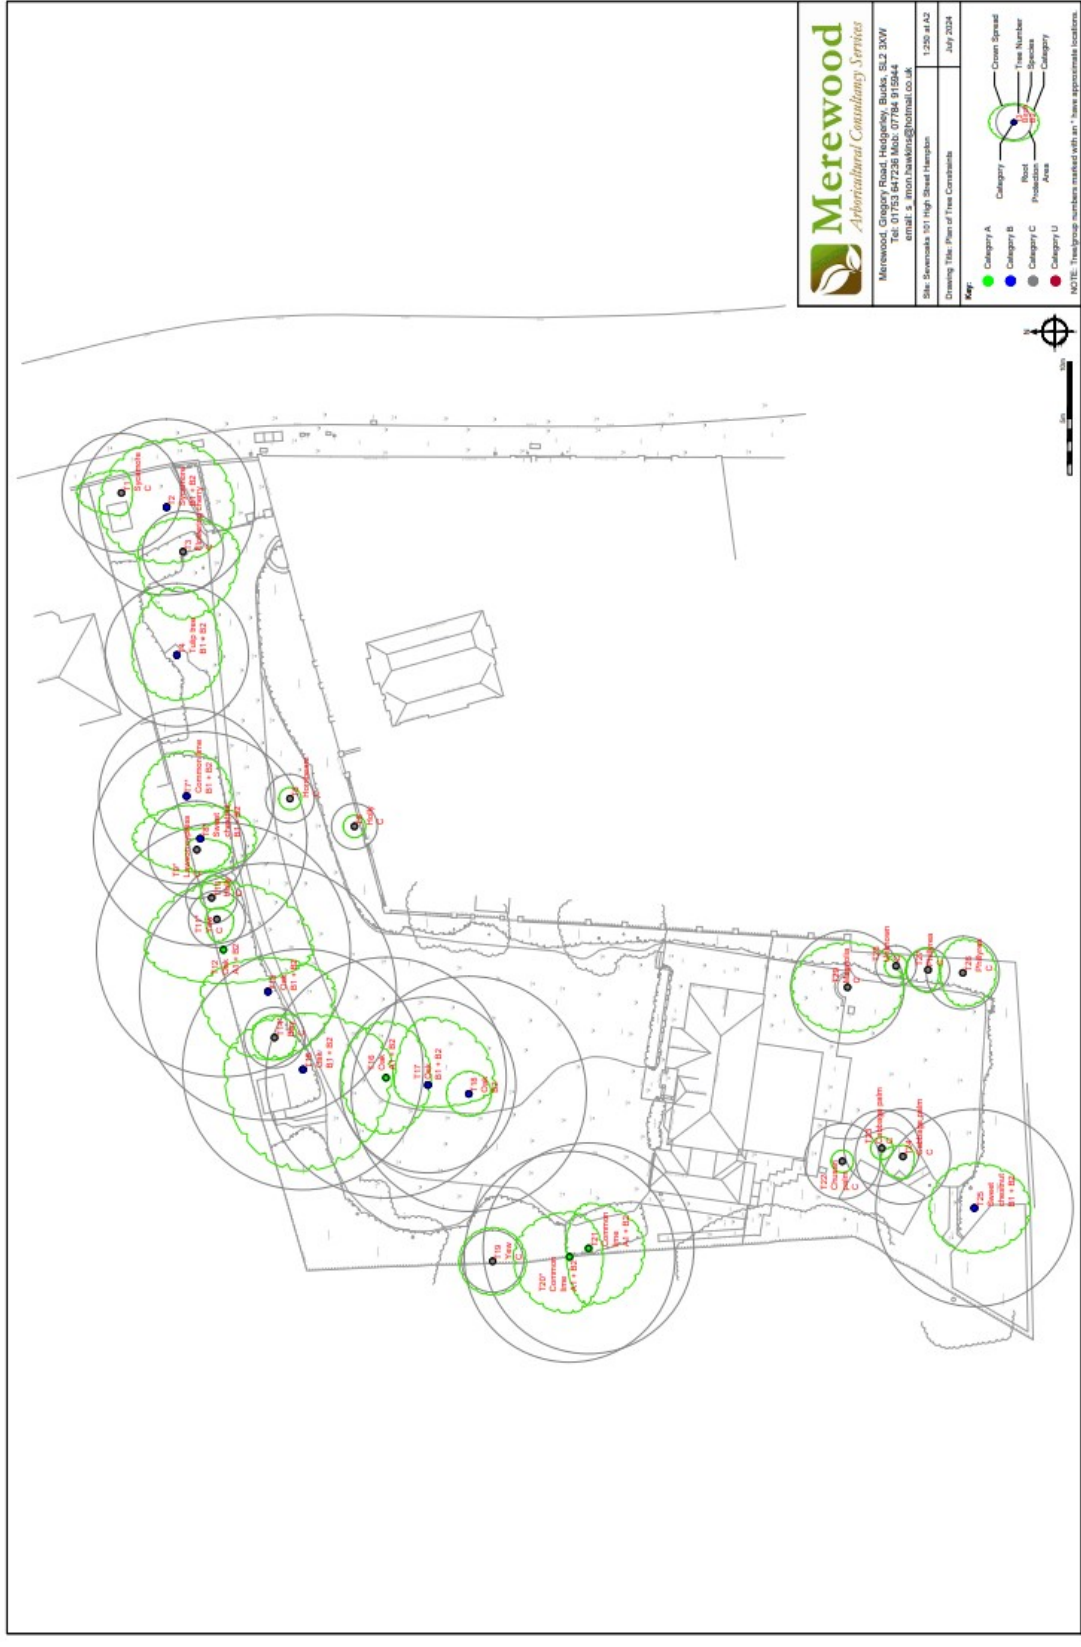
Drawing Title: Plan of Tree Constraints

Tree no	Species	Height	Stem diameter	Crown spread				Physiological condition	Structural condition	Age	Observations/ Management recommendations	Life expectancy	Category
				North	South	East	West						
T1	Sycamore	6	440	4	1	2	2	F	P	M	Tree has been lopped with decay developing in the main stem	10 - 20	C
T2	Sycamore	20	650	6	6	6	5	G	G	M	Tree has been lopped in the past	40+	B1 + B2
T3	Flowering cherry	6	300	4	5	3	6	F	F	M		20 - 40	C
T4	Tulip tree	17	530	4	4	6	4	F	G	M		40+	B1 + B2
T5	Hornbeam	6	180	1	1	1	1	G	G	M		40+	C
T6	Holly	4	170	1	1	1	1	G	F	M		40+	C
T7	Common lime	23	650	4	4	4	3	G	G	M		40+	B1 + B2
T8	Sweet chestnut	20	790	6	5	3	3	G	G	M		40+	B1 + B2
T9	Lawson cypress	4	360	1	3	1	2	G	G	M	Tree has been lopped in the past	20 - 40	C
T10	Holly	4	190	1	2	2	1	G	G	M		40+	C
T11	Yew	4	210	1	1.5	1	2	G	G	M		40+	C
T12	Oak	22	940	7	8	6	3	G	G	M		40+	A1 + B2

Tree no	Species	Height	Stem diameter	Crown spread				Physiological condition	Structural condition	Age	Observations/ Management recommendations	Life expectancy	Category
				North	South	East	West						
T13	Oak	22	950	6	6	3	6	F	G	M	Bacterial ooze on lower west stem	40+	B1 + B2
T14	Bay	5	200 100	2	2	2	2	G	G	M		40+	C
T15	Oak	18	890	7	8	5	9	G	G	M		40+	B1 + B2
T16	Oak	23	890	4	4	5	5	G	G	M		40+	A1 + B2
T17	Oak	20	650	3	6	6	2	G	G	M		40+	B1 + B2
T18	Oak	19	870	2	2	2	2	G	F	M	Tree has been lopped in the past. Some decay developing at wound points	40+	B2
T19	Yew	5	230	3	3	3	3	G	G	M		40+	C
T20	Common lime	24	780	5	3	4	5	G	G	M		40+	A1 + B2
T21	Common lime	24	780	2	5	4	5	G	G	M		40+	A1 + B2
T22	Chusan palm	6	280	1	1	1	1	G	G	M		40+	C
T23	Cabbage palm	7	280	1	1	1	1	G	G	M		40+	C
T24	Cabbage palm	7	310 120 120	2	1	1	2	G	G	M		40+	C

Tree no	Species	Height	Stem diameter	Crown spread				Physiological condition	Structural condition	Age	Observations/ Management recommendations	Life expectancy	Category
				North	South	East	West						
T25	Sweet chestnut	12	730	4	5	4	4	G	G	M		40+	B1 + B2
T26	Phillyrea	7	270	2	3	3	3	G	G	M		40+	C
T27	Phillyrea	7	160	2	1	2	2	G	G	M		40+	C
T28	Unknown	6	150	1	1	1	1	G	G	M		40+	C
T29	Magnolia	8	220 280 220	5	5	4	4	G	G	M		40+	C

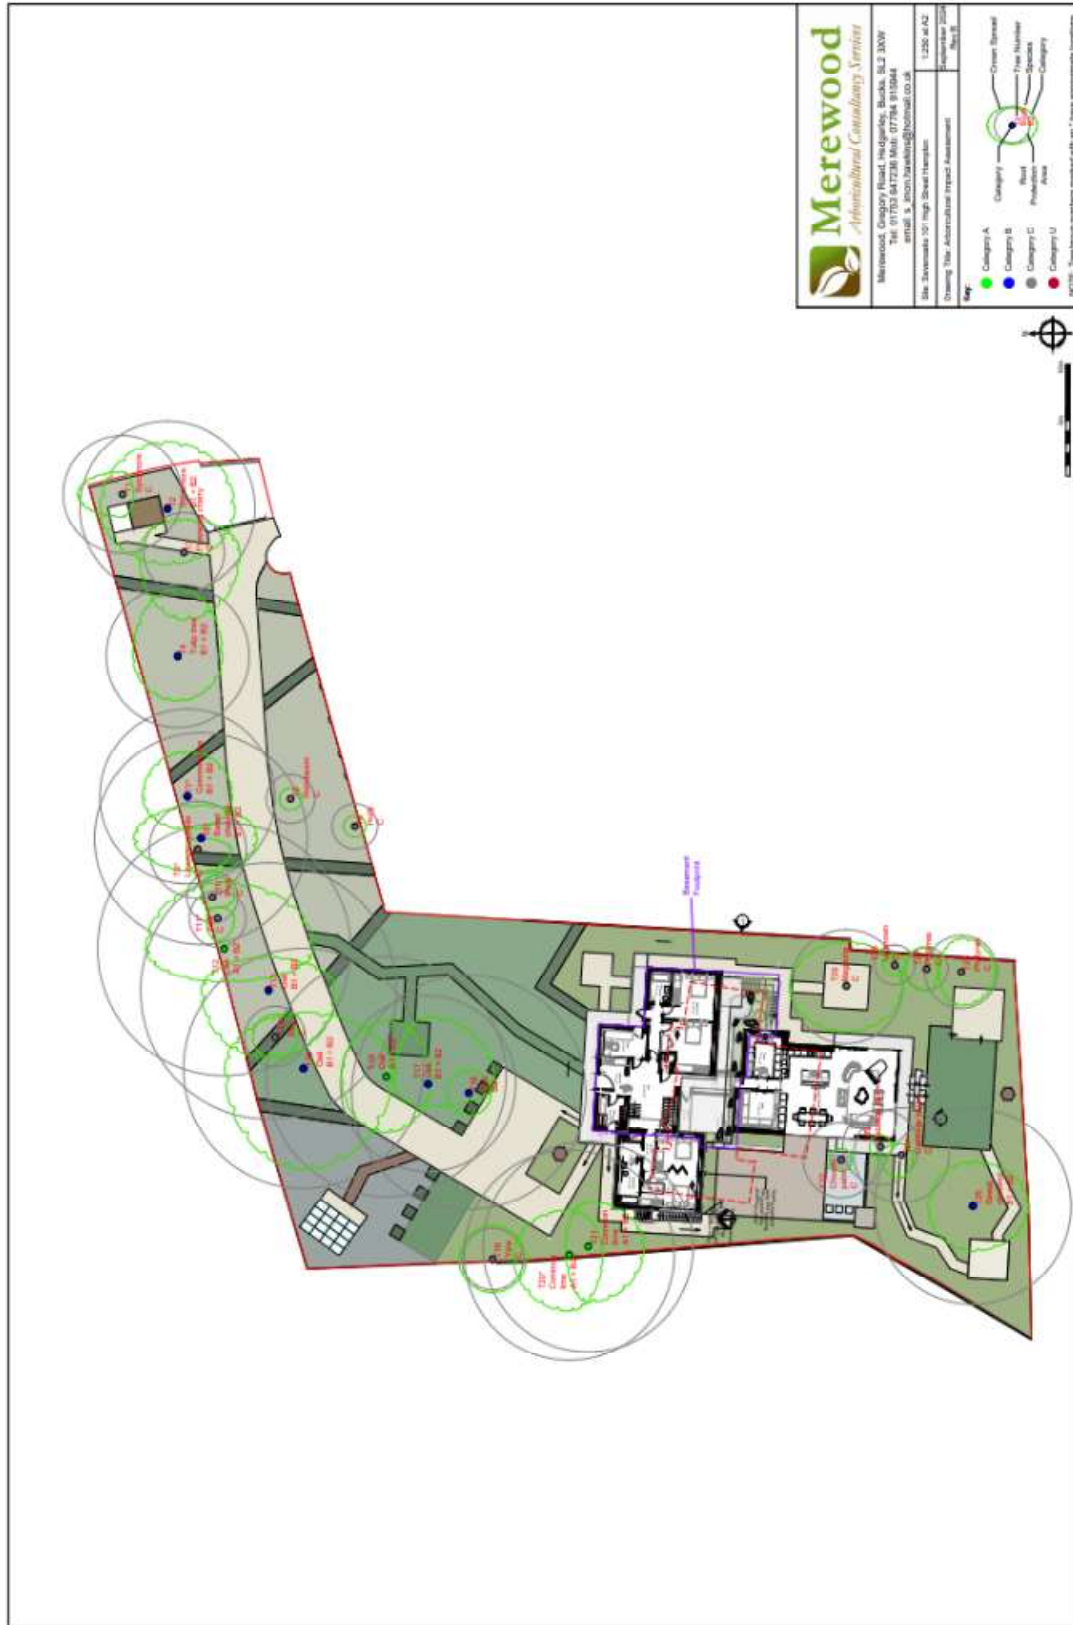
Appendix 4 Impact Assessment Plan

3.2.1 The proposed development will result in the loss of 3 category 'C' trees (T22, T23 and T24) in order to implement the proposed design.

- 3.4.2 It is clear from the Impact Assessment plan that there are areas where the required working space is needed to manoeuvre vehicles and position plant machinery such as a crane, which overlap the RPA's of certain trees. In order to protect the roots and the soil surrounding these trees, ground protection mats are to be secured into position.

3.6.2 The section of the proposed building on the northwest side of the new structure is a first floor level construction, cantilevering out across the RPA's of the limes (T20 and T21). Whilst this keeps the structure above ground level (thus avoiding any significant excavations), a single pad (1m x 1m x 0.8m deep) is to be constructed in order to provide the support for a column for the extension. B.S. 5837 provides advice in such circumstances.

- 3.4.3 The proposed widening and resurfacing of the driveway has the potential to impact on nearby roots. In order to overcome this potential impact it is proposed to install the Root Bridge system (provided by Green Grid systems).
- 3.4.4 The installation of the Root Bridge product needs to be undertaken before the main construction work commences, in order to provide a suitably robust surface for construction traffic to operate across.
- 3.4.5 Root Bridge is a robust grid system that requires the insertion of small screw piles to support the weight of the grids. The actual insertion of these piles is acknowledged to cause a small amount of minor root damage, but this is minimal and the benefits provided by this product outweigh the disadvantage of this slight harm.
