MICHAEL JONES ARCHITECTS

drav job title Chapel in The Woods Pr client drav St.Mary's University, Twickenham 19

awing title		scale	1:50@A3
roposed East Elevation		date	June 2024
awing number	rev	drawn by	XD
943.03.03.Pln.060		checked by	AB

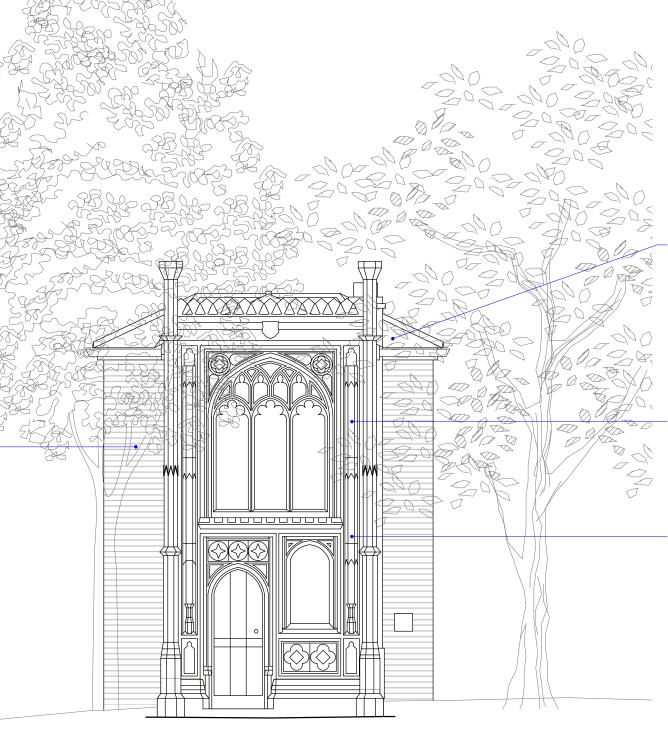
is to be re-set and/or repaired using materials to match existing. Particular attention to be paid to the leadwork above the east elevation, where it is flashing up the back of the damaged stone parapet. This will likely need to be redone once the stonework repairs have been

- Where stone is cracked and failing, it is to be cut back and portland stone indents are to be installed. - The portland stone carved shield from the parapet of the stone elevation is missing,

External Brickwork -Brickwork is to be stripped of the modern paint finish. - Any flaking and loose paint is to be removed by hand using a soft

surrounding ground and adjacent areas of stonework, to avoid damage and contamination. - All areas of painted brick are to be treated with a combination of KEIM and FUZE paint strippers, which are appropriate for heritage projects. (Both products will be tested on a discreet area to ensure they are effective and do not damage the underlying brick). - Once the paint stripper has lifted the paint from the surface of the brickwork, the Therma Tech steam cleaning system will be used to remove the locae paint.

clined out of set at the point. point. - It is anticipated that following stripping of the paintwork, the pointing on the external walls may need to be renewed. Should this be required, the existing mortar will be raked out by hand to a depth of 20mm, and the brickwork will be repointed using a hydraulic lime mortar. - Once the paint is successfully removed the brickwork condition and

Option 1 (preferred) - If the brickwork is in good condition and of an attractive appearance, it will be left as exposed brick.

Option 2 - if the brickwork is not attractive, and is in poor condition, we will paint over it with a breathable lime wash.

All gutters and downpipes are to be thoroughly cleaned and all connections and brackets are to be inspected and tested. Where failures have occurred repairs are to be carried out. All new parts to be in matching design and materials to existing.

- Slate roof covering is to be thoroughly cleaned and inspected. Any damaged or broken slates are to be removed and replaced with reclaimed slates to match existing. - All lead flashings to be inspected. Any leadwork that is damaged or lifted

completed. - Sections of rotting timber fascia beneath gutters are to be cut out and replaced with new hardwood fascia, to be joined carefully to existing. - All existing and repaired timber fascia to be rubbed down and thoroughly prepared, to be redecorated.

- Failed hanging finials to be repaired by specialist as follows: - Failed hanging finials to be replaced in portland stone to match originals, to be fixed using stainless steel threaded dowels and stone resin.

to be replicated and replaced in portland stone. - See also our Design and Access/Heritage Statement, and drawing 1943.01.03 Stonework Damage, showing the location of each of these areas on the elevation.

East facing stone facade to be cleaned by specialist as follows: - Stone to be gently brushed with soft brush to remove any loose or superficial dirt

Sone to be brushed with light to stiff brushes.
Sone to be brushed with light to stiff brushes.
Therma Tech steam cleaning system applied with very low pressure to avoid damage to the stonework. The heat from the steam cleaning system will lift the remaining dirt from the surface of the stone.
