LISTED BUILDING APPLICATION

JOB TITLE:
KNELLER HALL

DRAWING TITLE:
WEST ELEVATION - PROPOSED EXTERNAL REPAIRS

SCALE: 1 : 100	DRAWING SHEET SIZE: A1	
JOB CODE: 001506	DRAWING NUMBER: ADP-01-XX-DR- A-1219	REVISION: D2 P 7

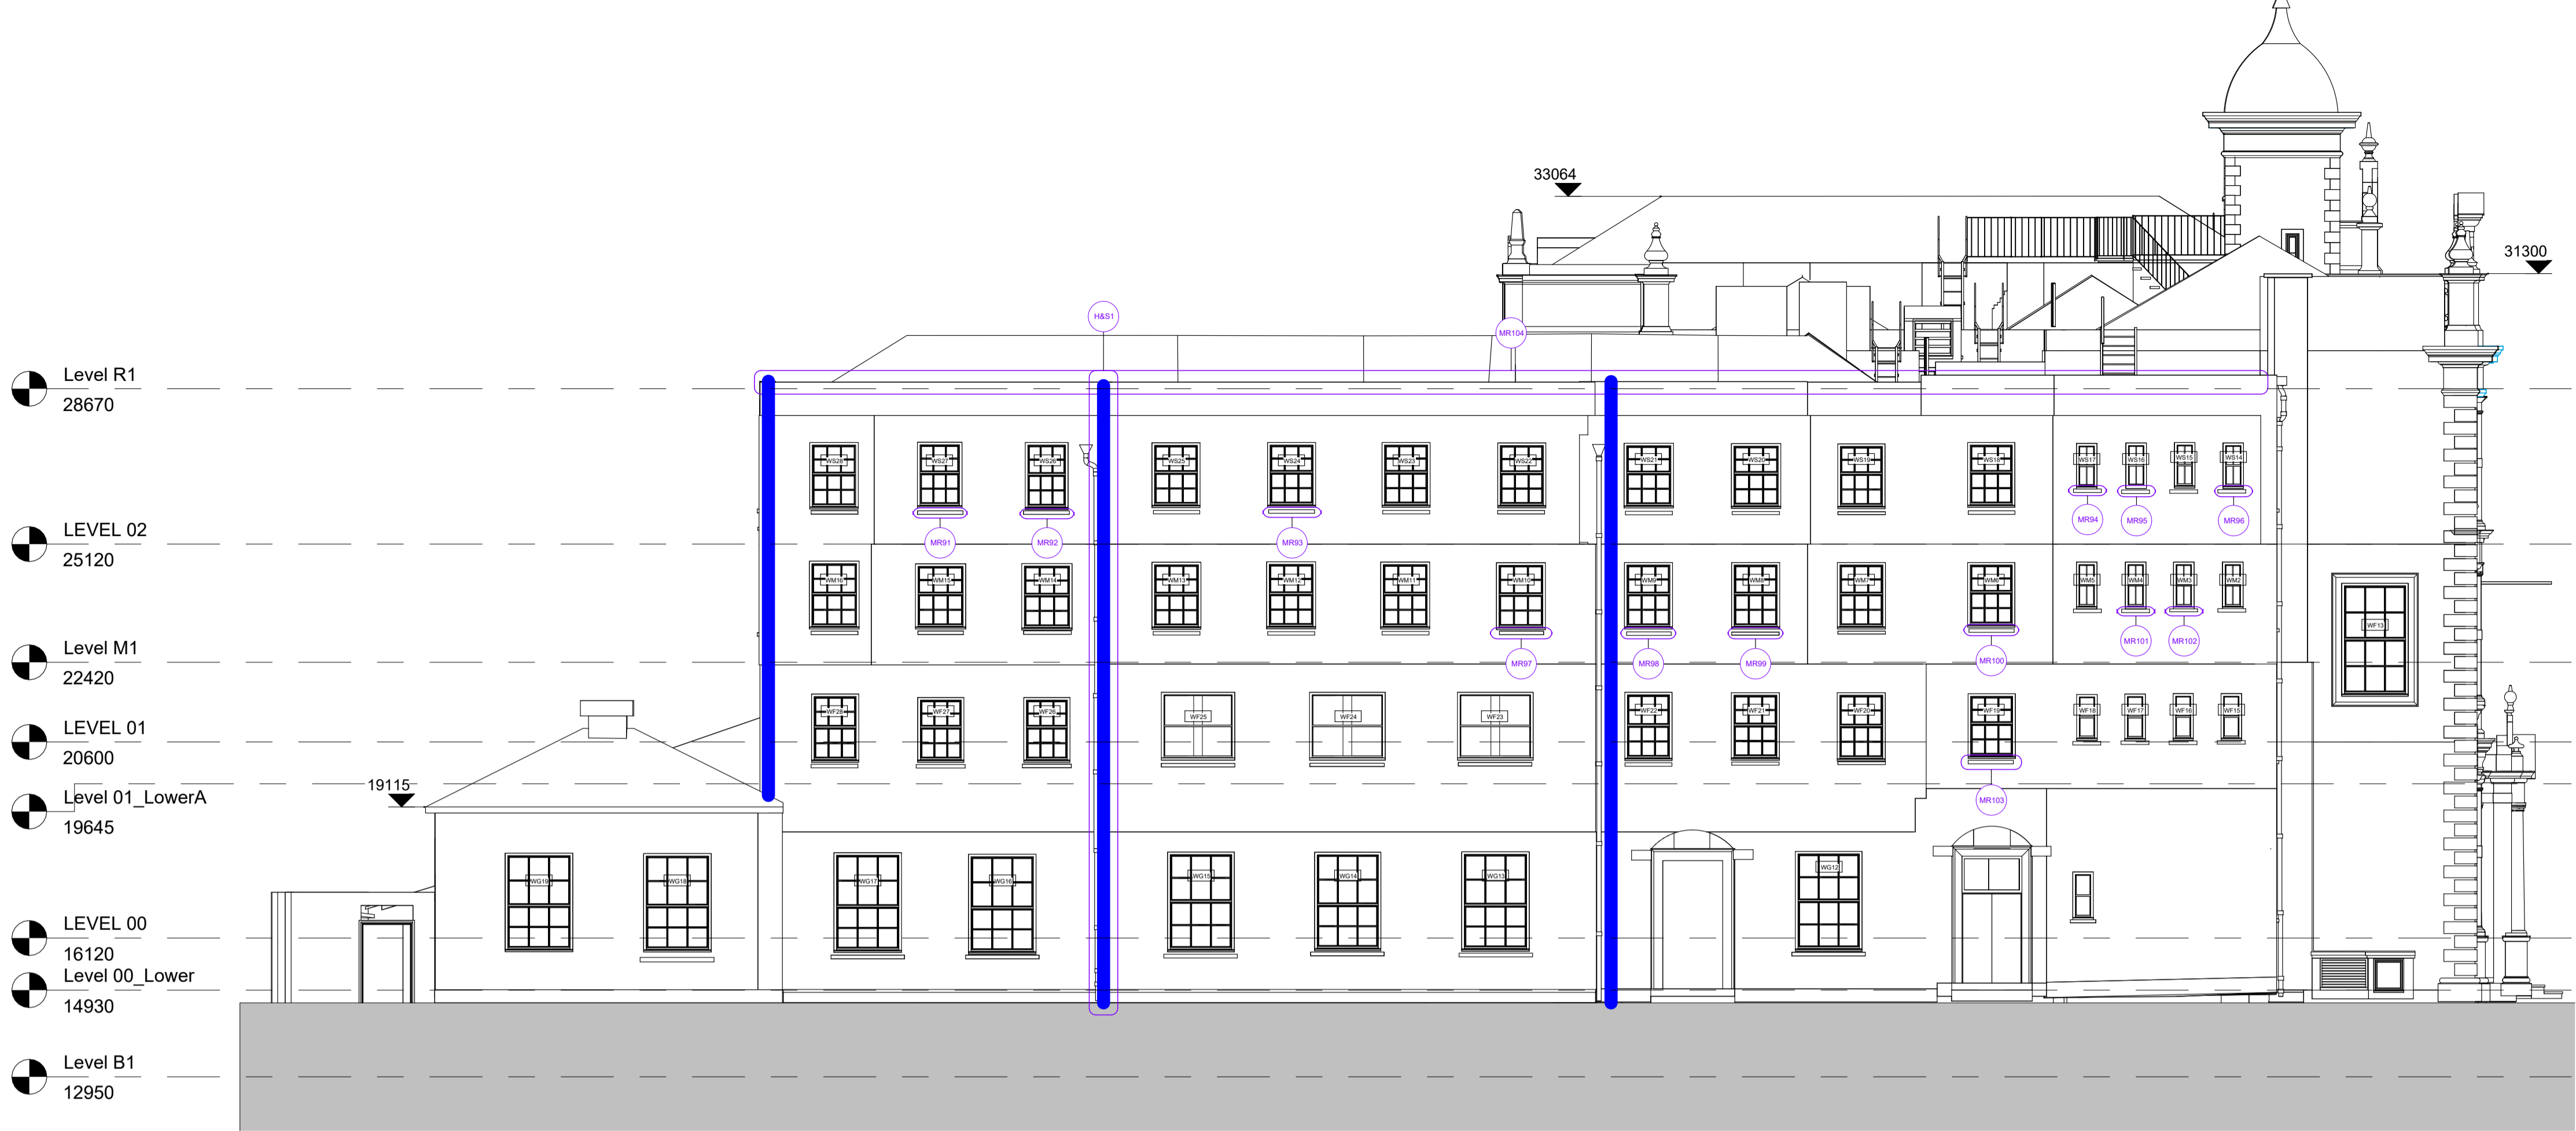
1 WEST ELEVATION PROPOSED EXTERNAL REPAIRS
1 : 100

External Repairs Schedule - West (Application Rev 01)			
Reference	Purpose	Notes	Decoration
H&S1	Health & safety	Proposed location for lightning protection. Refer to suppliers drawing for further information.	—
MR91	Water ingress	Defective York stone window cill to be replaced with Portland stone cill	
MR92	Water ingress	Defective York stone window cill to be replaced with Portland stone cill	
MR93	Water ingress	Defective York stone window cill to be replaced with Portland stone cill	
MR94	Water ingress	Defective York stone window cill to be replaced with Portland stone cill	
MR95	Water ingress	Defective York stone window cill to be replaced with Portland stone cill	
MR96	Water ingress	Defective York stone window cill to be replaced with Portland stone cill	
MR97	Water ingress	Defective York stone window cill to be replaced with Portland stone cill	
MR98	Water ingress	Defective York stone window cill to be replaced with Portland stone cill

MR99	Water ingress	Defective York stone window cill to be replaced with Portland stone cill	
MR100	Water ingress	Defective York stone window cill to be replaced with Portland stone cill	
MR101	Water ingress	Defective York stone window cill to be replaced with Portland stone cill	
MR102	Water ingress	Defective York stone window cill to be replaced with Portland stone cill	
MR103	Water ingress	Defective York stone window cill to be replaced with Portland stone cill	
MR104	Water ingress	Stone band to be re-pointed and isolated render repairs to be carried out where render is defective and loose. Stone on corner of West elevation to be replaced as methodology item 1

1. Repair to brickwork and stonework to be minimal and limited to structural defects. Repair where necessary to reduce future weathering and water ingress.
Repointing to stonework and brickwork to be undertaken using a lime based mortar to match the tone and texture of existing mortar. Sample to be prepared on site for approval. Profile to match existing.
Stonework repair to fall under the categories;

- Lime mortar/plastic repair
 - Stone indent
 - Stone replacement
2. The method of cleaning to all brickwork is to be light touch, non abrasive & the treatment to be of minimal impact to the underlying materials.

3. Tap testing of existing stonework & quoins is required to ensure it is structurally sound when scaffold is in place.
4. General scope of works to include the cleaning, unblocking of rainwater hoppers and inspection of downpipes and if required, replacement of downpipes with like-for-like cast iron downpipes.

5. General scope of works to include the complete removal of surface mounted wires and cables.
6. General scope of works to include the removal of netting & the installation of metal grating in lightwells for pigeon protection & protection from falling. Metal grating to be black & slimline. Structural support to sit under metal grating product.

7. General scope of works to include the removal of minimal existing pigeon deterrent spikes & their replacement in areas illustrated as outlined in PD1.

8. Further works may be identified as necessary once scaffold has been installed and further visual surveys can be undertaken.
9. General scope of works to include the complete removal of vegetation throughout.

10. Paint & lead spec to be conditioned.
11. General scope of works to include the decoration and painting of vents and grilles, to match specification of paint for rainwater pipes.

12. Brickwork to be repaired where scaffolding ties into brick.
13. Brickwork to be cleaned and repointed behind pipes and wires when removed.

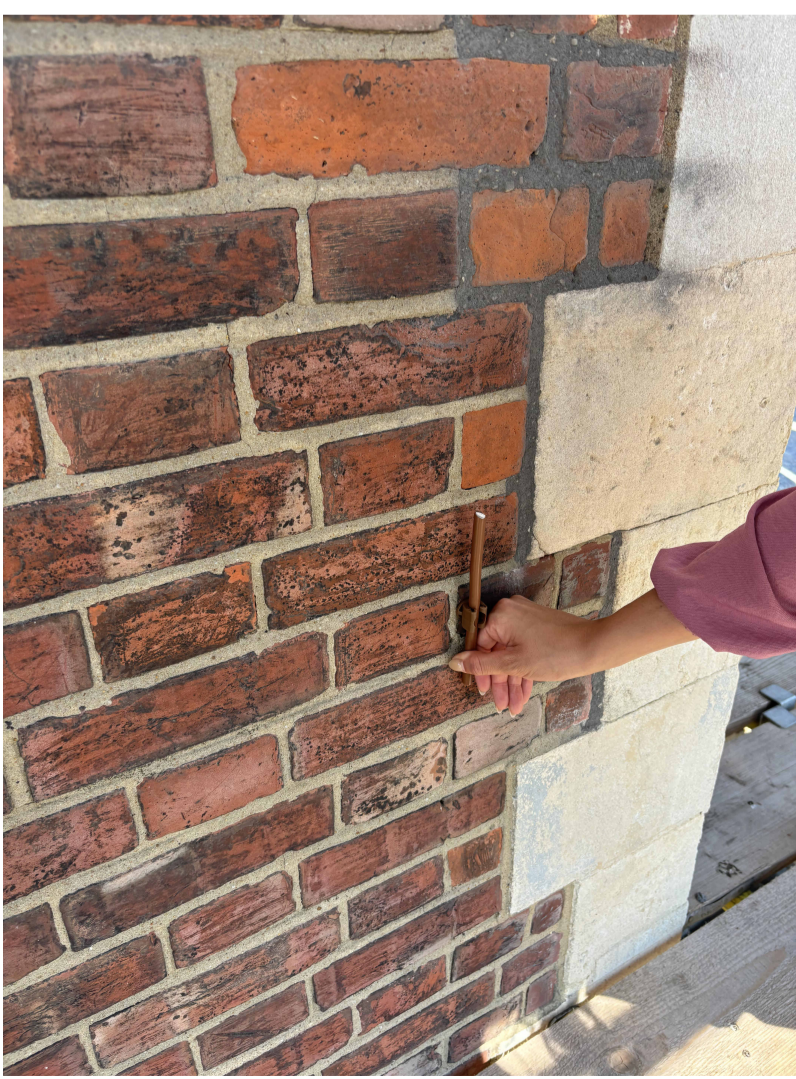
Image 1
Thin copper Lightning Protection tubes dropped down on elevations as per locations on drawing above

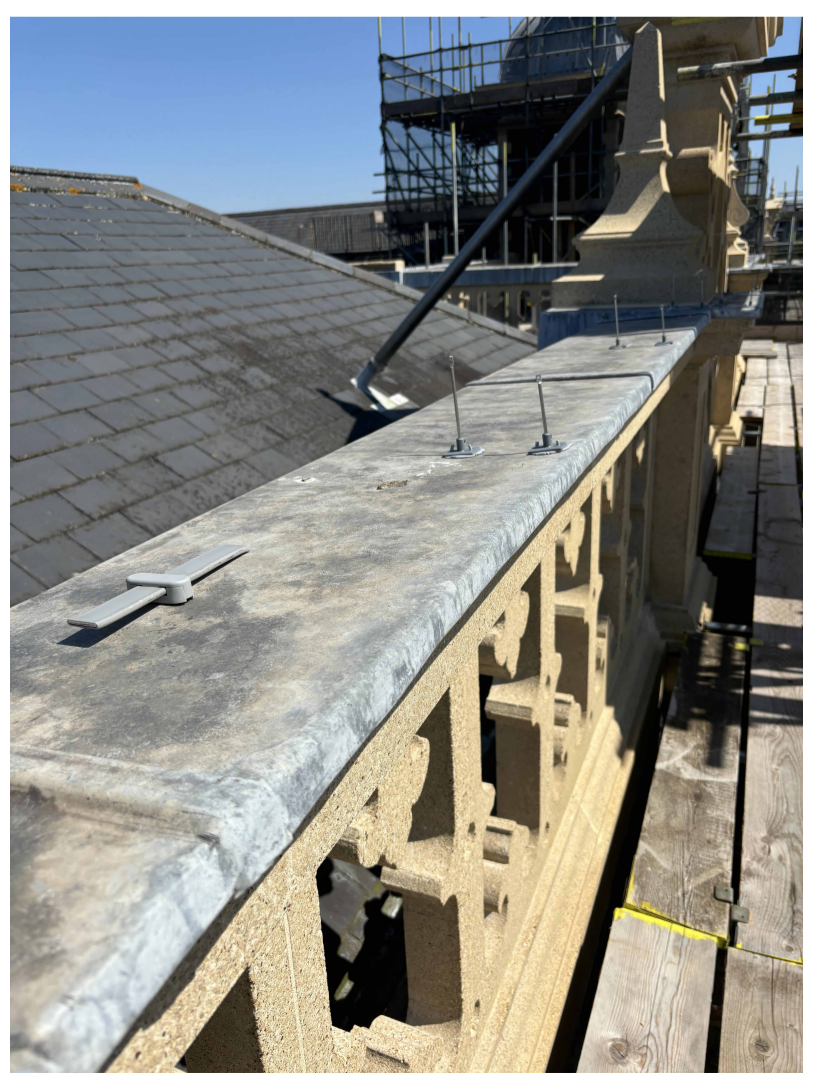
Image 2
Lightening Protection tape at roof level - refer to A-1005 & suppliers drawings for locations
