**Arboricultural Implications
Assessment
for a proposed development
at
Sevenoaks
101a High Street
Hampton
TW12 2SX
Rev B**

**Client: Holland Green Architecture
The Old Grammar School
Church Road
Thame
OX9 3AJ**

Date
29/10/2024

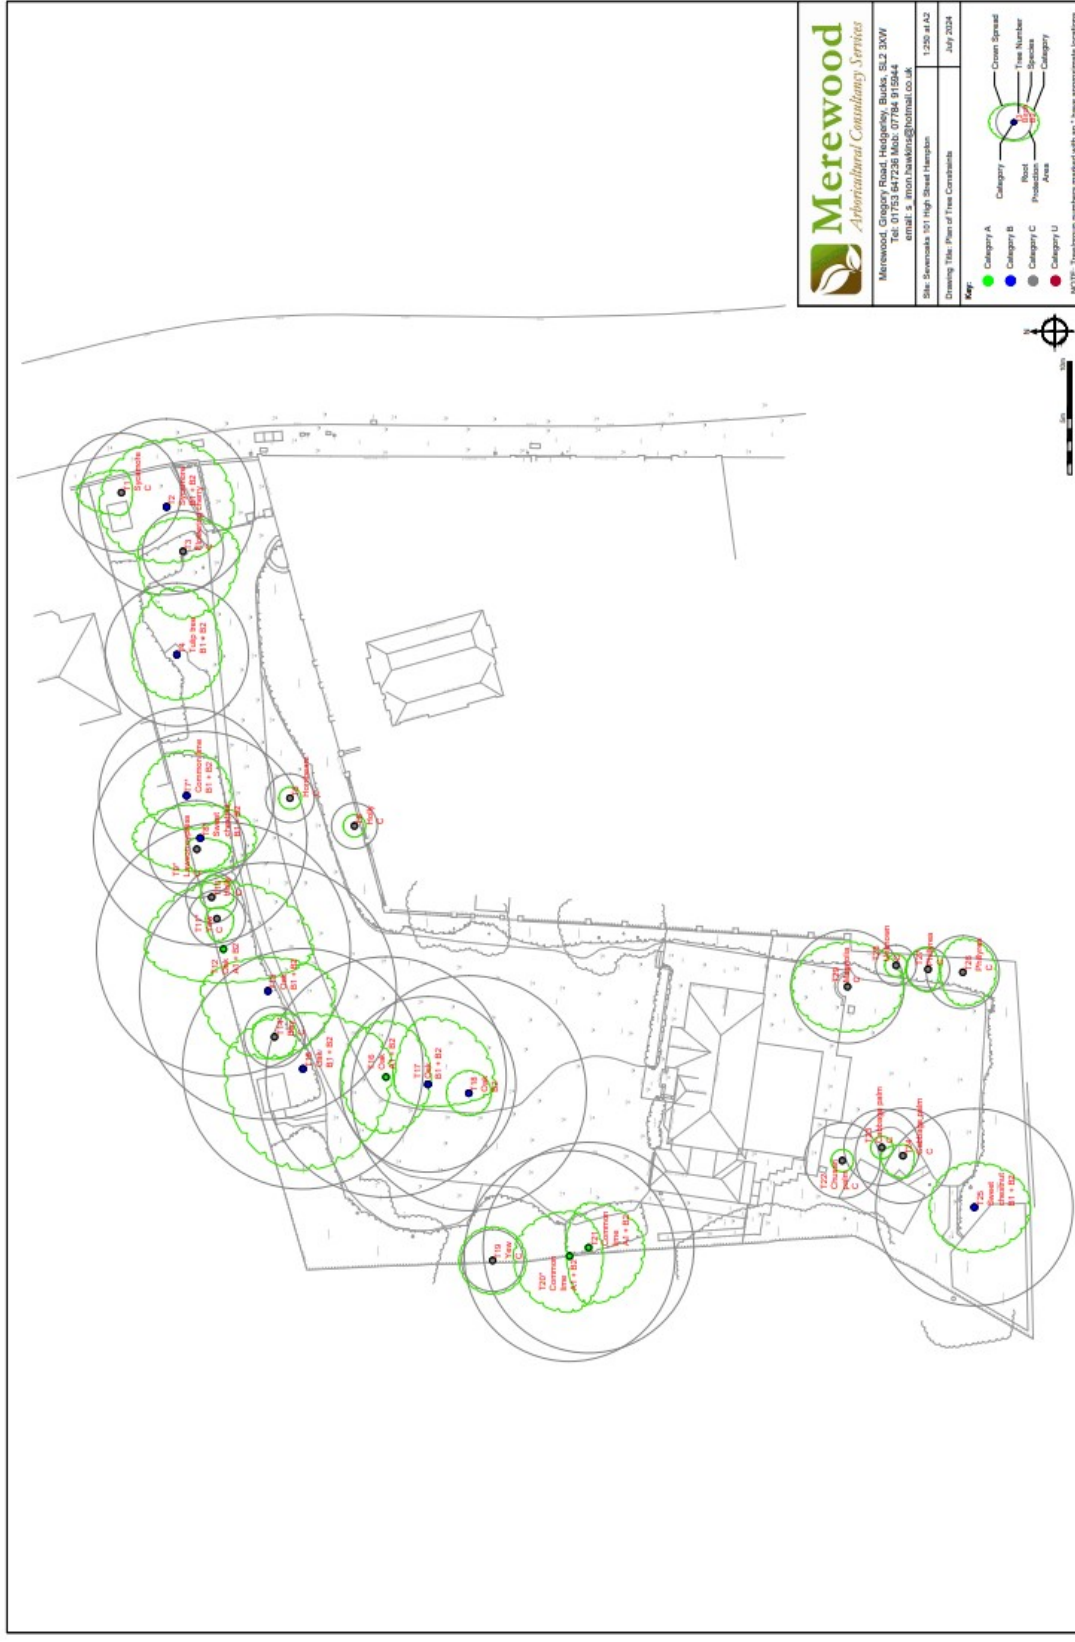
Appendix 3 Plan of Tree Constraints

- 2.1.1 Appendix 1 presents details of the individual trees and groups found during the assessment including heights, stem diameters and root protection areas (RPA's), crown spread (normally measured to cardinal points unless otherwise indicated), an indication of physiological and structural condition, age class, any appropriate management recommendations, estimated life expectancy and a BS5837 category of quality.
- 2.1.2 The survey has revealed that that of the 29 trees surveyed, 4 are category 'A'; 9 are category 'B'; 16 are category 'C' and 0 are category 'U'.

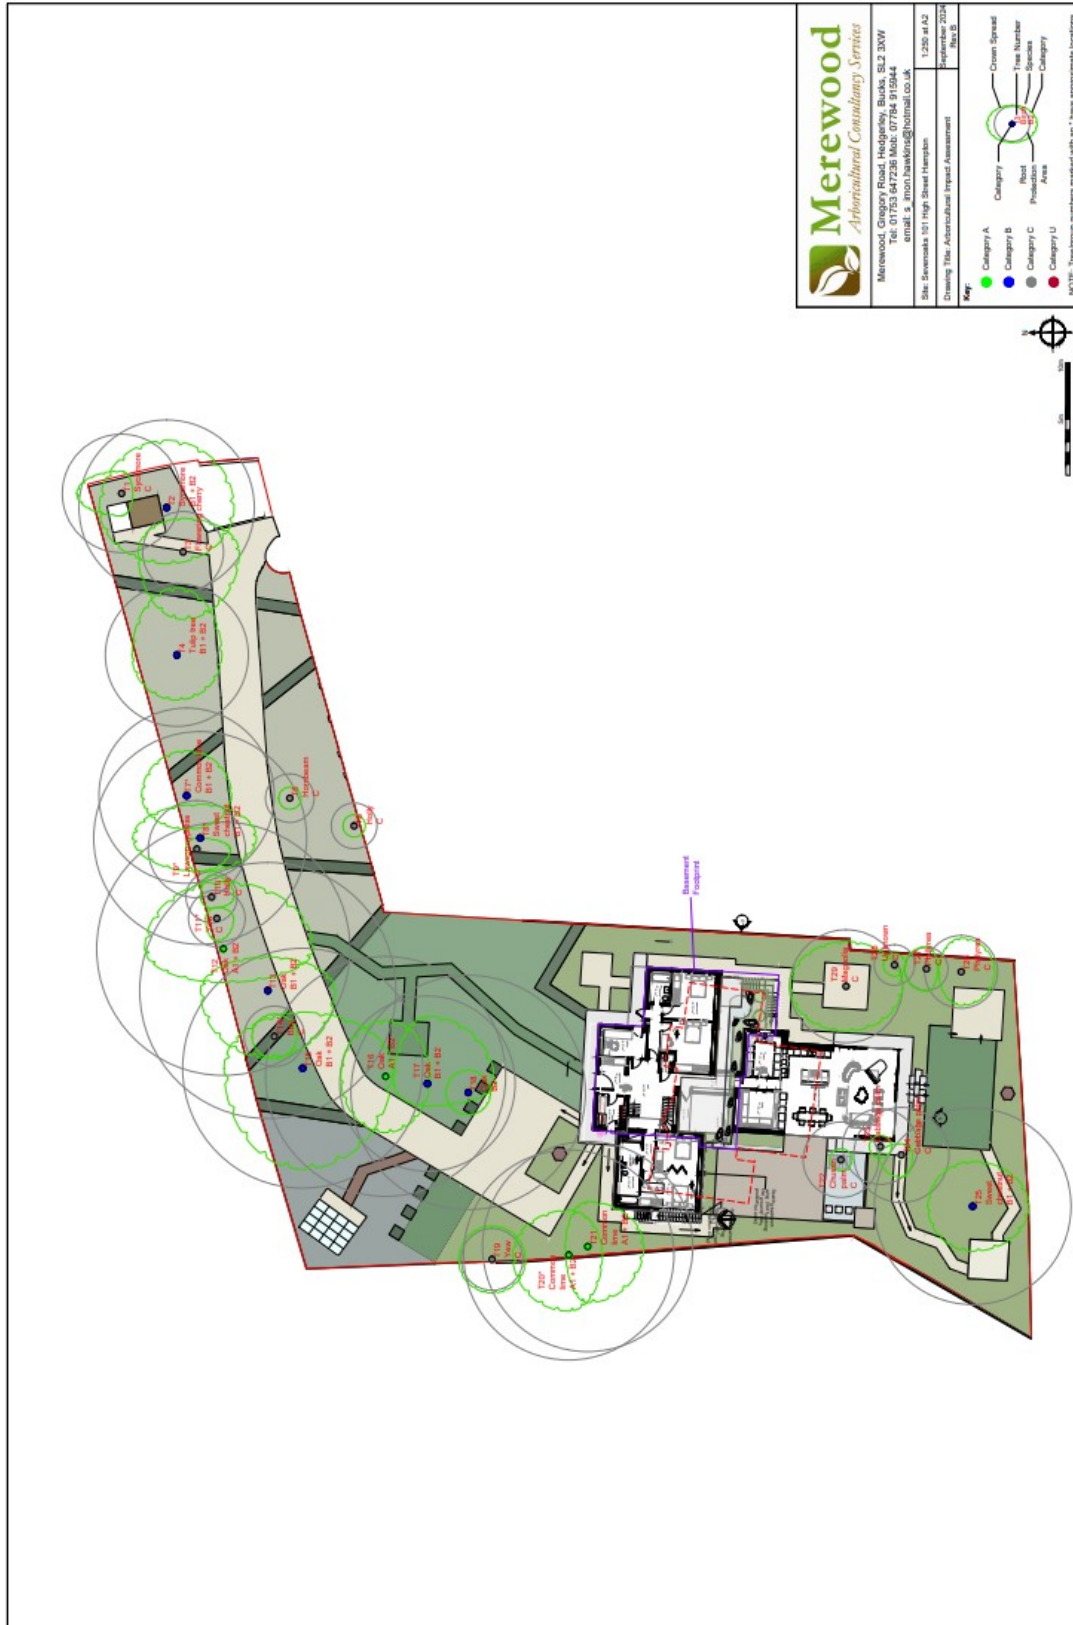
Appendix 4 Impact Assessment Plan

3.2.1 The proposed development will result in the loss of 3 category 'C' trees (T22, T23 and T24) in order to implement the proposed design.

- 3.4.2 It is clear from the Impact Assessment plan that there are areas where the required working space is needed to manoeuvre vehicles and position plant machinery such as a crane, which overlap the RPA's of certain trees. In order to protect the roots and the soil surrounding these trees, ground protection mats are to be secured into position.
