**BS5837 Arboricultural Report and
Arboricultural Impact Assessment**

OUR REFERENCE	AC.2024.301
CLIENT	Mr Uchechi Okereke
SITE	32 Park Road, Twickenham, Middlesex, TW1 2PX
REPORT BY	I S Thompson (known as Tom) M. Arbor. A., BSc. (Hons) Arb, MSc. eFor
DATE	2nd April 2024
DATE OF SITE VISIT	3rd April 2024

Application Ref No Unknown Construct a rear extension to the existing semi-detached residential dwelling

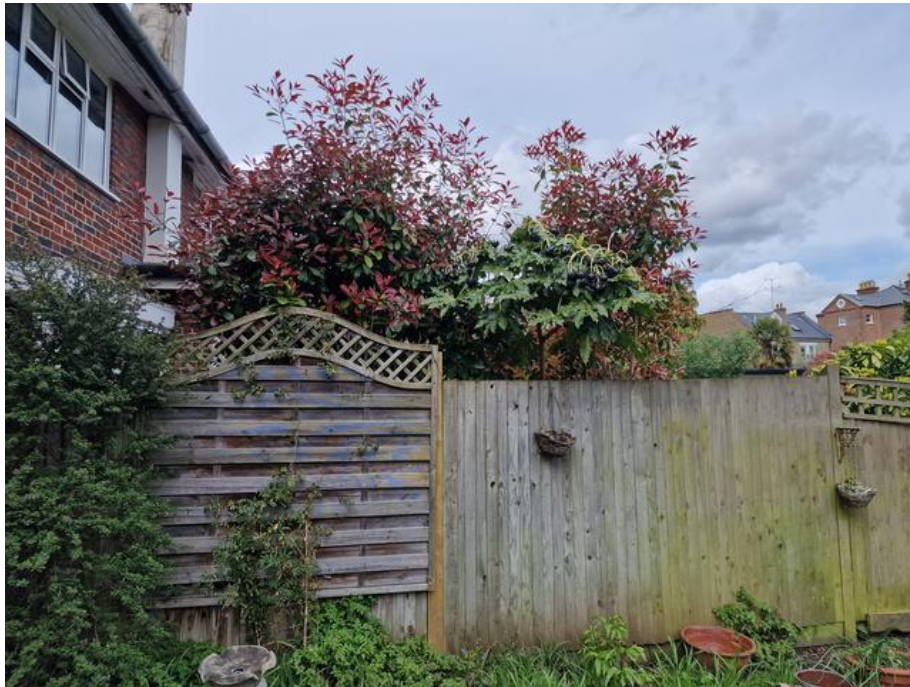
- 2.2.5** G01 is comprised of two photinia plants and one paper plant and is categorised as C2, see Images 1 to 6 and 9. G02 is comprised of a spotted laurel plant and a spindle tree and is also categorised as C2, see Image 10. Finally, there is a group of three fan palms towards the end of the clients back garden that have been grouped into G03 and categorised as C2, see Image 14.

Image 1 G01 a group of three shrubs in the adjacent property.

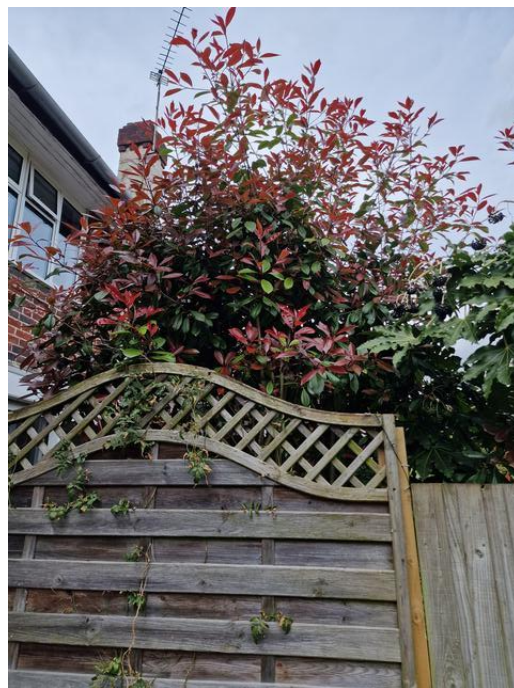
Image 2 Plant 1 of G01 a Photinia.

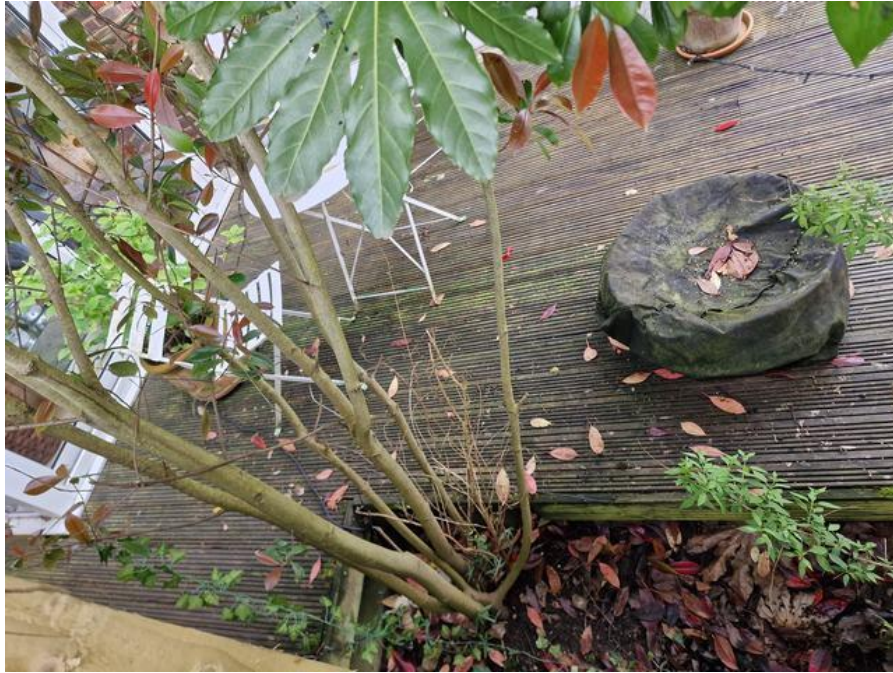
3.3.1 There is proposed construction of foundations within 1½ m of the shrubs in group G01. These all have small fibrous roots because that is all that these plants ever have, see Images 3 and 5 in Appendix III. The proposed works will not impact on the future growth potential or long term health of these plants.

Image 3 **Roots of Plant 1 a Photinia in G01.**

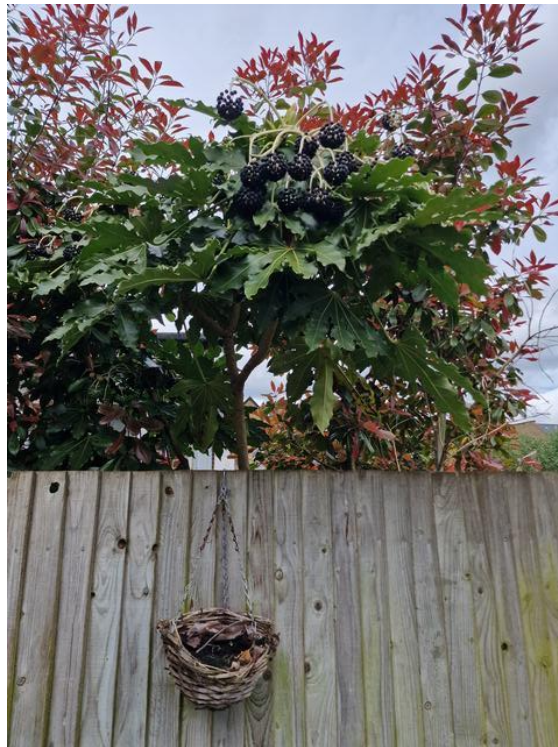
Image 4 **Plant 2 of G01 a Paper plant.**

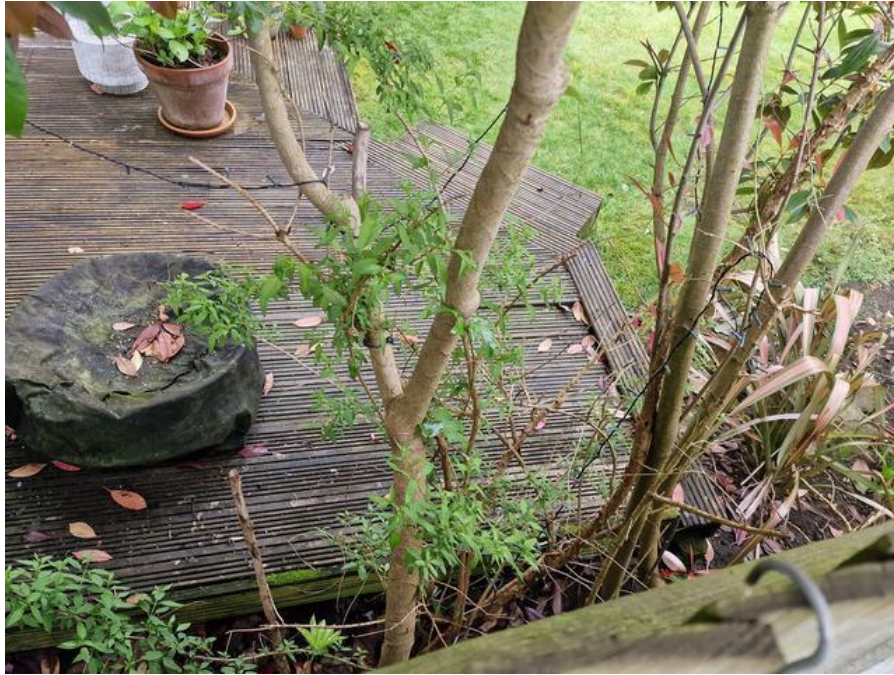
Image 5 Roots of Plant 2 a Paper plant and Plant 3 a Photinia in G01.

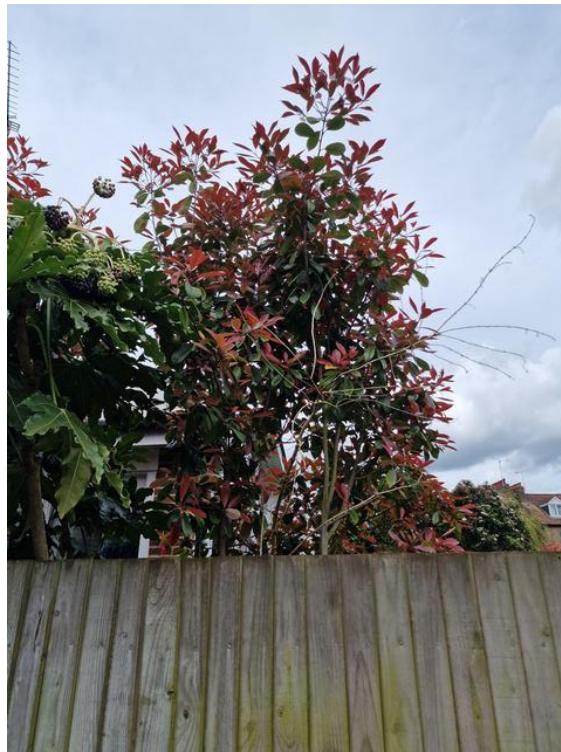
Image 6 Plant 3 of G01 a Photinia.

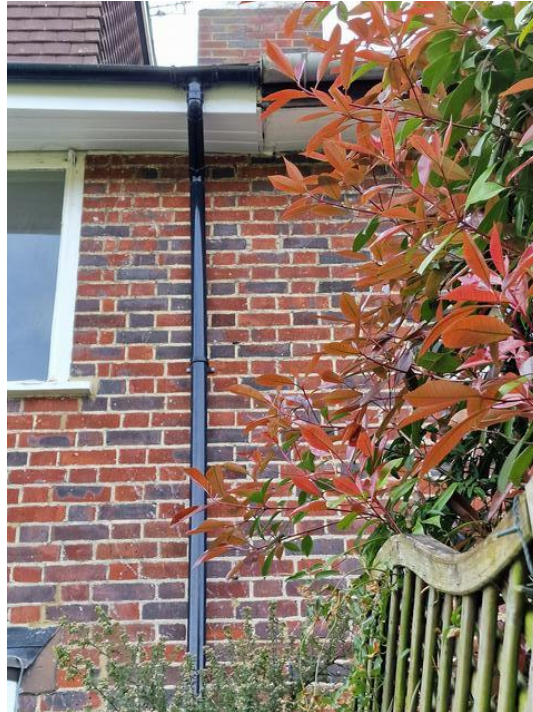
Image 7 No overhang from Plant 1 the Photinia in relation to the building line.

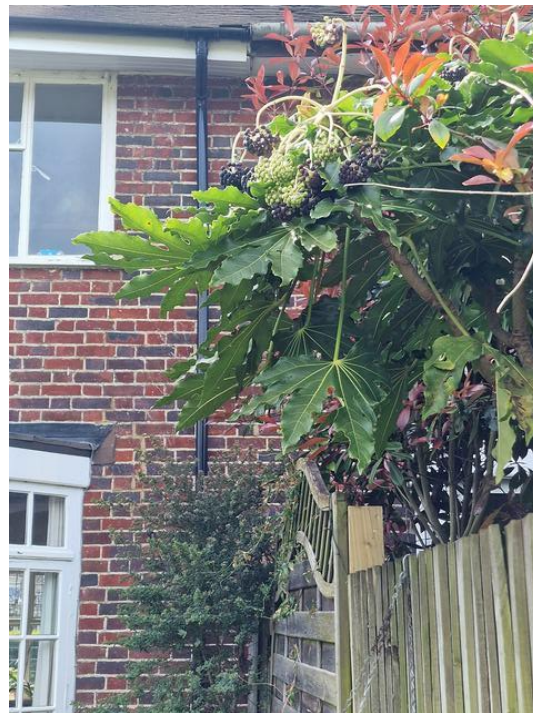
Image 8 Very limited overhang from Plant 2 the Paper plant in relation to building line.

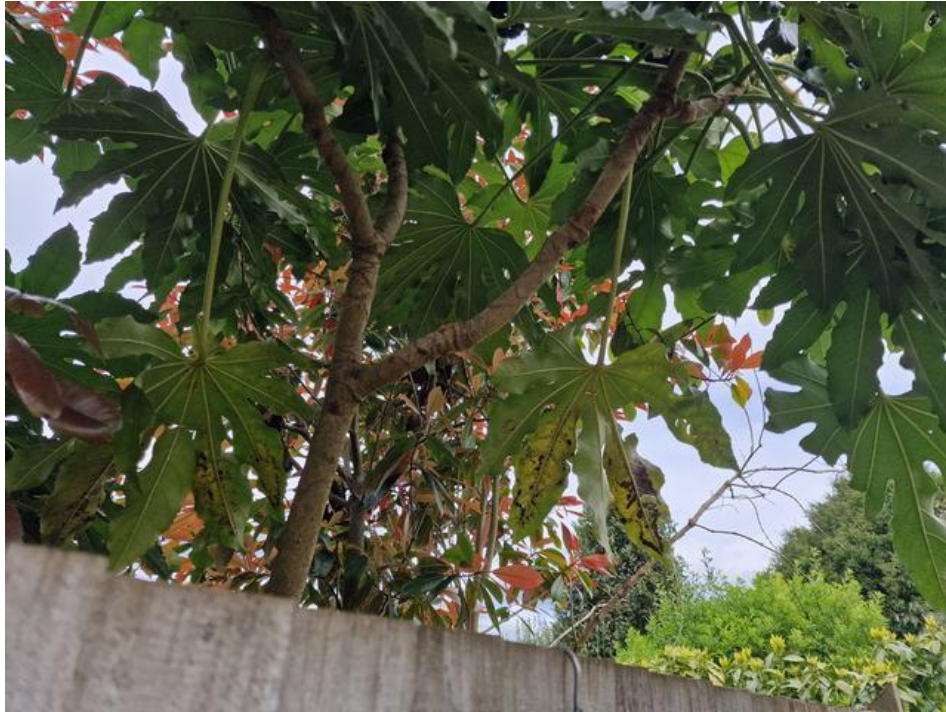
Image 9 One exceedingly small diameter (20 mm), branch to be cut back to the boundary.

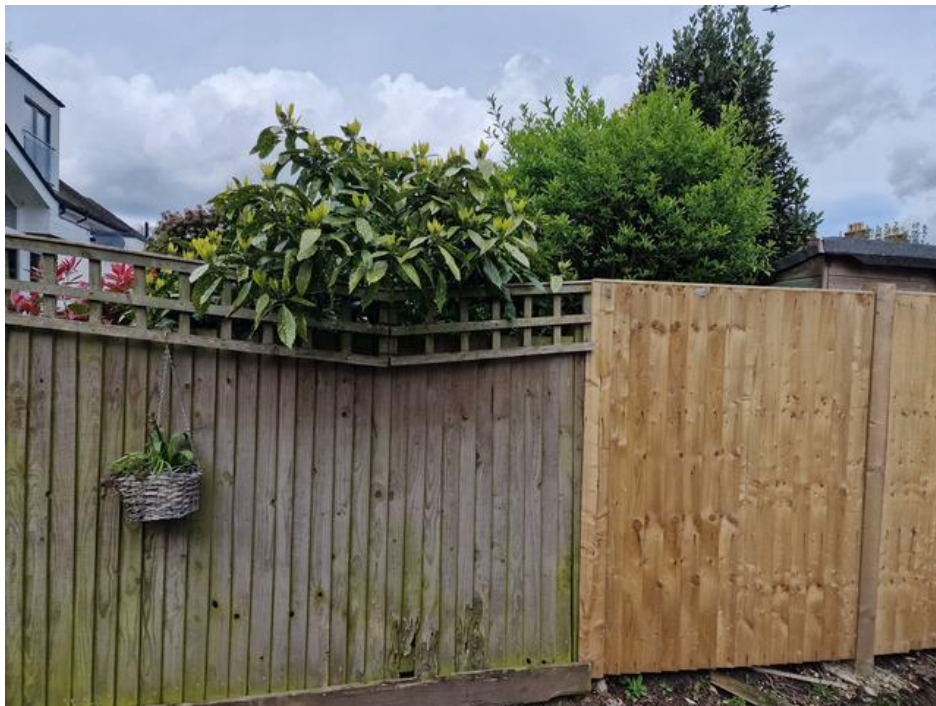
Image 10 G02 a spotted laurel and a spindle tree on the adjacent property.

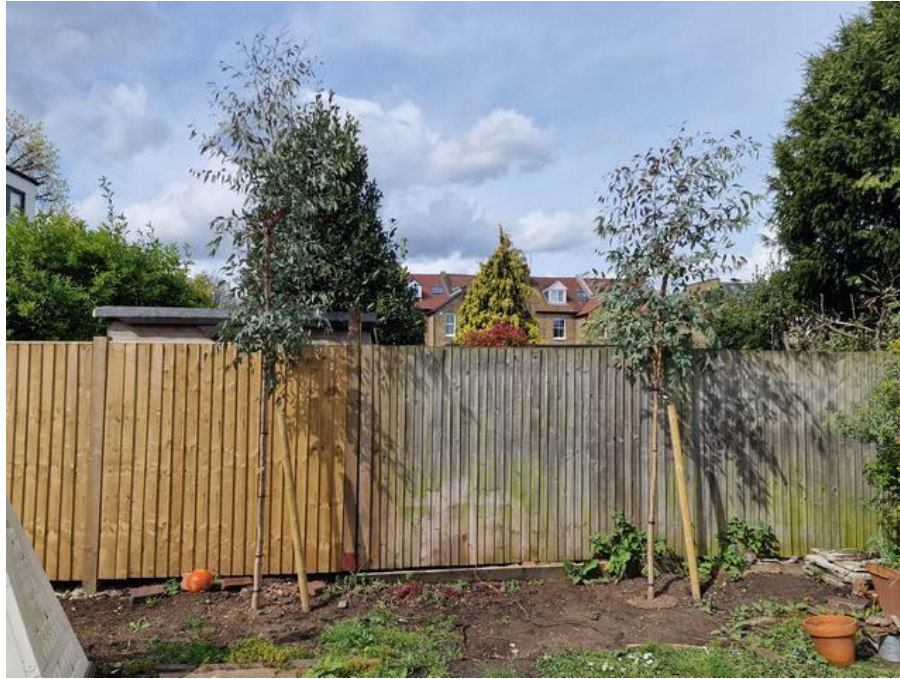
- 2.2.4** There were a total of three individual trees and three groups of trees surveyed. This comprised of two individual eucalyptus trees in the clients property, see Image 11 in Appendix III, that were both new plantings and categorised as C1 trees, and a B1 yew tree with minor bark damage, which was at the end of the adjacent property, see Images 12 and 13.

Image 11 T01 and T02 both recently planted eucalyptus trees in the clients property.

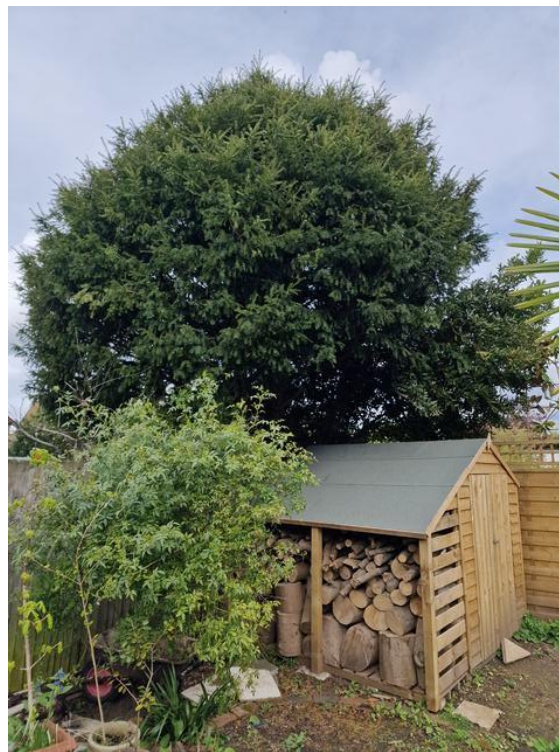
Image 12 T03 a yew tree in the adjacent property at the bottom of the garden.

Ref	Species	Measurements	Spread	General Observations	Retention Category	RPA	Recommendations	Condition	Reinspect
T03	English yew <i>(Taxus baccata)</i>	Height (m): 6.5 Stem Diam(mm): 270# Spread (m): 3.5N, 3.5E, 3.5S, 3.5W Crown Clearance (m): 2 Life Stage: Young Rem. Contrib.: 20+ Years	N:3.5 E:3.5 S:3.5 W:3.5	Just inside adjacent property. Minor bark damage at around 2 m on the south west side. Formatively pruned.	B1	Radius: 3.2m. Area: 32 sq. m.	NAR	Physiological Cond: Good Structural Cond: Fair Bat Habitat: Low	3 Yrs.

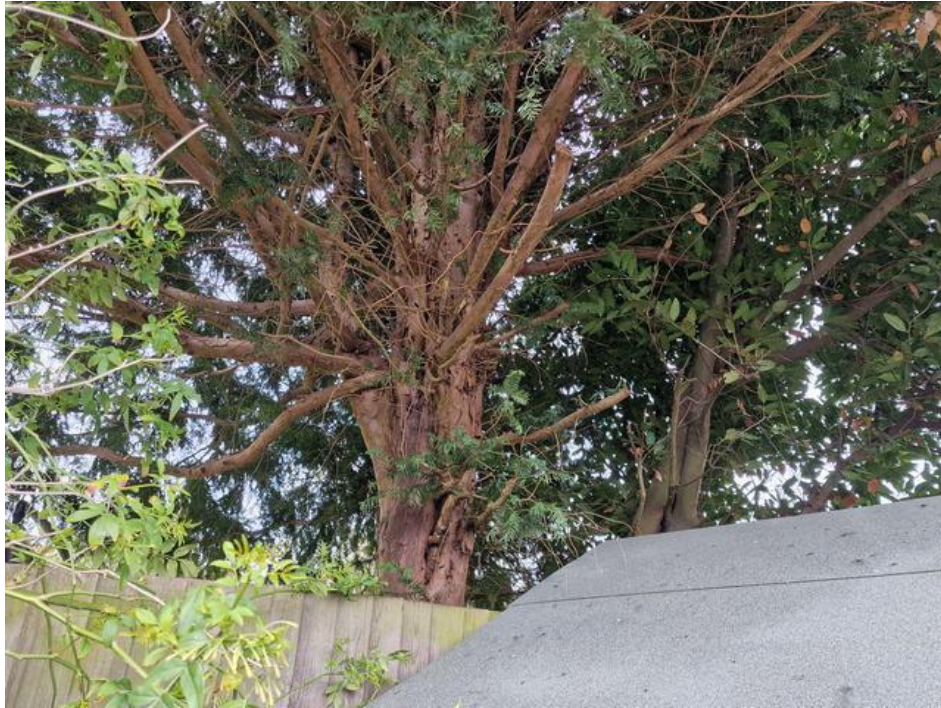
Image 13 Monor bark damage on the yew tree at around 2m on the main trunk.

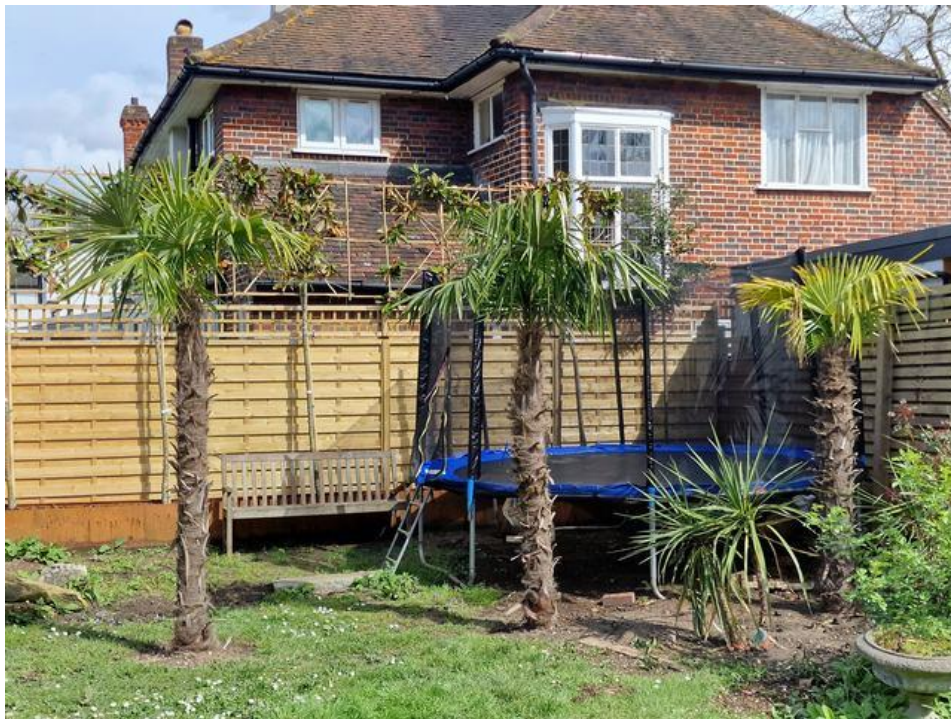
Image 14 Group G03 a row of three fan palms at the far end of the clients garden.

Ref	Species	Measurements	Spread	General Observations	Retention Category	RPA	Recommendations	Condition	Reinspect
G03	Mixed species (Mixed species)	Height (m): 2.5 Stem Diam(mm): 100 Spread (m): 0.5N, 0.5E, 0.5S, 0.5W Crown Clearance (m): 2 Life Stage: Young Rem. Contrib.: 10+ Years	N:0.5 E:0.5 S:0.5 W:0.5	Three fan palms in a row.	C1	Area: 31 sq. m.	NAR	Physiological Cond: Good Structural Cond: Good Bat Habitat: None	3 Yrs.
T01	Eucalyptus (<i>Eucalyptus sp.</i>)	Height (m): 5 Stem Diam(mm): 30 Spread (m): 0.5N, 0.5E, 0.5S, 0.5W Crown Clearance (m): 2 Life Stage: Newly planted Rem. Contrib.: 10+ Years	N:0.5 E:0.5 S:0.5 W:0.5	Recently planted tree just inside client property.	C1	Radius: 0.4m. Area: 1 sq. m.	NAR	Physiological Cond: Good Structural Cond: Good Bat Habitat: None	3 Yrs.
T02	Eucalyptus (<i>Eucalyptus sp.</i>)	Height (m): 4.5 Stem Diam(mm): 40 Spread (m): 0.5N, 0.5E, 0.5S, 0.5W Crown Clearance (m): 2 Life Stage: Newly planted Rem. Contrib.: 10+ Years	N:0.5 E:0.5 S:0.5 W:0.5	Recently planted tree just inside client property.	C1	Radius: 0.5m. Area: 1 sq. m.	NAR	Physiological Cond: Good Structural Cond: Good Bat Habitat: None	3 Yrs.

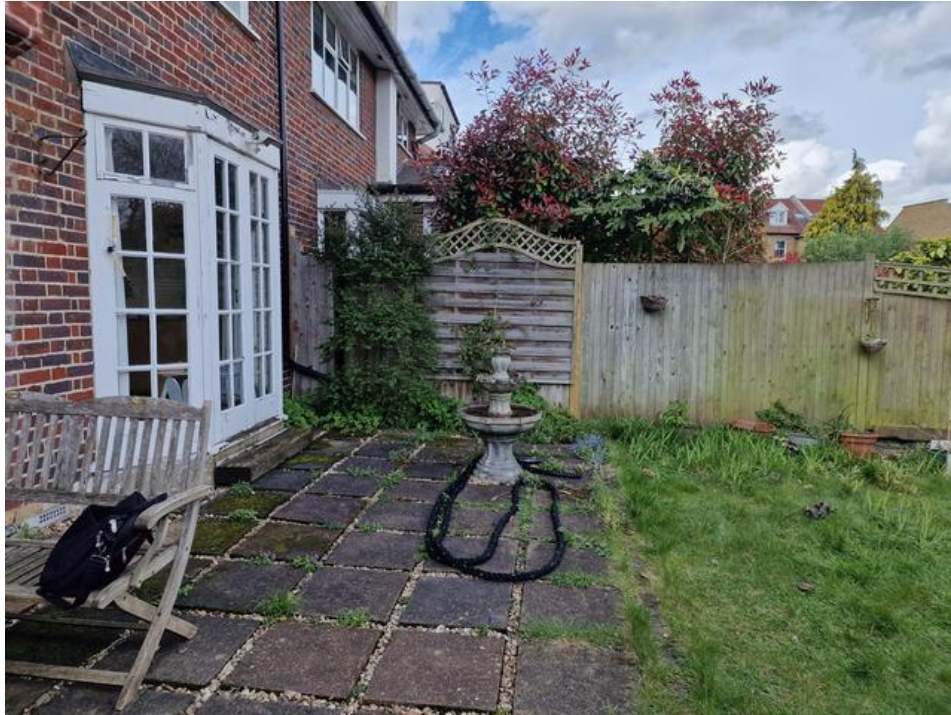
2.3.1 The proposed works consist of a rear extension, extending between 3 m and 4 m from the rear of the current wall. This area is already almost entirely covered by paving see Image 15 in Appendix III.

Image 15 Existing patio covering 3.4 m of the proposed extension.

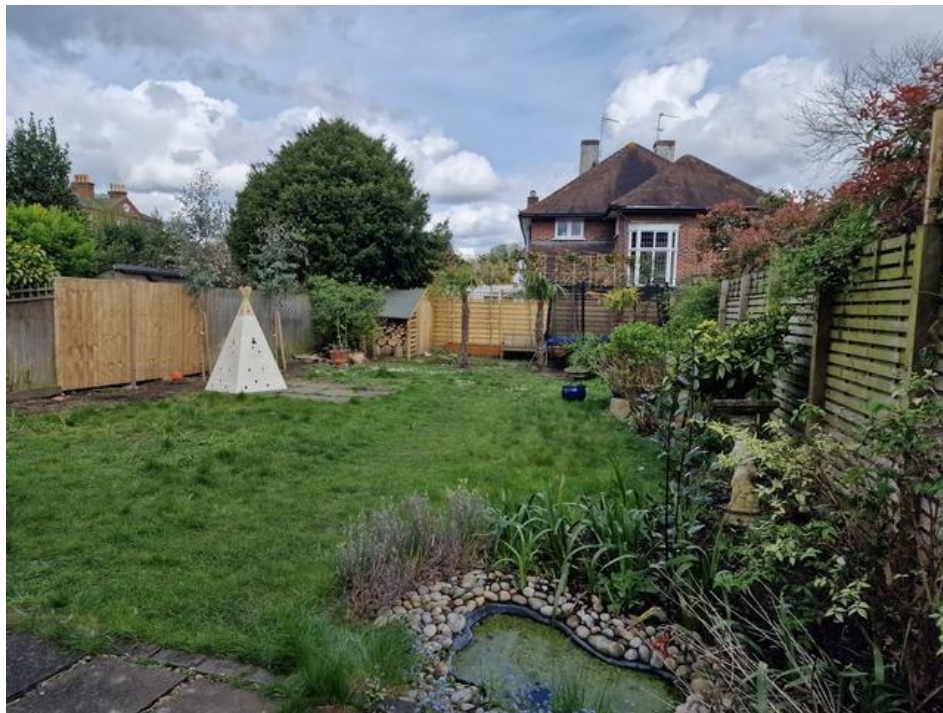
3.1.2 The client has informed me that there are no TPOs in place on or adjacent to the property. I have not been able to confirm this online as there is not a publicly accessible TPO map on the Richmond website. The only tree that is potentially covered by a TPO would be the yew tree at the far end of the garden, far away from the proposed works and protected by the shed, see Image 16 in Appendix III.

Image 16 View down the clients garden showing the distance to the trees and G03.

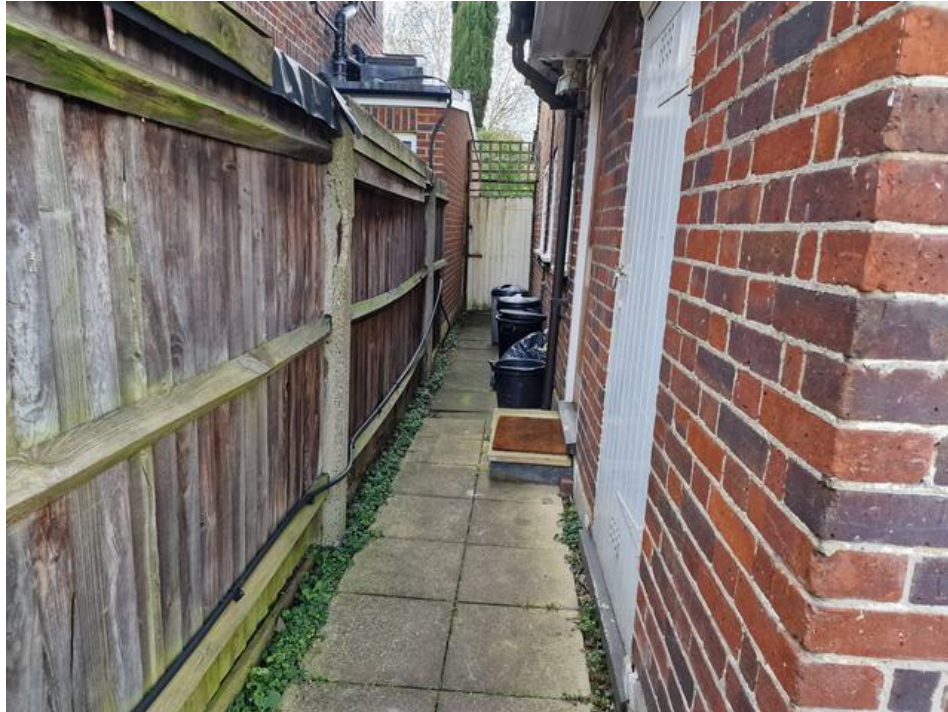
3.3.4 Site access will be from the south-western end of the site, which is the existing entrance and driveway. There is a pedestrian access around the southeastern side of the building, to get to the back garden, see Images 17 and 18 in Appendix III.

Image 17 Side entrance viewed from the back garden.

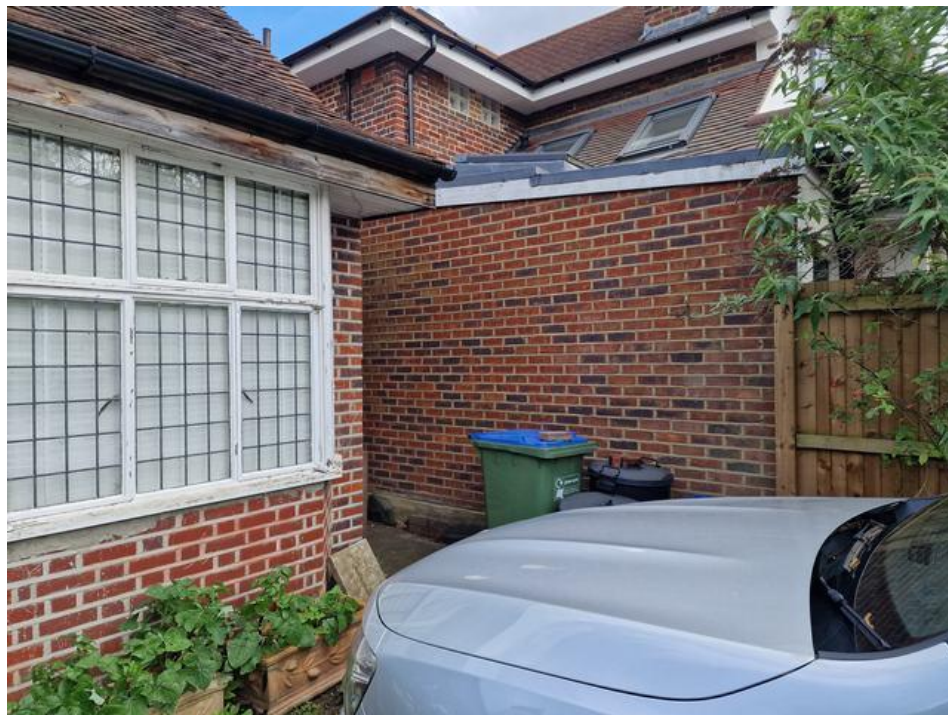
Image 18 Side entrance viewed from the front garden.
