**Arboricultural Report – Thomas’s College:
Tree Survey,
Arboricultural Impact Assessment,
Arboricultural Method Statement
& Tree Protection Plan**

Thomas’s College, Queen's Rd, Richmond Hill, London. TW10 6JP.

25th October 2024

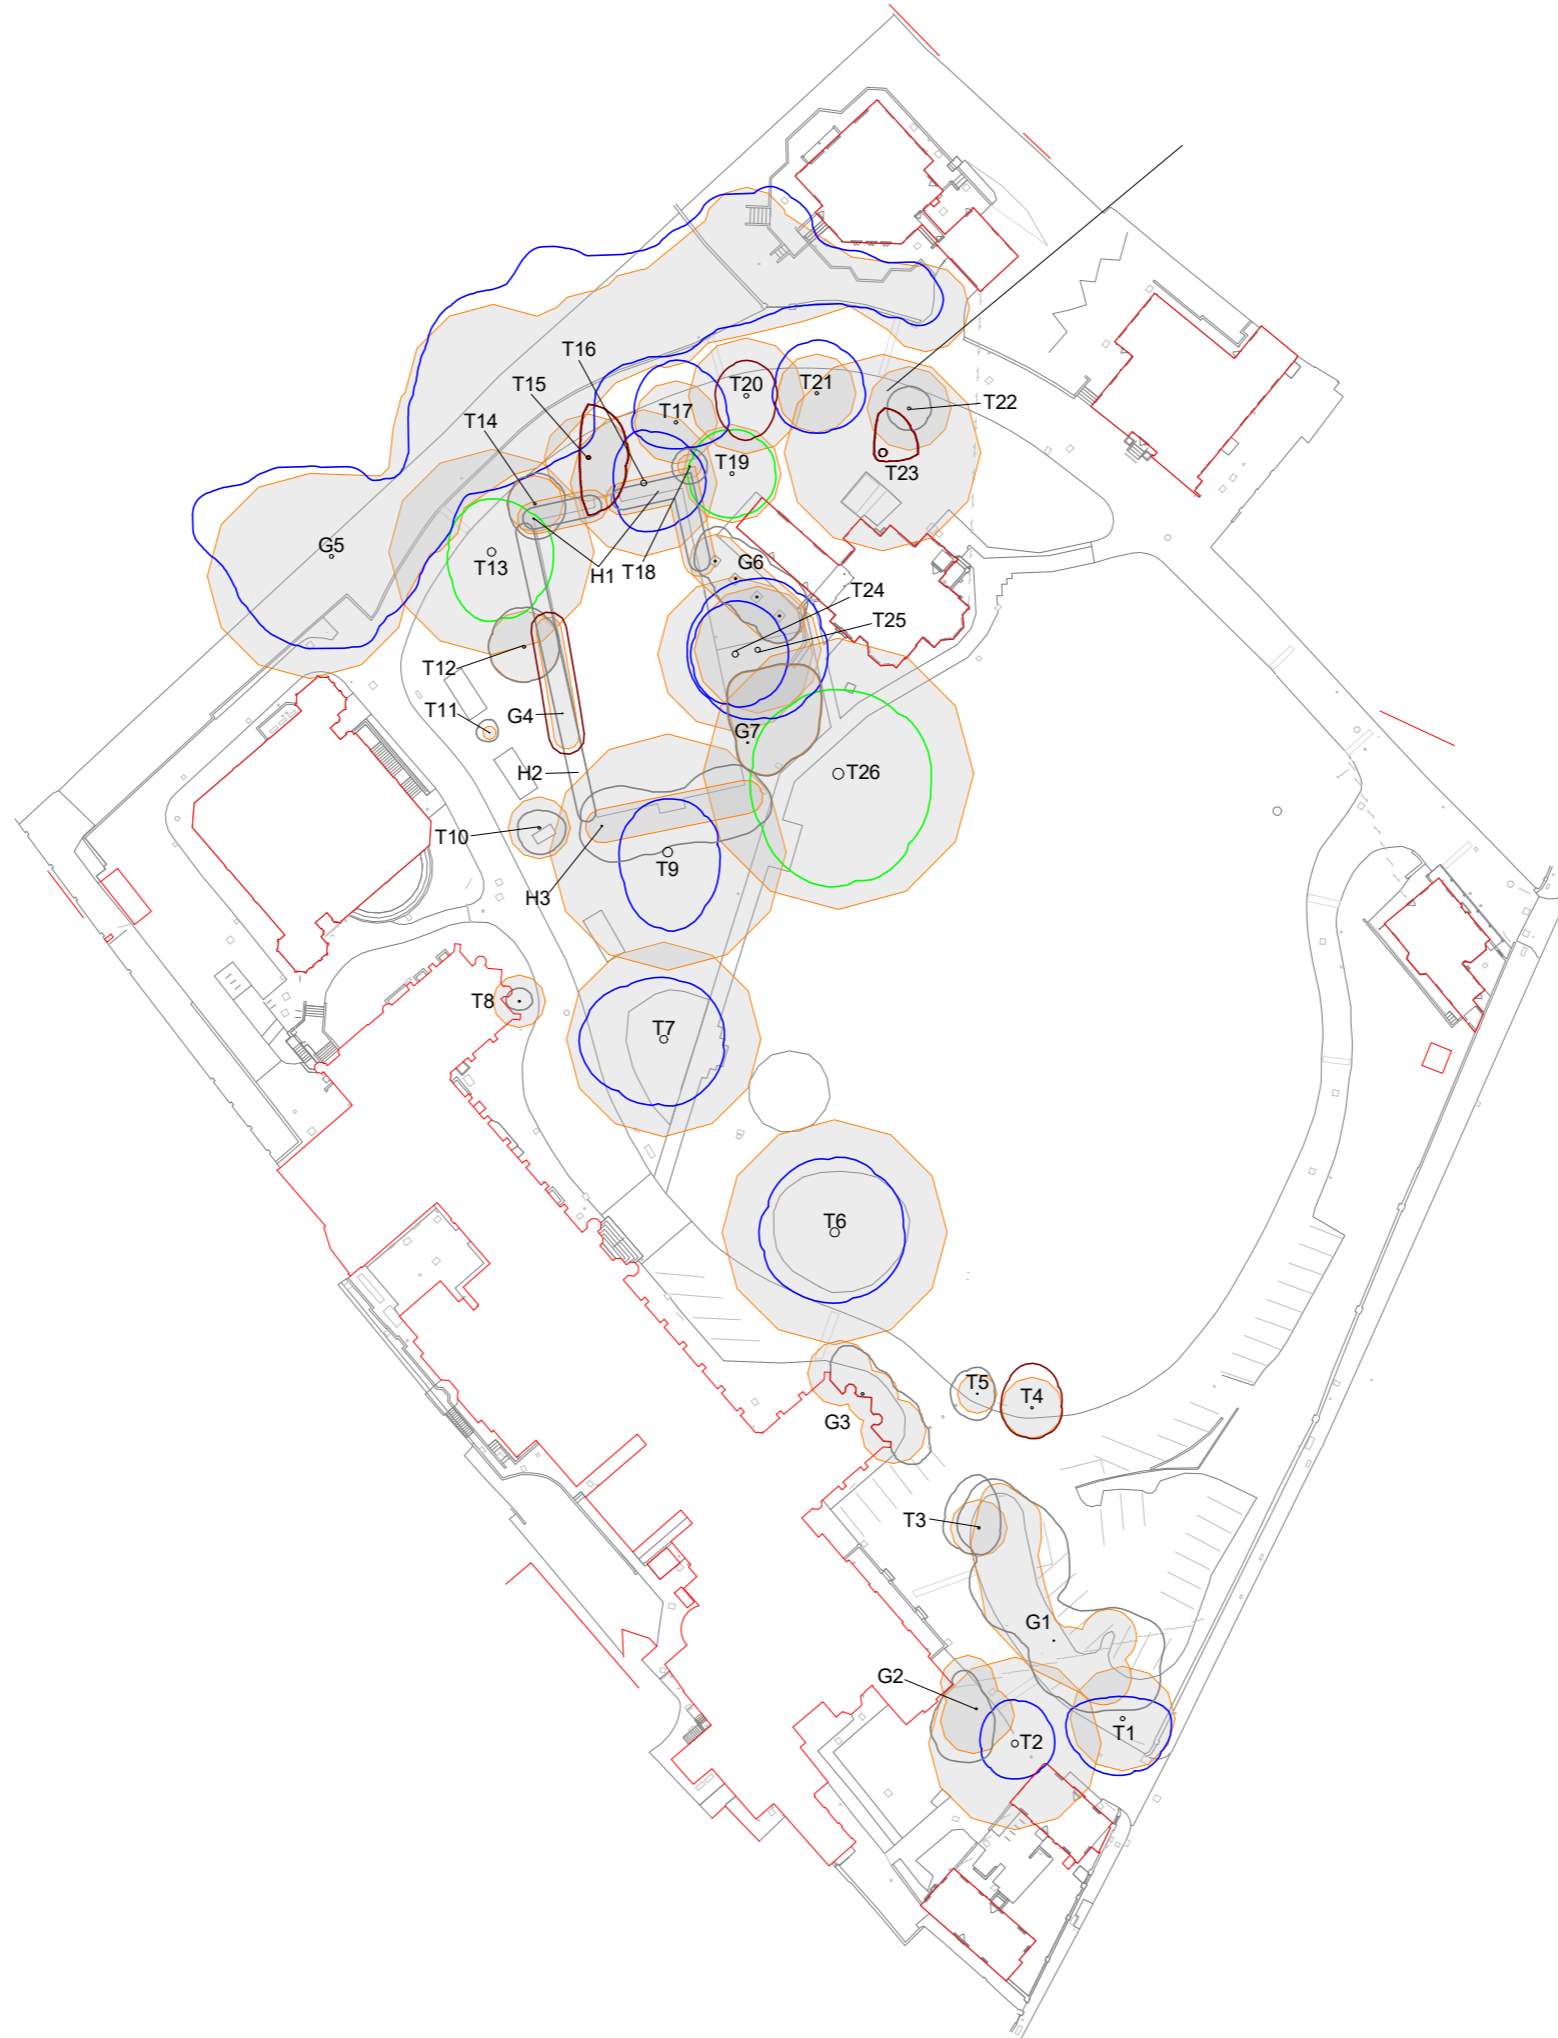
MAP FILENAME : Figure 2 - TPP Thomas-s College 2024

To be read in conjunction with Arb Report - Thomas's College.

6.8.3 Recommended planting placement has been plotted on the Tree Protection Plan - Figure 2. Locations have been selected based on the species requirements and with a view to maintain and improve the overall arboricultural value and visual amenity of the site. Care has been taken to consider the various vistas both on and off site.
